Appendix L

Investigation Report for Exceedances

Entrusted Portion of Widening of Tolo Highway / Fanling Highway between Island House Interchange and Fanling Stage 2

Investigation Report of Environmental Quality Exceedance(s)

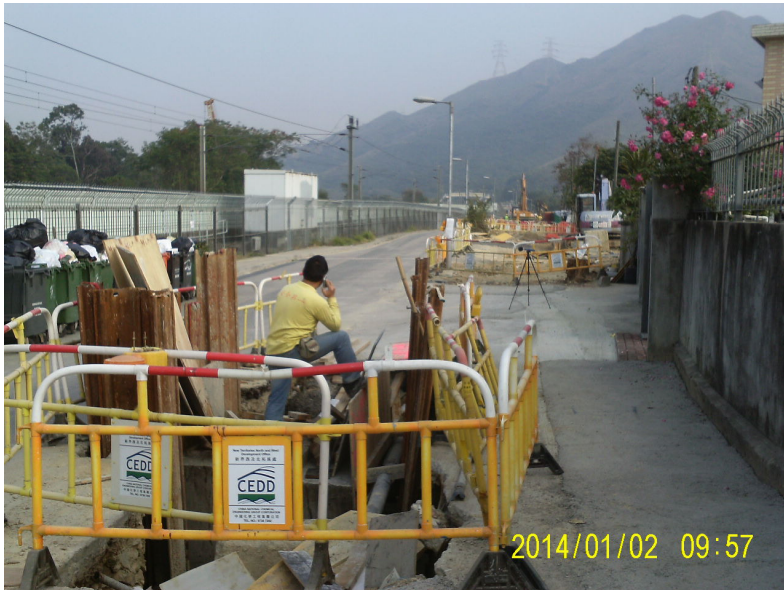
Date	2 January 2014
Time	--
Monitoring Location	SR77
Parameter	24-Hr Total Suspended Particulate
Action / Limit Levels	Action Level: 170.3µg/m ³ Limit Level: 260µg/m ³
Measured Level	200.5µg/m ³ (Action level being exceeded)
Possible reason for the exceedance	<p>It was noticed that there were construction works being undertaken by another Contractor which then occurred in very close proximity (about 5m) to the High Volume Sampler (HVS) of the air quality monitoring station at SR77 (refer to the attached photo).</p> <p>Such works mainly involved excavation of earth materials, operation of excavator (with exhaust emission), handling and moving of earth materials, etc. These construction works are anticipated to have considerable suspended particulates impact that may lead to high TSP levels as have been measured by the nearby HVS.</p> <p>On the other hand, as there were no records of large scale excavation and earth movement works carried out for the Entrusted Works. Only the extension of box culverts were undertaken during the monitoring, which were at a much farther distance from the air quality monitoring station at SR77 (refer to the attached location plan showing the works activities of the entrusted portion).</p> <p>As a conclusion, the exceedance was unlikely due to the construction works of the project.</p>

Construction works observed within close proximity of SR77 (Date: 2 January 2014)

Action taken / to be taken	<p>As the exceedance was non-project related, no further investigation and specific remedial measure(s) would be recommended for the Entrusted Works.</p> <p>Nevertheless, the following mitigation measures had been implemented on-site for dust suppression:</p> <ol style="list-style-type: none"> 1. Exposed slopes near the river were covered with impervious sheets; 2. Any open stockpile of construction materials were covered with impervious sheet; 3. Sufficient watering was applied along the haul road.
Remarks	-

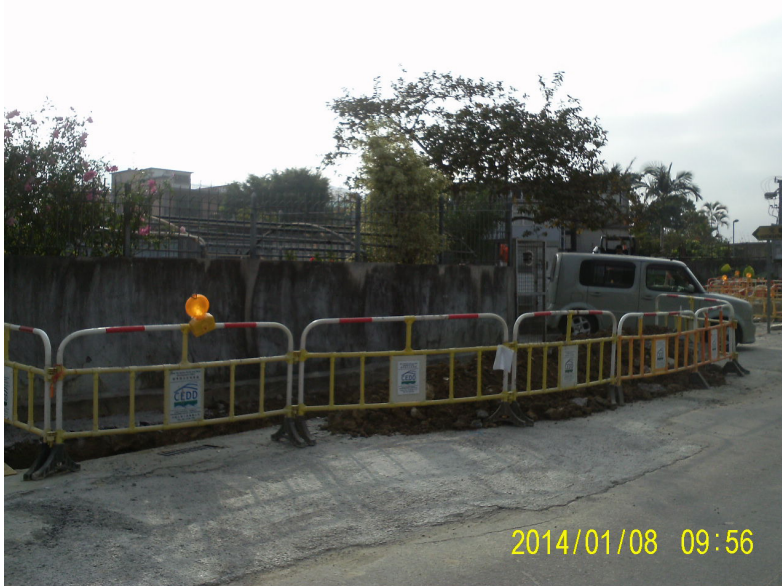
Date	8 January 2014
Time	--
Monitoring Location	SR77
Parameter	24-Hr Total Suspended Particulate
Action / Limit Levels	Action Level: 170.3µg/m ³ Limit Level: 260µg/m ³
Measured Level	229.5µg/m ³ (Action level being exceeded)
Possible reason for the exceedance	<p>It was noticed that there were construction works being undertaken by another Contractor (under Contract No. TP/2010/02) which then occurred in very close proximity (less than 1m) to the High Volume Sampler (HVS) of the air quality monitoring station at SR77 (refer to the attached photo).</p> <p>Such works mainly involved excavation of earth materials, operation of excavator (with exhaust emission), handling and moving of earth materials, etc. These construction works are anticipated to have considerable suspended particulates impact that may lead to high TSP levels as have been measured by the nearby HVS.</p> <p>The construction works is anticipated to be completed by the end of April.</p> <p>On the other hand, as there were no records of large scale excavation and earth movement works carried out for the Entrusted Works. Only the extension of box culverts were undertaken during the monitoring, which were at a much farther distance from the air quality monitoring station at SR77 (refer to the attached location plan showing the works activities of the entrusted portion).</p> <p>As a conclusion, the exceedance was unlikely due to the construction works of the project.</p>

Construction works observed within close proximity of SR77 (Date: 8 January 2014)

Action taken / to be taken	<p>As the exceedance was non-project related, no further investigation and specific remedial measure(s) would be recommended for the Entrusted Works.</p> <p>Nevertheless, the following mitigation measures had been implemented on-site for dust suppression:</p> <ol style="list-style-type: none"> 1. Exposed slopes near the river were covered with impervious sheets; 2. Any open stockpile of construction materials were covered with impervious sheet; 3. Sufficient watering was applied along the haul road.

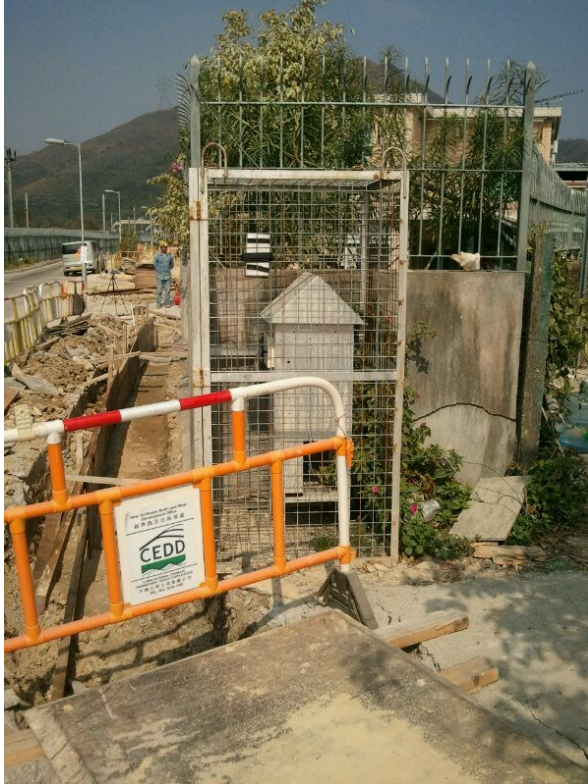
Date	14 January 2014
Time	--
Monitoring Location	SR77
Parameter	24-Hr Total Suspended Particulate
Action / Limit Levels	Action Level: 170.3µg/m ³ Limit Level: 260µg/m ³
Measured Level	210µg/m ³ (Action level being exceeded)
Possible reason for the exceedance	<p>It was noticed that there were construction works being undertaken by another Contractor (under Contract No. TP/2010/02) which then occurred immediately next to the High Volume Sampler (HVS) of the air quality monitoring station at SR77 (refer to the attached photo).</p> <p>Such works mainly involved excavation of earth materials, operation of excavator (with exhaust emission), handling and moving of earth materials, etc. These construction works are anticipated to have considerable suspended particulates impact that may lead to high TSP levels as have been measured by the nearby HVS.</p> <p>The construction works is anticipated to be completed by the end of April.</p> <p>On the other hand, as there were no records of large scale excavation and earth movement works carried out for the Entrusted Works. Only the extension of box culverts were undertaken during the monitoring, which were at a much farther distance from the air quality monitoring station at SR77 (refer to the attached location plan showing the works activities of the entrusted portion).</p> <p>As a conclusion, the exceedance was unlikely due to the construction works of the project.</p>

Construction works observed within close proximity of SR77 (Date: 14 January 2014)

Action taken / to be taken	<p>As the exceedance was non-project related, no further investigation and specific remedial measure(s) would be recommended for the Entrusted Works.</p> <p>Nevertheless, the following mitigation measures had been implemented on-site for dust suppression:</p> <ol style="list-style-type: none"> 1. Exposed slopes near the river were covered with impervious sheets; 2. Any open stockpile of construction materials were covered with impervious sheet; 3. Sufficient watering was applied along the haul road.

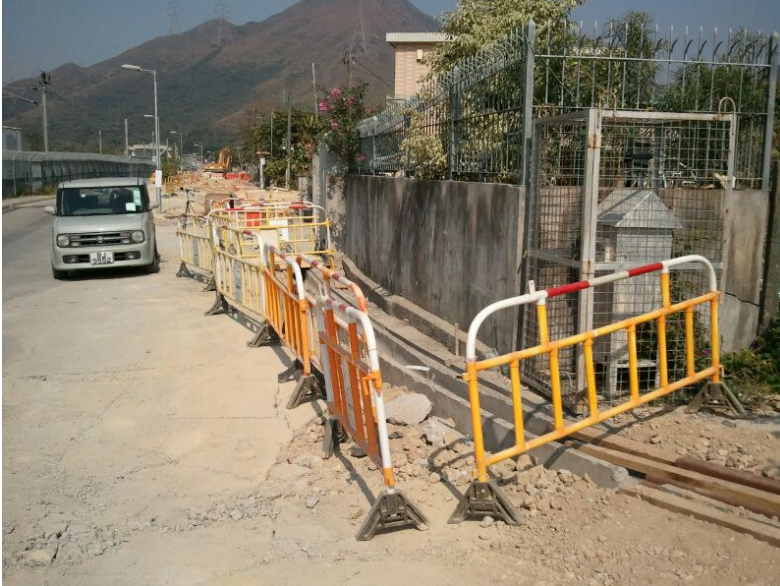
Date	20 January 2014
Time	--
Monitoring Location	SR77
Parameter	24-Hr Total Suspended Particulate
Action / Limit Levels	Action Level: 170.3µg/m ³ Limit Level: 260µg/m ³
Measured Level	322.8µg/m ³ (Limit level being exceeded)
Possible reason for the exceedance	<p>It was noticed that there were construction works being undertaken by another Contractor (under Contract No. TP/2010/02) which then occurred immediately next to the High Volume Sampler (HVS) of the air quality monitoring station at SR77 (refer to the attached photo).</p> <p>Such works mainly involved excavation of earth materials, operation of excavator (with exhaust emission), handling and moving of earth materials, etc. These construction works are anticipated to have considerable suspended particulates impact that may lead to high TSP levels as have been measured by the nearby HVS.</p> <p>The construction works is anticipated to be completed by the end of April.</p> <p>On the other hand, as there were no records of large scale excavation and earth movement works carried out for the Entrusted Works. Only the extension of box culverts were undertaken during the monitoring, which were at a much farther distance from the air quality monitoring station at SR77 (refer to the attached location plan showing the works activities of the entrusted portion).</p> <p>As a conclusion, the exceedance was unlikely due to the construction works of the project.</p>

Construction works observed within close proximity of SR77 (Date: 20 January 2014)

Action taken / to be taken	<p>As the exceedance was non-project related, no further investigation and specific remedial measure(s) would be recommended for the Entrusted Works.</p> <p>Nevertheless, the following mitigation measures had been implemented on-site for dust suppression:</p> <ol style="list-style-type: none"> 1. Exposed slopes near the river were covered with impervious sheets; 2. Any open stockpile of construction materials were covered with impervious sheet; 3. Sufficient watering was applied along the haul road.

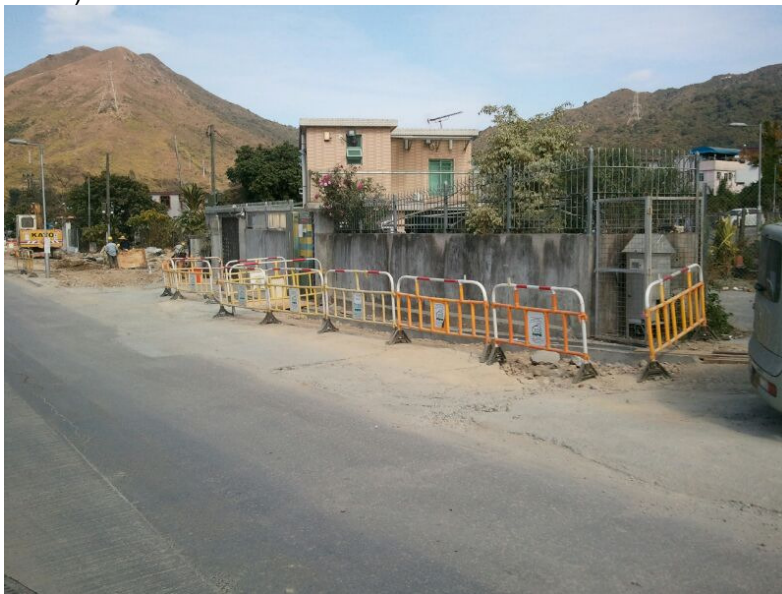
Date	25 January 2014
Time	--
Monitoring Location	SR77
Parameter	24-Hr Total Suspended Particulate
Action / Limit Levels	Action Level: $170.3\mu\text{g}/\text{m}^3$ Limit Level: $260\mu\text{g}/\text{m}^3$
Measured Level	$172.0\mu\text{g}/\text{m}^3$ (Action level being exceeded)
Possible reason for the exceedance	<p>It was noticed that there were construction works being undertaken by another Contractor (under Contract No. TP/2010/02) which then occurred immediately next to the High Volume Sampler (HVS) of the air quality monitoring station at SR77 (refer to the attached photo).</p> <p>Such works mainly involved excavation of earth materials, operation of excavator (with exhaust emission), handling and moving of earth materials, etc. These construction works are anticipated to have considerable suspended particulates impact that may lead to high TSP levels as have been measured by the nearby HVS.</p> <p>The construction works is anticipated to be completed by the end of April.</p> <p>Also, the HVS is located close to roadside. When there is traffic, the vehicles may disturb the fugitive dust from nearby open excavation sites, generates dust impact and affects the TSP results recorded by the HVS.</p> <p>On the other hand, construction works carried out during the monitoring period include backfilling works being carried out at northern side of the site and extension of box culverts, which were at a much farther distance from the air quality monitoring station at SR77 (refer to the attached location plan showing the works activities of the entrusted portion).</p> <p>Hence, considered the fact that TSP level has only marginally exceeded the action level by about $2\mu\text{g}/\text{m}^3$ and the exceedance is regarded as minor, as a conclusion, the exceedance was unlikely due to the construction works of the project.</p>

Construction works observed within close proximity of SR77 (Date: 25 January 2014)

Action taken / to be taken	<p>As the exceedance was non-project related, no further investigation and specific remedial measure(s) would be recommended for the Entrusted Works.</p> <p>Nevertheless, the following mitigation measures had been implemented on-site for dust suppression:</p> <ol style="list-style-type: none"> 1. Exposed slopes near the river were covered with impervious sheets; 2. Any open stockpile of construction materials were covered with impervious sheet; 3. Sufficient watering was applied along the haul road.
Remarks	-

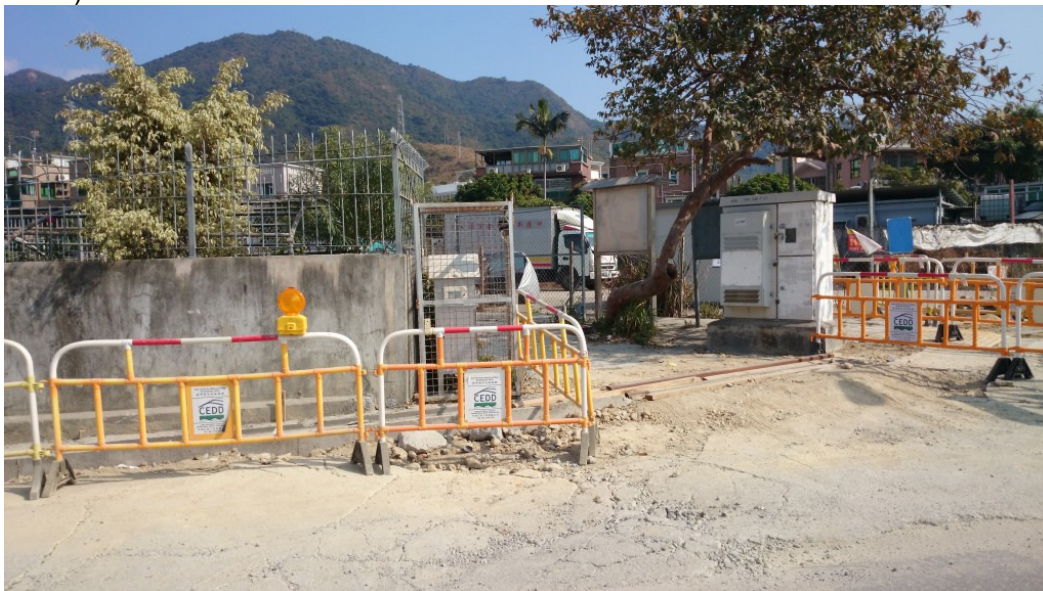
Date	30 January 2014
Time	--
Monitoring Location	SR77
Parameter	24-Hr Total Suspended Particulate
Action / Limit Levels	Action Level: $170.3\mu\text{g}/\text{m}^3$ Limit Level: $260\mu\text{g}/\text{m}^3$
Measured Level	$175.8\mu\text{g}/\text{m}^3$ (Action level being exceeded)
Possible reason for the exceedance	<p>It was noticed that there were construction works being undertaken by another Contractor (under Contract No. TP/2010/02) which then occurred immediately next to the High Volume Sampler (HVS) of the air quality monitoring station at SR77 (refer to the attached photo).</p> <p>Such works mainly involved excavation of earth materials, operation of excavator (with exhaust emission), handling and moving of earth materials, etc. These construction works are anticipated to have considerable suspended particulates impact that may lead to high TSP levels as have been measured by the nearby HVS.</p> <p>The construction works is anticipated to be completed by the end of April.</p> <p>Also, the HVS is located close to roadside. When there is traffic, the vehicles may disturb the fugitive dust from nearby open excavation sites, generates dust impact and affects the TSP results recorded by the HVS.</p> <p>On the other hand, construction works carried out during the monitoring period include backfilling works being carried out at northern side of the site and extension of box culverts, which were at a much farther distance from the air quality monitoring station at SR77 (refer to the attached location plan showing the works activities of the entrusted portion).</p> <p>Hence, considered the fact that TSP level has only marginally exceeded the action level by about $6\mu\text{g}/\text{m}^3$ and the exceedance is regarded as minor, as a conclusion, the exceedance was unlikely due to the construction works of the project.</p>

Construction works observed within close proximity of SR77 (Date: 30 January 2014)

Action taken / to be taken	<p>As the exceedance was non-project related, no further investigation and specific remedial measure(s) would be recommended for the Entrusted Works.</p> <p>Nevertheless, the following mitigation measures had been implemented on-site for dust suppression:</p> <ol style="list-style-type: none"> 1. Exposed slopes near the river were covered with impervious sheets; 2. Any open stockpile of construction materials were covered with impervious sheet; 3. Sufficient watering was applied along the haul road.
Remarks	-

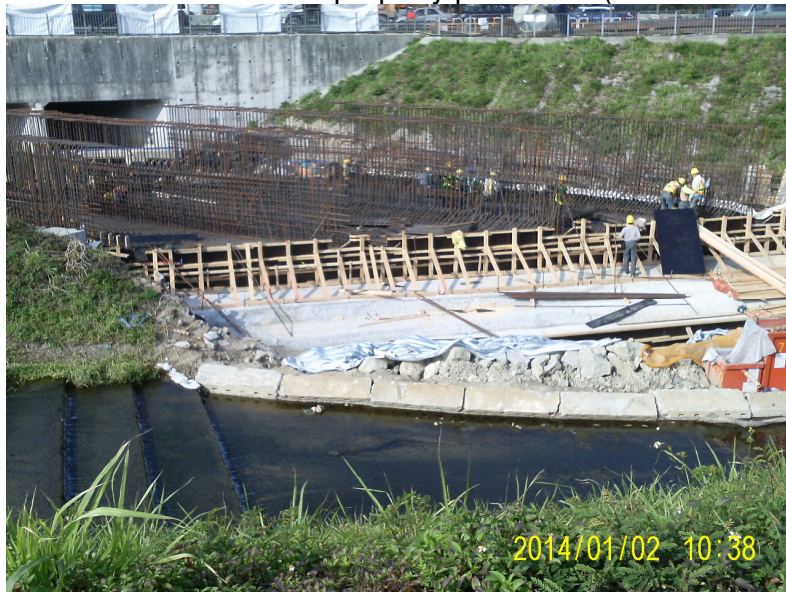
Construction works are properly protected. (Date: 2 January 2014)

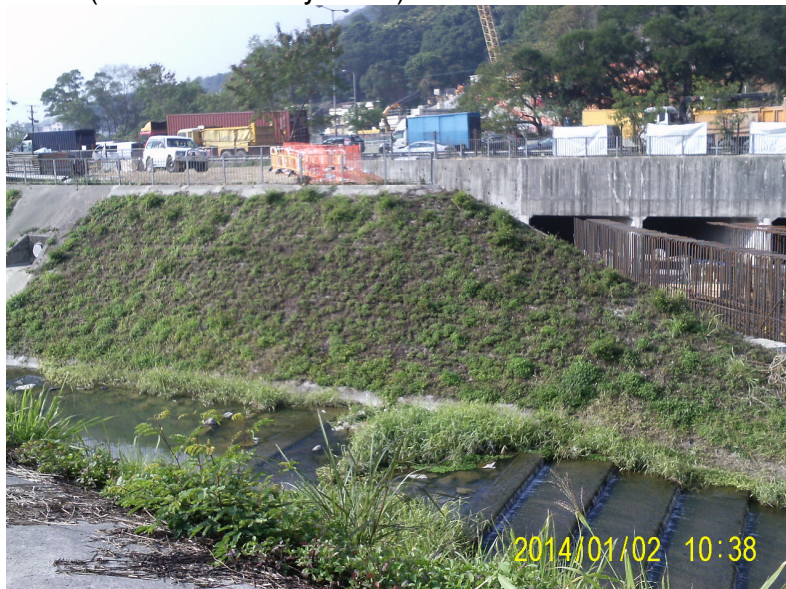
Date	2 January 2014
Time	10:44
Monitoring Location	I5
Parameter	Turbidity
Action / Limit Levels	Action level: 81.9 NTU or 120% of upstream control station's Tby of the same day (i.e. 31.1NTU) Limit Level: 91.9 NTU or 130% of upstream control station's Tby of the same day (i.e. 33.7NTU)
Measured Level	32.5NTU (Action level being exceeded - 120% of C3b)
Possible reason for the exceedance	<p>Construction within proximity of the river channel is listed as follows:</p> <p><u>Box Culvert ID4</u> Formworks erection for base slab</p> <p><u>Box Culvert ID5</u> Formworks erection for walls</p> <p>Construction works at the river stream are properly enclosed by a bund to avoid site runoff. No spillage is identified.</p> <p>Consider the suspended solids level for the water sample is only 9mg/L, which is significantly lower than the SS level in C3a (17.5mg/L) and C3b (21.5mg/L), it is considered that the exceedance would not due to the construction works.</p> <p>Site observation at C3b observed the river water quality would be at high turbidity level.</p> <p>For comparison, turbidity levels at C3a and C3b on 2 January 2014 are 18.9NTU and 25.9NTU respectively. During baseline monitoring the turbidity level can be as high as 86.9NTU and 116NTU at C3a and at C3b respectively. Recorded turbidity level at I5 has not exceeded the maximum recorded level of 92.3NTU during baseline monitoring.</p> <p>It is therefore considered that elevation of turbidity would be due to natural fluctuation.</p>

Site observation at C3b observed the river water quality would be at high turbidity level. (Date: 2 January 2014)

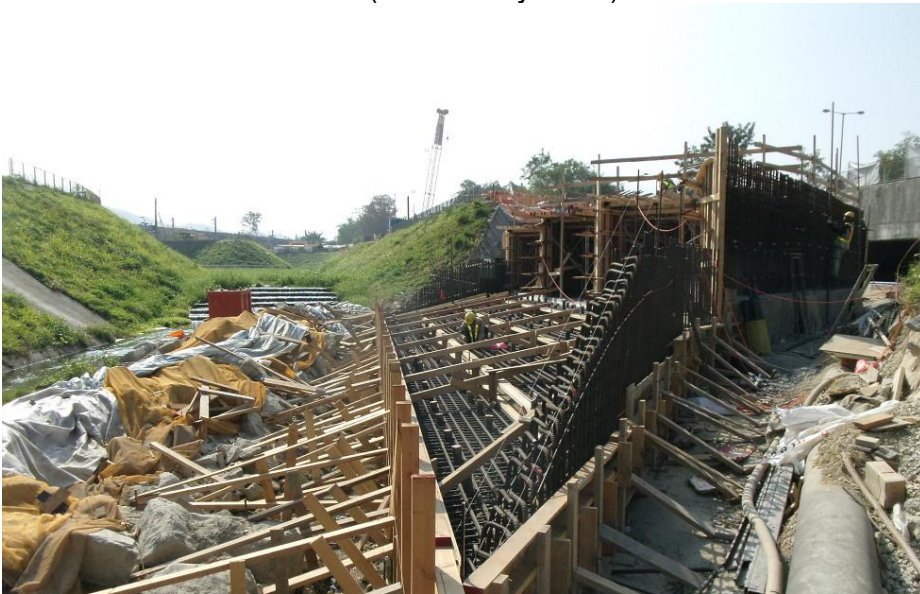
Construction works at ID4 (15 January 2014)

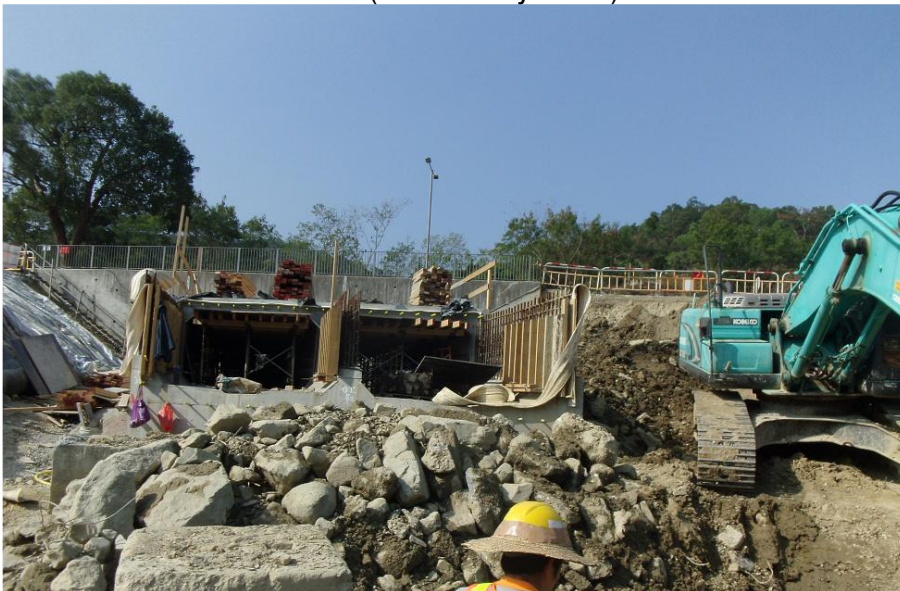
Construction works at ID5 (15 January 2014)

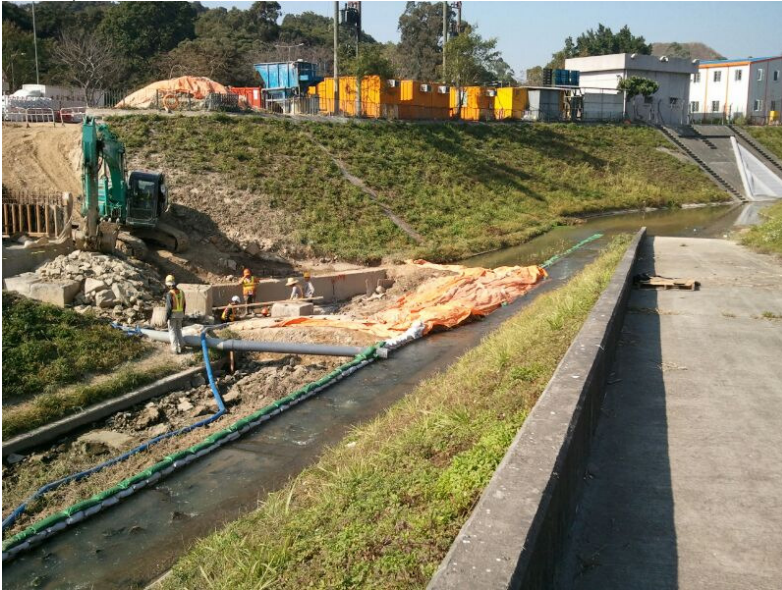
The construction works are properly protected with sand bags. (Date: 15 January 2014)

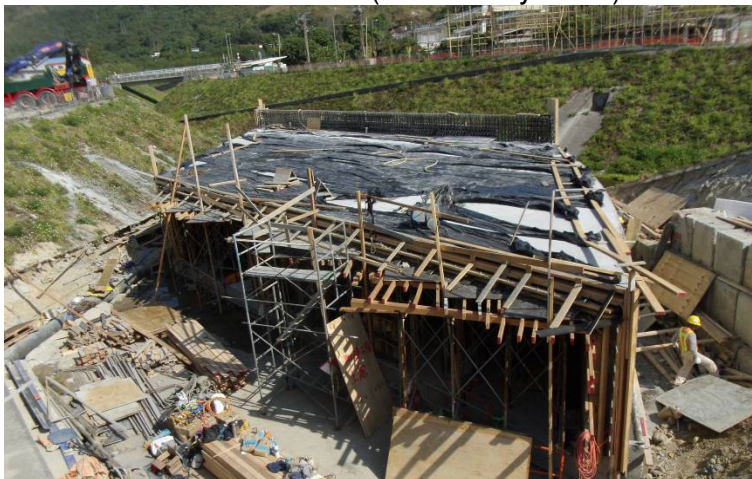
Construction works at ID4 (24 January 2014)

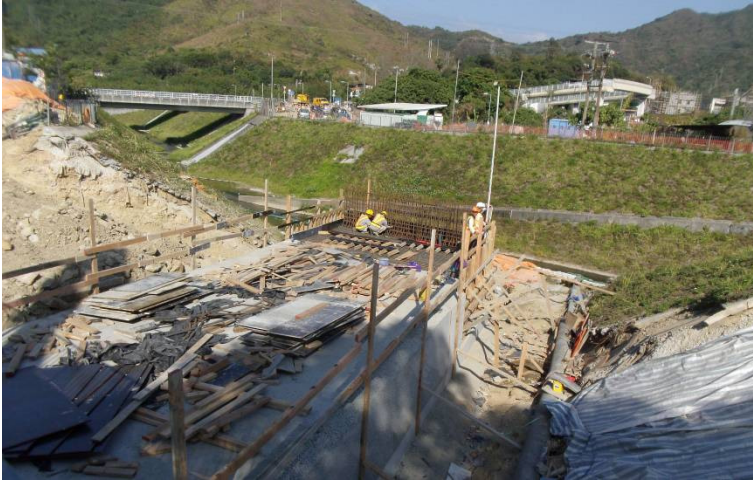
Construction works at ID5 (24 January 2014)

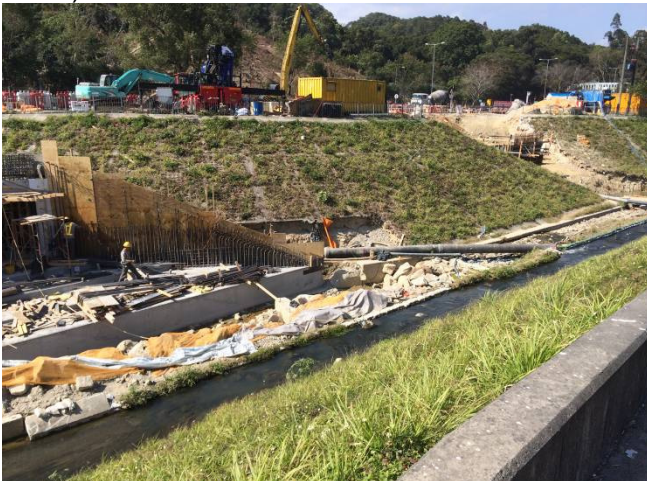
The construction works are properly protected with sand bags. (Date: 24 January 2014)

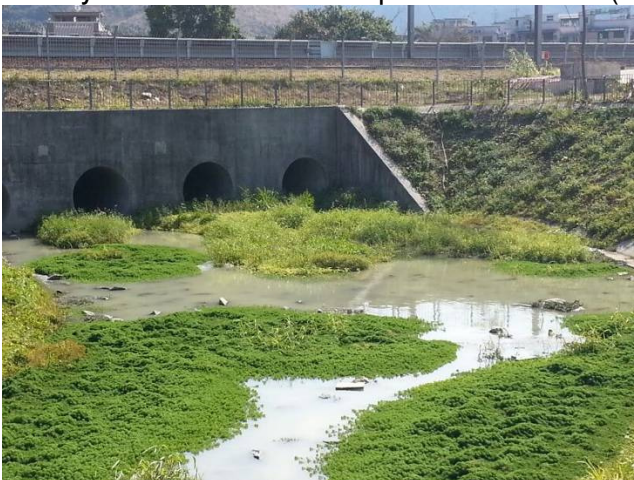
<p>Site walk at about 11:00 on the same day identified some muddy water being discharged at upstream of C5b. This may contribute to the elevation of SS level at I5. (refer to attached photos)</p> <p>Aquatic plants growth was also identified in the river course between C3a and I5. Since the location of plantation growth located before the Box Culvert ID4 the growth would not be introduced by construction works. The plants being washed away by the water would cause the level of suspended solid level to elevate. (refer to attached photos)</p> <p>It is therefore considered that elevation of suspended solids would be due to natural fluctuation.</p>
Action taken / to be taken	As the non-compliance was non-project related, no further investigation and remedial measure(s) would be required.
Remarks	-

Muddy water observed at upstream of C3b. (Date: 24 January 2014)
