Investigation Report for Exceedances

Entrusted Portion of Widening of Tolo Highway / Fanling Highway between Island House Interchange and Fanling Stage 2

Investigation Report of Environmental Quality Exceedance(s)

Ref. No.: W140207_SS

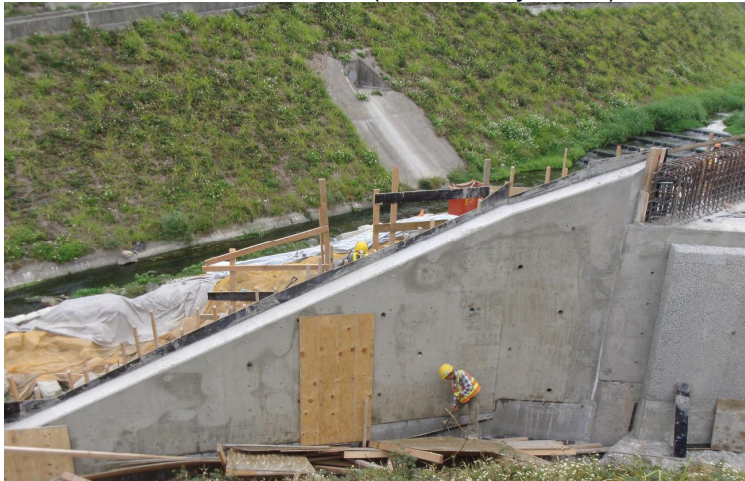
Construction works at ID4 (7 February 2014)

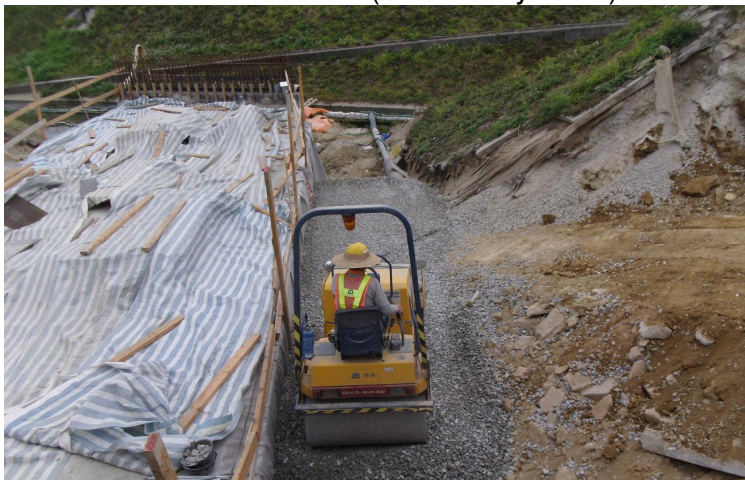
Construction works at ID5 (7 February 2014)

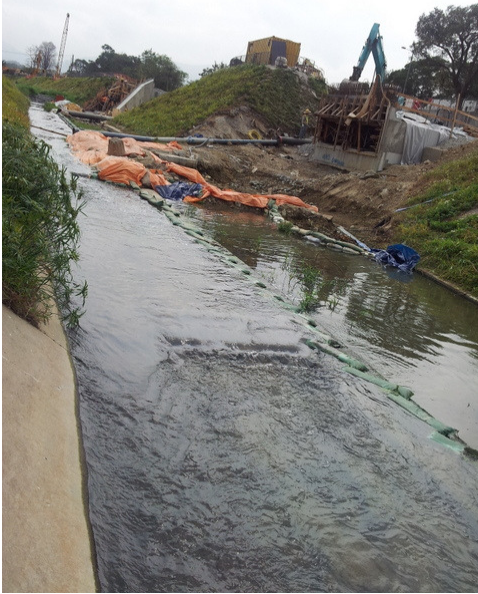
The construction works are properly protected with sand bags. (Date: 7 February 2014)

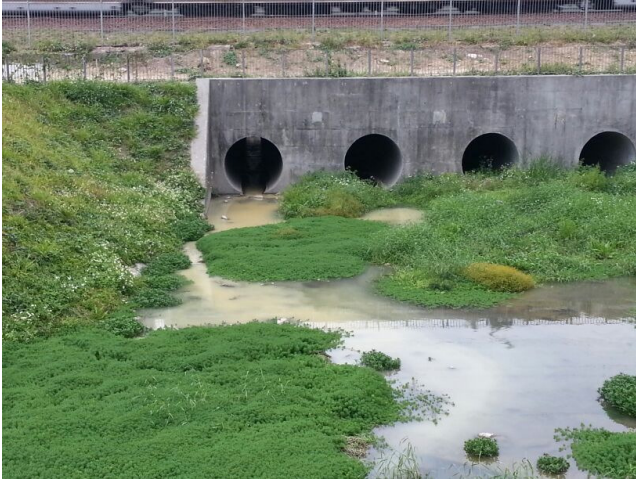
Muddy water observed at upstream of C3b. (Date: 7 February 2014)

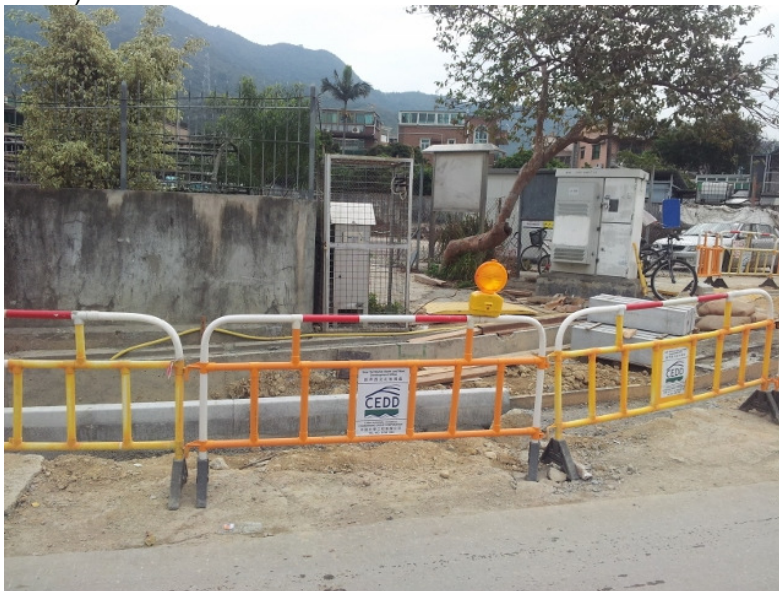
Date	22 February 2014
Time	--
Monitoring Location	SR77
Parameter	24-Hr Total Suspended Particulate
Action / Limit Levels	Action Level: 170.3µg/m ³ Limit Level: 260µg/m ³
Measured Level	185.1µg/m ³ (Action level being exceeded)
Possible reason for the exceedance	<p>It was noticed that there were construction works being undertaken by another Contractor (under Contract No. TP/2010/02) which occurred immediately next to the High Volume Sampler (HVS) of the air quality monitoring station at SR77 (refer to the attached photo).</p> <p>Such works mainly involved excavation of earth materials, operation of excavator (with exhaust emission), handling and moving of earth materials, etc. These construction works are anticipated to cause considerable suspended particulates impact that may lead to high TSP levels as have been measured by our HVS.</p> <p>The construction works are anticipated to be completed by the end of April 2014.</p> <p>Also, the HVS is located close to roadside. When there is traffic, the vehicles may cause disturbance to the nearby open excavation sites, generate dust impact and affect the TSP results recorded by the HVS.</p> <p>On the other hand, the construction works carried out during the monitoring period included backfilling works being carried out at northern side of the site and extension of box culverts, which were at a much farther distance from the air quality monitoring station at SR77 (refer to the attached location plan showing the works activities of the entrusted portion).</p> <p>As such, the exceedance was unlikely due to the construction works of the project.</p>

Construction works observed within close proximity of SR77 (Date: 22 February 2014)

Action taken / to be taken	<p>As the exceedance was non-project related, no further investigation and specific remedial measure(s) would be recommended for the Entrusted Works.</p> <p>Nevertheless, the following mitigation measures had been implemented on-site for dust suppression:</p> <ol style="list-style-type: none"> 1. Exposed slopes near the river were covered with impervious sheets; 2. Any open stockpile of construction materials were covered with impervious sheet; 3. Sufficient watering was applied along the haul road.
Remarks	-

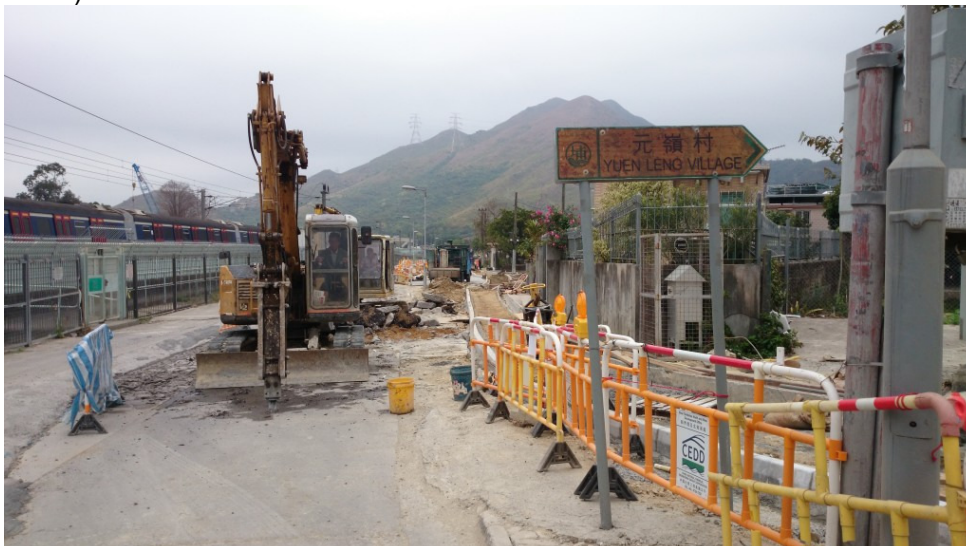
Date	28 February 2014
Time	--
Monitoring Location	SR77
Parameter	24-Hr Total Suspended Particulate
Action / Limit Levels	Action Level: 170.3µg/m ³ Limit Level: 260µg/m ³
Measured Level	221.5µg/m ³ (Action level being exceeded)
Possible reason for the exceedance	<p>It was noticed that there were construction works being undertaken by another Contractor (under Contract No. TP/2010/02) which occurred immediately next to the High Volume Sampler (HVS) of the air quality monitoring station at SR77 (refer to the attached photo).</p> <p>Such works mainly involved excavation of earth materials, operation of excavator (with exhaust emission), handling and moving of earth materials, etc. These construction works are anticipated to cause considerable suspended particulates impact that may lead to high TSP levels as have been measured by our HVS.</p> <p>The construction works are anticipated to be completed by the end of April 2014.</p> <p>Also, the HVS is located close to roadside. When there is traffic, the vehicles may cause disturbance to the nearby open excavation sites, generate dust impact and affect the TSP results recorded by the HVS.</p> <p>On the other hand, the construction works carried out during the monitoring period included backfilling works being carried out at northern side of the site and extension of box culverts, which were at a much farther distance from the air quality monitoring station at SR77 (refer to the attached location plan showing the works activities of the entrusted portion).</p> <p>As such, the exceedance was unlikely due to the construction works of the project.</p>

Construction works observed within close proximity of SR77 (Date: 28 February 2014)

Action taken / to be taken	<p>As the exceedance was non-project related, no further investigation and specific remedial measure(s) would be recommended for the Entrusted Works.</p> <p>Nevertheless, the following mitigation measures had been implemented on-site for dust suppression:</p> <ol style="list-style-type: none"> 1. Exposed slopes near the river were covered with impervious sheets; 2. Any open stockpile of construction materials were covered with impervious sheet; 3. Sufficient watering was applied along the haul road.
Remarks	-
