Appendix M Investigation Report for Exceedances

Entrusted Portion of Widening of Tolo Highway / Fanling Highway between Island House Interchange and Fanling Stage 2

Investigation Report of Environmental Quality Exceedance(s)

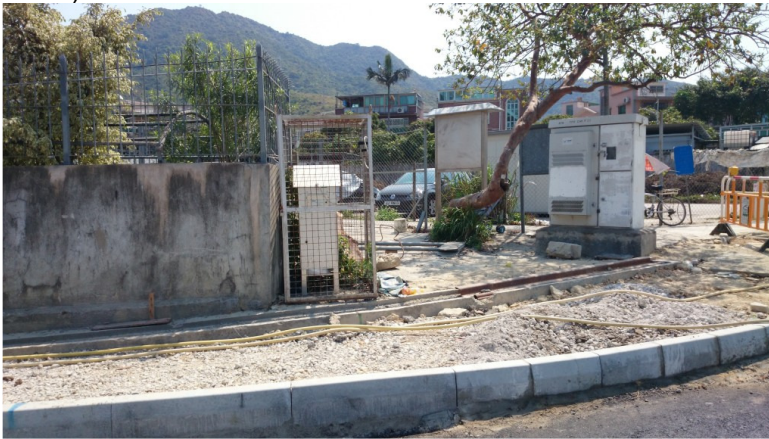
Date	24 March 2014
Time	--
Monitoring Location	SR77
Parameter	24-Hr Total Suspended Particulate
Action / Limit Levels	Action Level: 170.3µg/m ³ Limit Level: 260µg/m ³
Measured Level	188.1µg/m ³ (Action level being exceeded)
Possible reason for the exceedance	<p>It was noticed that there were construction works being undertaken by another Contractor (under Contract No. TP/2010/02) which occurred immediately next to the High Volume Sampler (HVS) of the air quality monitoring station at SR77 (refer to the attached photo).</p> <p>Such works mainly involved excavation of earth materials, operation of excavator (with exhaust emission), handling and moving of earth materials, etc. These construction works are anticipated to cause considerable suspended particulates impact that may lead to high TSP levels as have been measured by our HVS.</p> <p>The construction works are anticipated to be completed by the end of April 2014.</p> <p>Also, the HVS is located close to roadside. When there is traffic, the vehicles may cause disturbance to the nearby open excavation sites, generate dust impact and affect the TSP results recorded by the HVS.</p> <p>On the other hand, the construction works carried out during the monitoring period included backfilling works being carried out at northern side of the site and extension of box culverts, which were at a much farther distance from the air quality monitoring station at SR77 (refer to the attached location plan showing the works activities of the entrusted portion).</p> <p>As such, the exceedance was unlikely due to the construction works of the project.</p>

Construction works observed within close proximity of SR77 (Date: 24 March 2014)

Action taken / to be taken	<p>As the exceedance was non-project related, no further investigation and specific remedial measure(s) would be recommended for the Entrusted Works.</p> <p>Nevertheless, the following mitigation measures had been implemented on-site for dust suppression:</p> <ol style="list-style-type: none"> 1. Exposed slopes near the river were covered with impervious sheets; 2. Any open stockpile of construction materials were covered with impervious sheet; 3. Sufficient watering was applied along the haul road.
Remarks	-

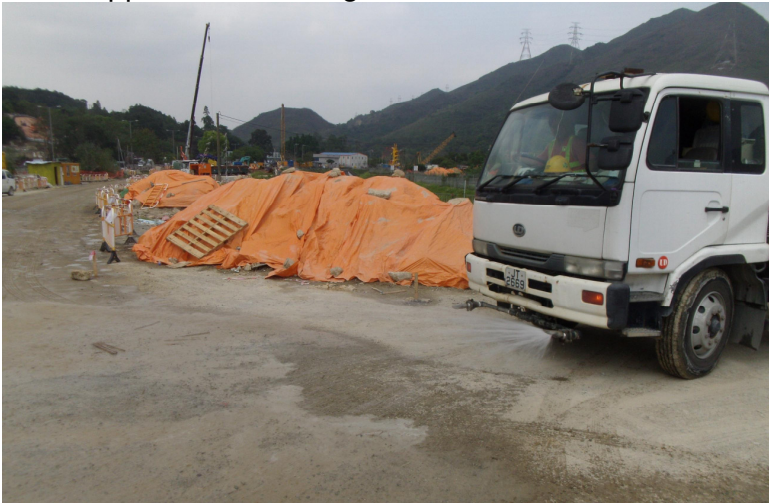
Dust suppression is being undertaken at construction site (Date: 24 March 2014)

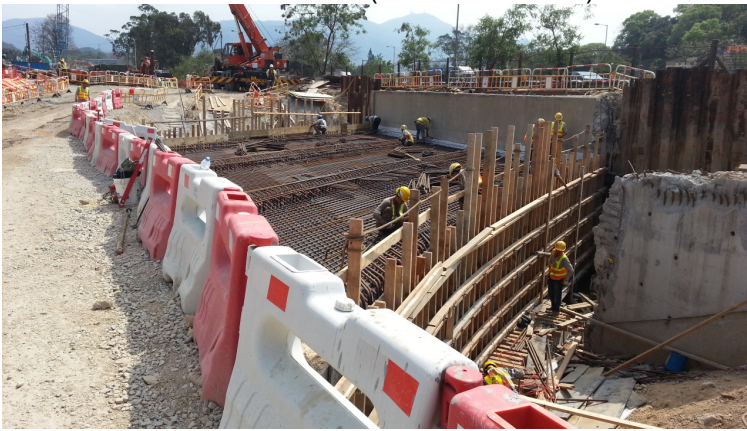
Date	24 March 2014
Time	10:03am
Monitoring Location	I5
Parameter	Suspended Solids
Action / Limit Levels	Action Level: 42.6 mg/L or 120% of upstream control station's SS of the same day (i.e. 5.3mg/L) Limit Level: 46.8 mg/L or 130% of upstream control station's SS of the same day (i.e. 5.8mg/L)
Measured Level	11.3mg/L (Limit level being exceeded - 130% of C3a)
Possible reason for the exceedance	<p>Construction within proximity of the river channel is listed as follows:</p> <p><u>Box Culvert ID4</u> (refer to attached photos) - Formwork erection for casting Bay 3</p> <p><u>Box Culvert ID5</u> (refer to attached photos) - Backfill of outfall</p> <p>Construction works at the river stream are properly enclosed by sandbags to avoid site runoff. No spillage is identified. (refer to attached photos)</p> <p>For comparison, suspended solids levels at C3a and C3b on 24 March 2014 are 4.5mg/L and 4.1mg/L respectively. The results are very low when comparing against the baseline monitoring where the suspended level can be as high as 51mg/L and 88mg/L at C3a and at C3b respectively. Also, recorded suspended solids level at I5 has not exceeded the maximum recorded level of 47mg/L during baseline monitoring and significantly below the absolute action level of 42.6mg/L.</p> <p>As 11.3mg/L is considered low level, and proper mitigations were fully implemented as a preventive measure to ensure no adverse water quality impact to the river environment, it is unlikely that the construction works activities would be the possible sources and reasons of contamination.</p>

Construction works at ID4 (24 March 2014)

It is therefore considered that elevation of suspended solids would be due to natural fluctuation.
Action taken / to be taken	As the non-compliance was non-project related, no further investigation and remedial measure(s) would be required. Nonetheless, contractor has been reminded to closely monitor the mitigation measures and ensure no site-runoff into the river channel.
Remarks	-

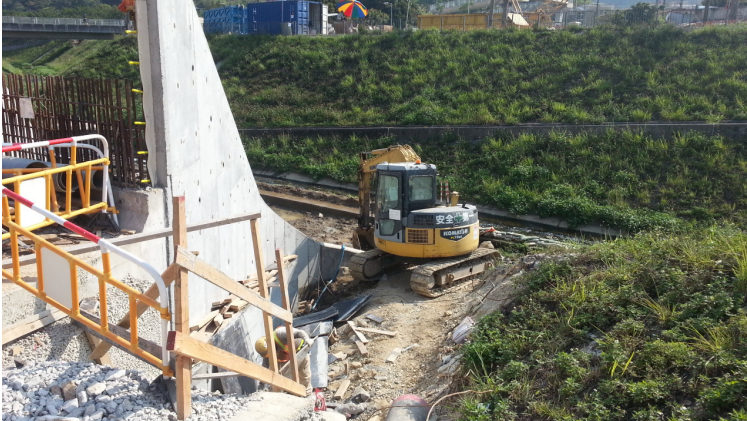
Construction works at ID5 (24 March 2014)

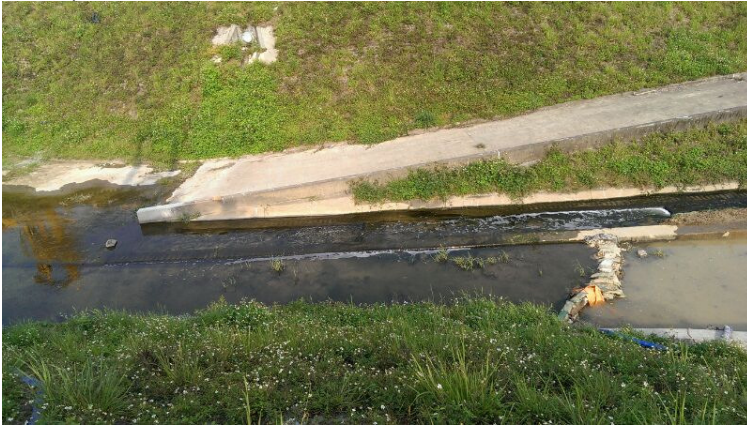
The construction works are properly protected with sand bags. (Date: 24 March 2014)

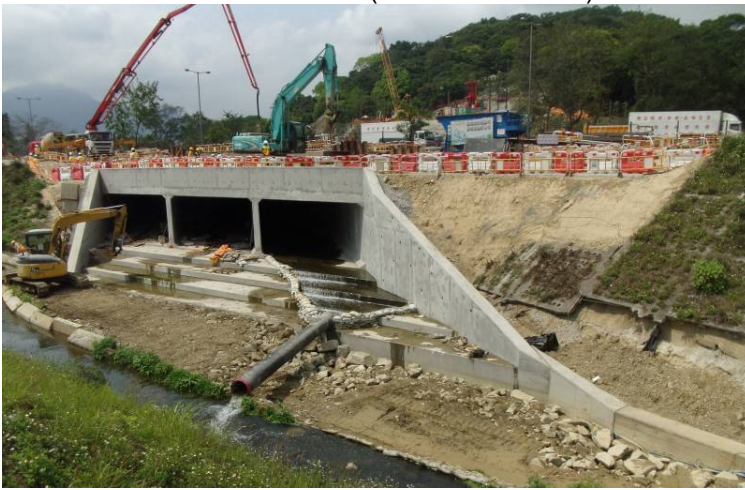
Date	26 March 2014
Time	10:09am
Monitoring Location	I5
Parameter	Suspended Solids
Action / Limit Levels	Action Level: 42.6 mg/L or 120% of upstream control station's SS of the same day (i.e. 5.9mg/L) Limit Level: 46.8 mg/L or 130% of upstream control station's SS of the same day (i.e. 6.4mg/L)
Measured Level	13mg/L (Limit level being exceeded - 130% of C3a)
Possible reason for the exceedance	<p>Construction within proximity of the river channel is listed as follows:</p> <p><u>Box Culvert ID4</u> (refer to attached photos) - Concreting of Bay 3</p> <p><u>Box Culvert ID5</u> (refer to attached photos) - Formwork erection for headwell</p> <p>Construction works at the river stream are properly enclosed by sandbags to avoid site runoff. No spillage is identified. (refer to attached photos)</p> <p>For comparison, suspended solids levels at C3a and C3b on 26 March 2014 are 4.6mg/L and 4.9mg/L respectively. The results are very low when comparing against the baseline monitoring where the suspended level can be as high as 51mg/L and 88mg/L at C3a and at C3b respectively. Also, recorded suspended solids level at I5 has not exceeded the maximum recorded level of 47mg/L during baseline monitoring and significantly below the absolute action level of 42.6mg/L.</p> <p>As 13mg/L is considered low level, and proper mitigations were fully implemented as a preventive measure to ensure no adverse water quality impact to the river environment, it is unlikely that the construction works activities would be the possible sources and reasons of contamination.</p>

Construction works at ID4 (26 March 2014)

It is therefore considered that elevation of suspended solids would be due to natural fluctuation.
Action taken / to be taken	As the non-compliance was non-project related, no further investigation and remedial measure(s) would be required. Nonetheless, contractor has been reminded to closely monitor the mitigation measures and ensure no site-runoff into the river channel.
Remarks	-

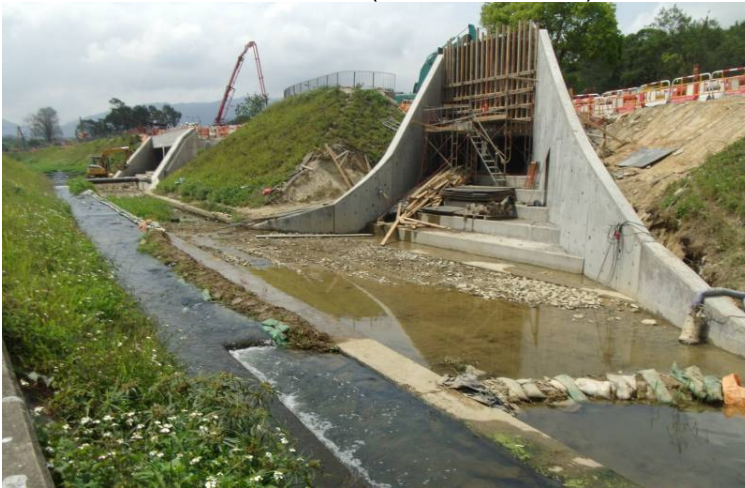
Construction works at ID5 (26 March 2014)

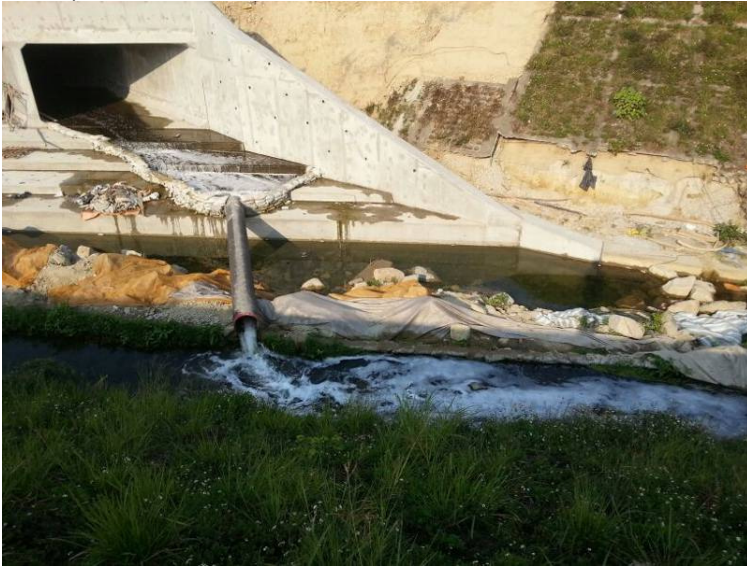
The construction works are properly protected with sand bags. (Date: 26 March 2014)

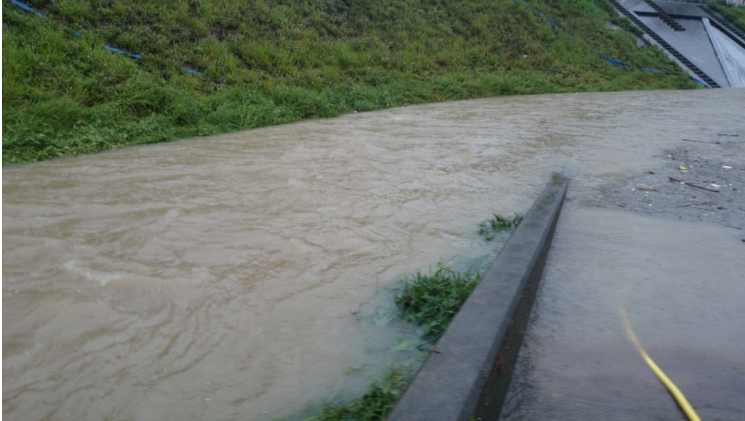
Date	31 March 2014
Time	11:09am
Monitoring Location	I5
Parameter	Suspended Solids
Action / Limit Levels	Action Level: 42.6 mg/L or 120% of upstream control station's SS of the same day (i.e. 90mg/L) Limit Level: 46.8 mg/L or 130% of upstream control station's SS of the same day (i.e. 97.5mg/L)
Measured Level	72.5.mg/L (Limit level being exceeded)
Possible reason for the exceedance	There was a heavy rainstorm during water sampling and the river is muddy due to vigorous water flow. The elevated suspended solids level was due to riverbed disturbed by the river flow. During the water sampling, there is no works being carried out within proximity of the river channel due to adverse weather condition. Both control stations also showed elevated suspended solids levels due to the adverse weather condition. It is therefore considered that elevation of suspended solids level would be due to natural fluctuation.

Muddy water observed at I5 during rainstorm. (Date: 31 March 2014)

Action taken / to be taken	As the non-compliance was non-project related, no further investigation and remedial measure(s) would be required. Nonetheless, contractor has been reminded to closely monitor the mitigation measures and ensure no site-runoff into the river channel.
Remarks	-

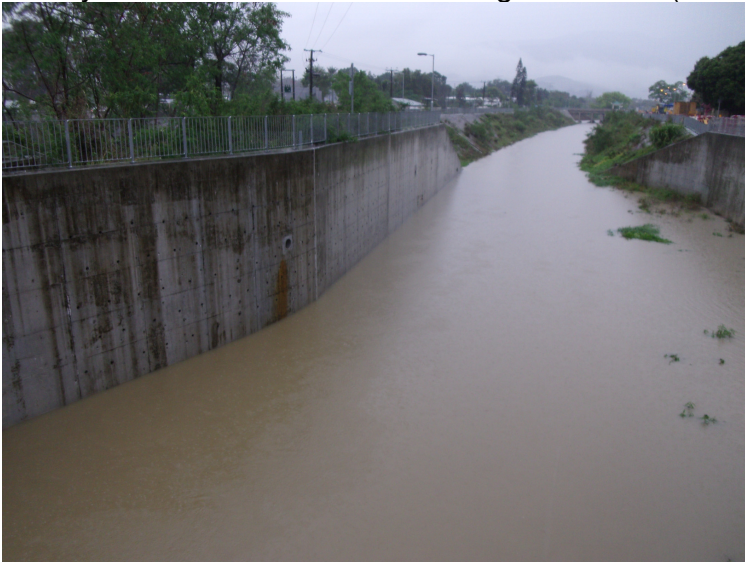
Muddy water observed at C3a during rainstorm. (Date: 31 March 2014)

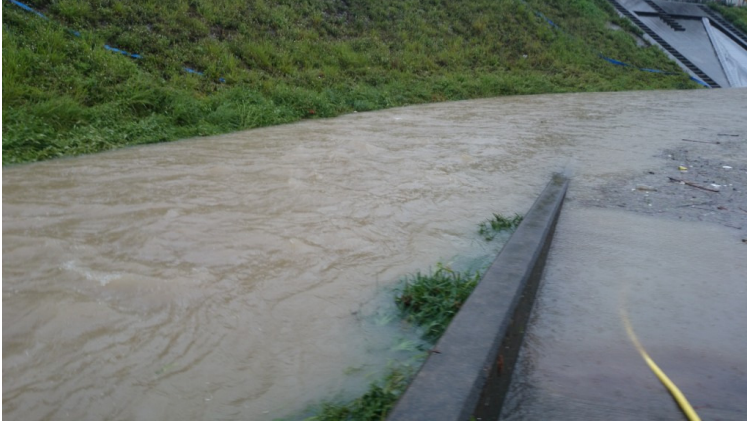
Date	31 March 2014
Time	11:09am
Monitoring Location	I5
Parameter	Turbidity
Action / Limit Levels	Action level: 81.9 NTU or 120% of upstream control station's Tby of the same day (i.e. 108.4NTU) Limit Level: 91.9 NTU or 130% of upstream control station's Tby of the same day (i.e. 117.4NTU)
Measured Level	86.7NTU (Action level being exceeded)
Possible reason for the exceedance	There was a heavy rainstorm during water sampling and the river is muddy due to vigorous water flow. The elevated turbidity was due to riverbed disturbed by the river flow. During the water sampling, there is no works being carried out within proximity of the river channel due to adverse weather condition. Both control stations also showed elevated turbidity levels due to the adverse weather condition. It is therefore considered that elevation of turbidity would be due to natural fluctuation.
Action taken / to be taken	As the non-compliance was non-project related, no further investigation and remedial measure(s) would be required. Nonetheless, contractor has been reminded to closely monitor the mitigation measures and ensure no site-runoff into the river channel.

Muddy water observed during rainstorm. (Date: 31 March 2014)

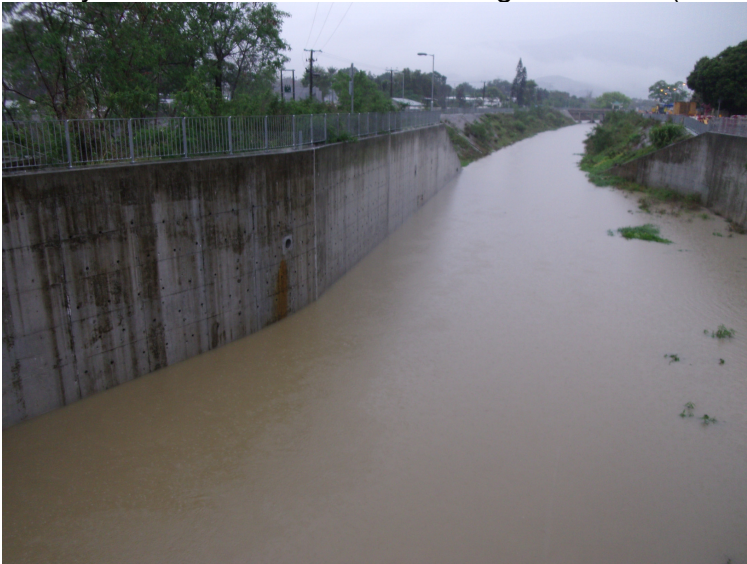
Muddy water observed at C3a during rainstorm. (Date: 31 March 2014)
