Appendix M Investigation Report for Exceedances

Entrusted Portion of Widening of Tolo Highway / Fanling Highway between Island House Interchange and Fanling Stage 2

Investigation Report of Environmental Quality Exceedance(s)

Ref. No.: A140527_24TSP

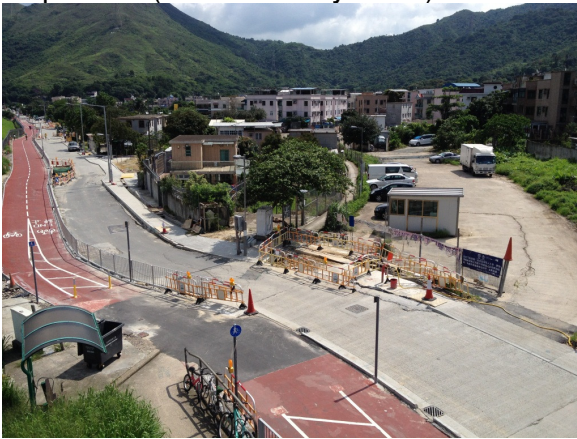
Date	27 May 2014
Time	--
Monitoring Location	SR77
Parameter	24-Hr Total Suspended Particulate
Action / Limit Levels	Action Level: 170.3µg/m ³ Limit Level: 260µg/m ³
Measured Level	195.6µg/m ³ (Action level being exceeded)
Possible reason for the exceedance	<p>The construction works being undertaken by another Contractor (under Contract No. TP/2010/02) has been generally completed and operations of Powered Mechanical Equipment (PME) are not observed. Exposed excavation sites, however, are still observed within close proximity of the High Volume Sampler (HVS) of the air quality monitoring station at SR77 (refer to the attached photo taken during weekly site inspection on 26 May 2014). Such exposed earth would release fugitive dust during the sunny weather and the emission would contribute to a higher TSP Level.</p> <p>In addition, a stockpile of spoil was observed immediately next to the HVS (refer to the attached photo taken on 27 May 2014). Handling of such spoils (loading onto trucks for disposal etc) would also generate fugitive dust emissions and due to the short separation distance, such emission would significantly affect the monitoring result .</p> <p>These construction works are anticipated to cause the elevated TSP levels as have been measured by our HVS.</p> <p>Also, the HVS is located close to roadside. When there is traffic, the vehicles may cause disturbance to the nearby open excavation sites, generate dust impact and affect the TSP results recorded by the HVS.</p> <p>On the other hand, the construction works carried out during the monitoring period included backfilling works being carried out at northern side of the site and erection of noise barrier NB71, which were at a much farther distance from the air quality monitoring station at SR77 (refer to the attached location plan showing the works activities of the entrusted portion).</p> <p>As such, the exceedance was unlikely due to the construction works of the project.</p>

Construction works observed within close proximity of SR77 during weekly site inspection (Date: 26 May 2014)

Action taken / to be taken	<p>As the exceedance was non-project related, no further investigation and specific remedial measure(s) would be recommended for the Entrusted Works.</p> <p>Nevertheless, the following mitigation measures had been implemented on-site for dust suppression:</p> <ol style="list-style-type: none"> 1. Exposed slopes near the river were covered with impervious sheets; 2. Any open stockpile of construction materials were covered with impervious sheet; 3. Sufficient watering was applied along the haul road.
Remarks	-

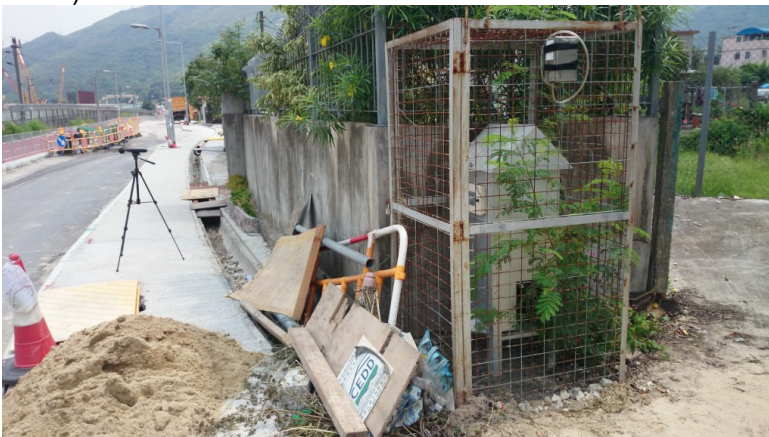
A stockpile of spoils was observed immediately next to the HVS (Date: 27 May 2014)

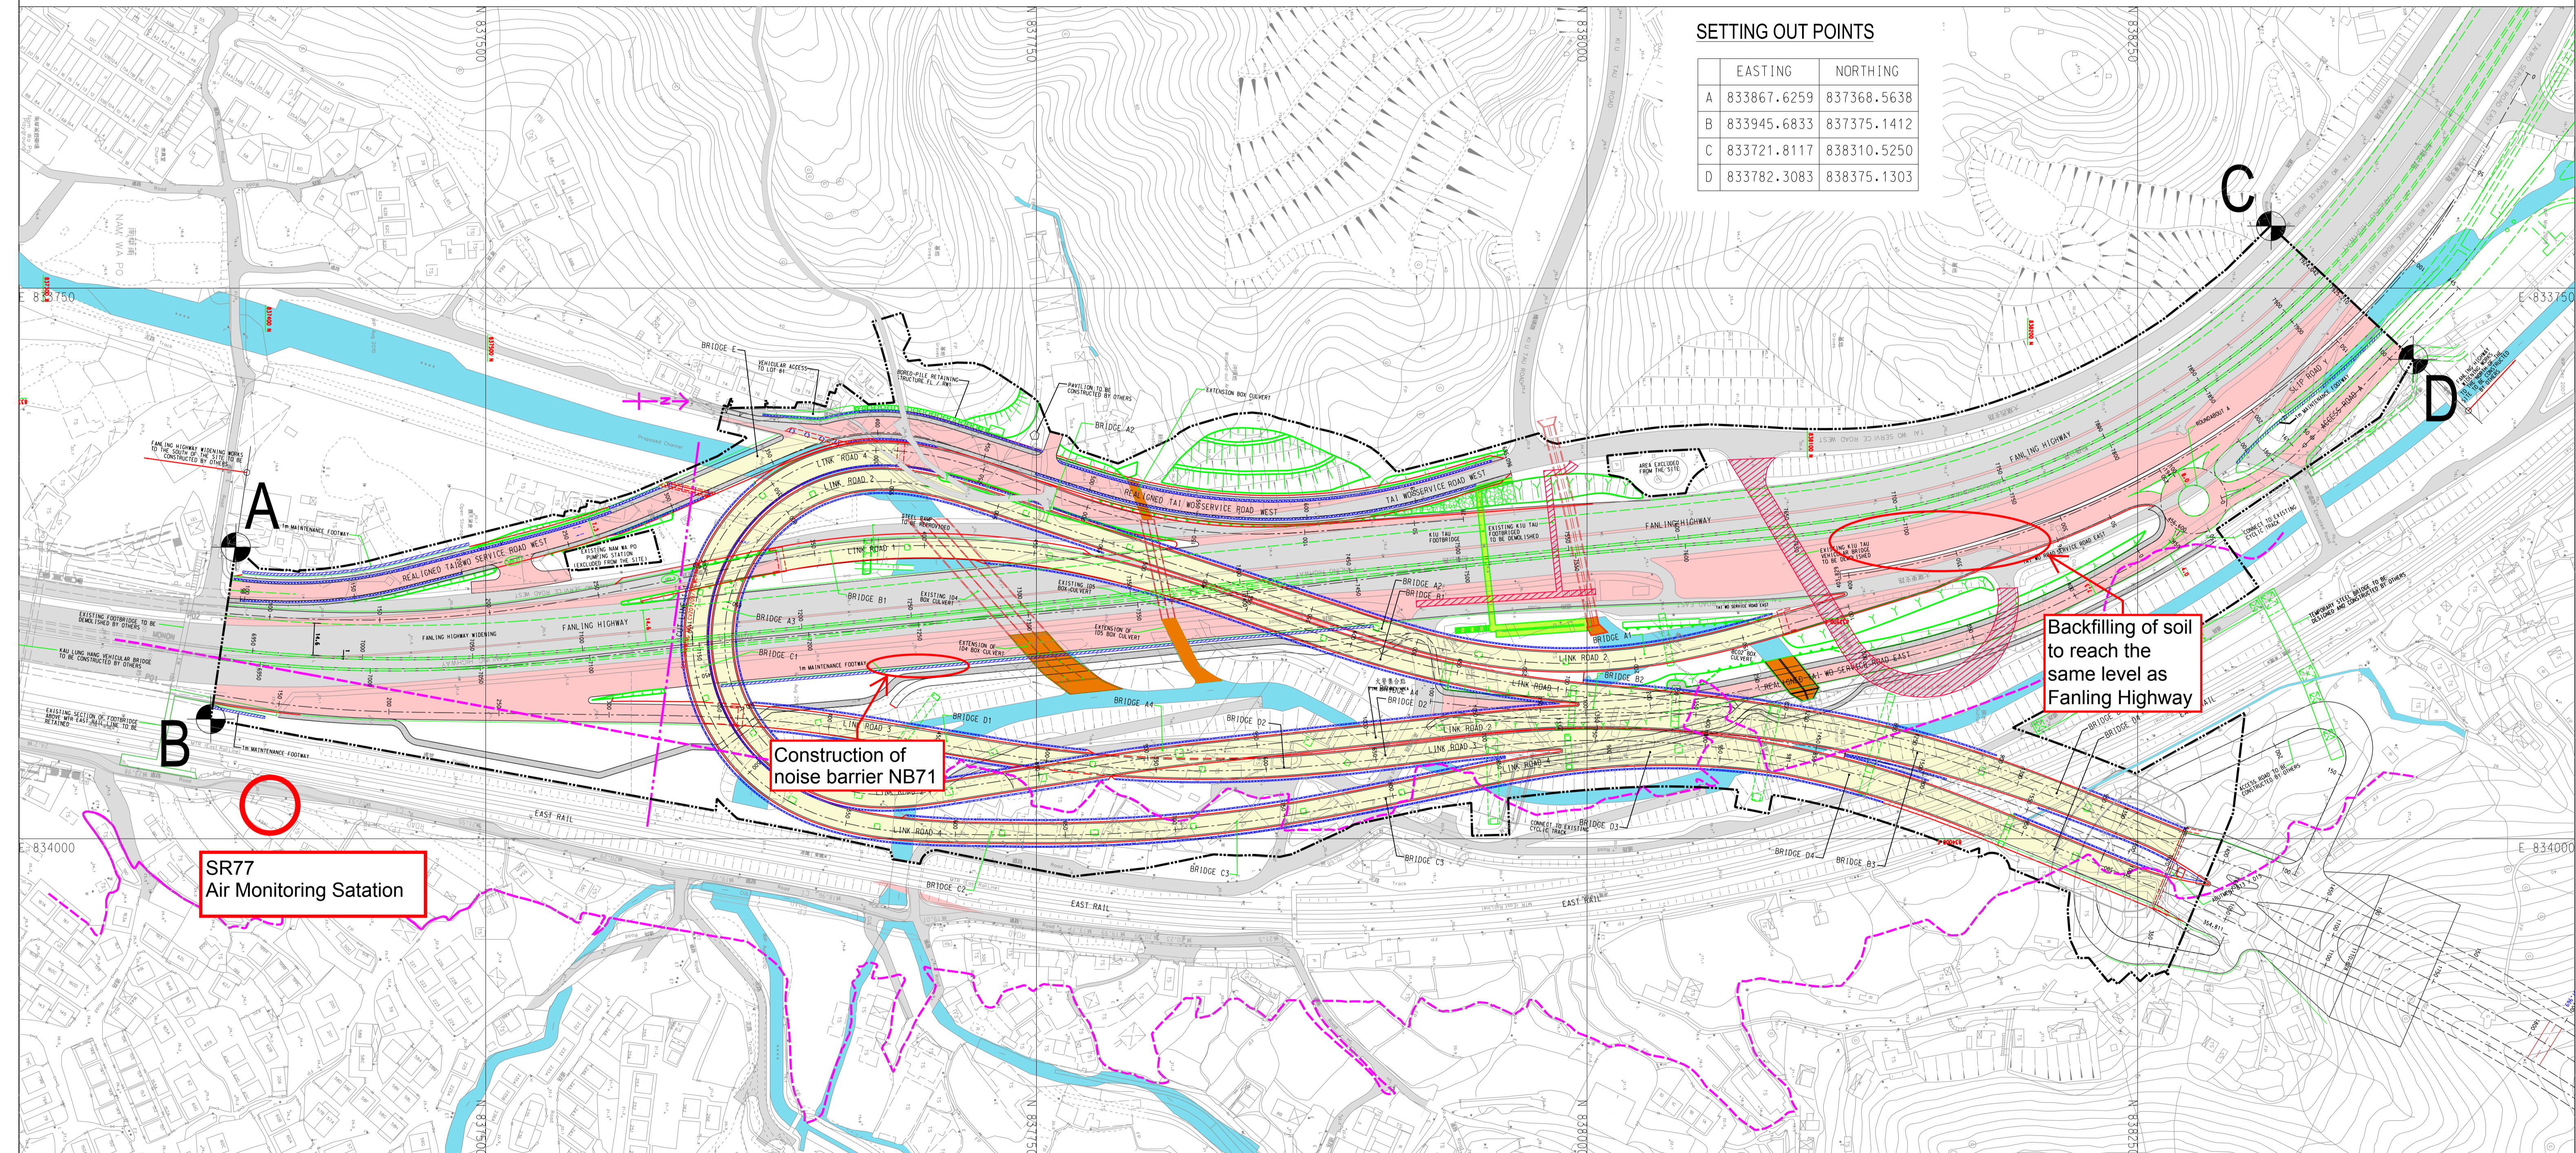
Backfilling of soil to reach the same level as Fanling Highway

Construction of noise barrier NB71

SR77
 Air Monitoring Satation
