Investigation Report for Exceedances

Entrusted Portion of Widening of Tolo Highway / Fanling Highway between Island House Interchange and Fanling Stage 2

Investigation Report of Environmental Quality Exceedance(s)

Ref. No.: A140723_24TSP

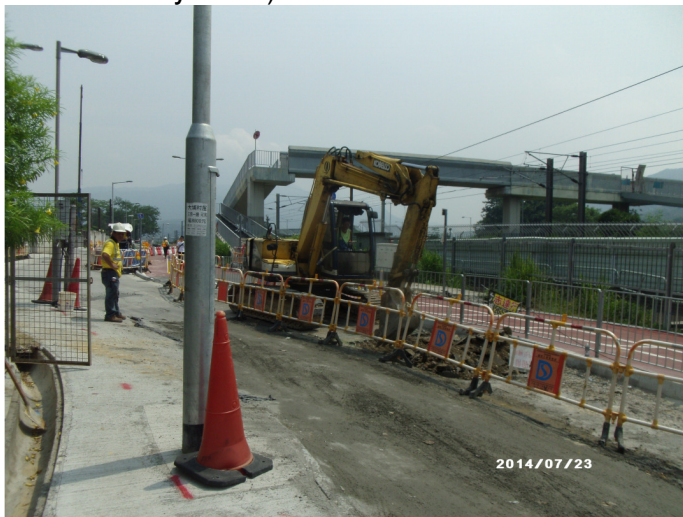
Date	23 July 2014
Time	--
Monitoring Location	SR77
Parameter	24-Hr Total Suspended Particulate
Action / Limit Levels	Action Level: 170.3µg/m ³ Limit Level: 260µg/m ³
Measured Level	402.1µg/m ³ (Limit level being exceeded)
Possible reason for the exceedance	<p>The construction works being undertaken by another Contractor (under Contract No. DC/2010/10) has been observed within close proximity of the High Volume Sampler (HVS) of the air quality monitoring station at SR77 (refer to the attached photos).</p> <p>Observed construction works including excavation with an excavator (refer to the attached Photo 1) and some works conducted at the u-channel next to the HVS (refer to the attached Photo 2).</p> <p>Such construction works would release fugitive dust during the sunny weather and the emission would contribute to a higher TSP Level.</p> <p>Thus, these construction works are anticipated to cause the elevated TSP levels as have been measured by our HVS.</p> <p>Also, the HVS is located close to roadside. When there is traffic, the vehicles may cause disturbance to the nearby open excavation sites, generate dust impact and affect the TSP results recorded by the HVS.</p> <p>On the other hand, the construction works carried out for the Entrusted Portion during the monitoring period included backfilling works being carried out at northern side of the site and erection of noise barrier NB71, which were at a much farther distance from the air quality monitoring station at SR77 (refer to the attached location plan showing the works activities of the entrusted portion).</p> <p>In addition, proper mitigation measures for these construction works, including the use of water spraying and covering of exposed slopes where applicable, have been implemented and being monitored by an EM&A programme. No significant dust emission has been observed (refer to the attached Photo 3)</p> <p>As such, the exceedance was unlikely due to the construction works of the project.</p>

Photo 1: Construction works observed within close proximity of SR77 (Date: 23 July 2014)

Action taken / to be taken	As the exceedance was non-project related, no further investigation and specific remedial measure(s) would be recommended for the Entrusted Works. Nevertheless, the following mitigation measures had been implemented on-site for dust suppression: 1. Exposed slopes near the river were covered with impervious sheets; 2. Any open stockpile of construction materials were covered with impervious sheet; and 3. Sufficient watering was applied along the haul road.
Remarks	-

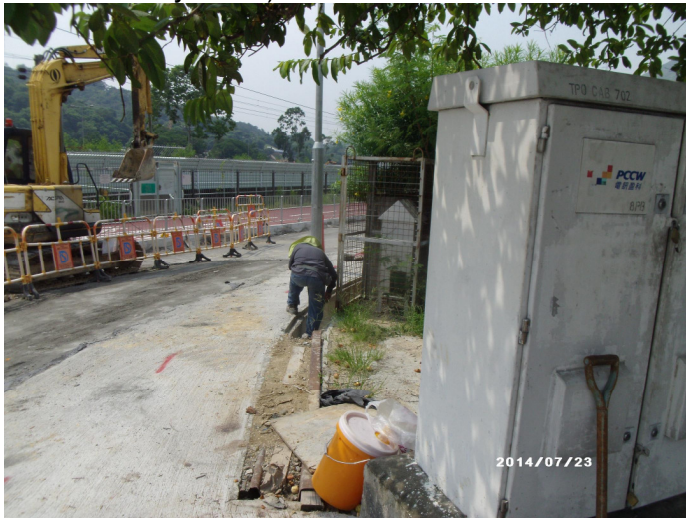
Photo 2: Construction works observed within close proximity of SR77 (Date: 23 July 2014)

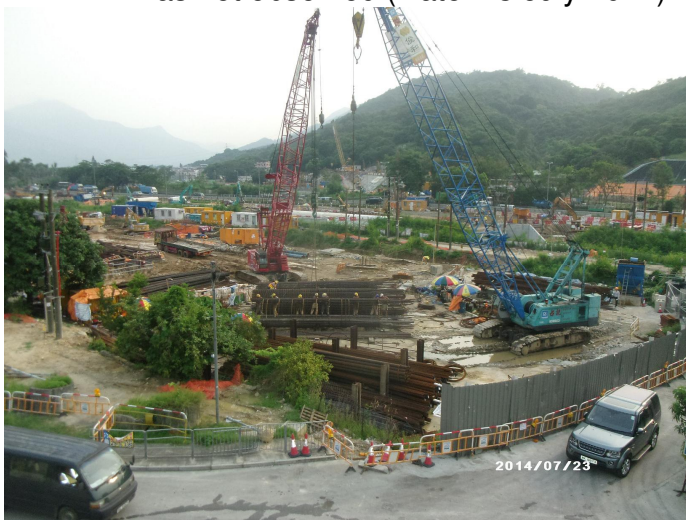
Photo 3: Overview of the construction works site which significant dust emission was not observed (Date: 23 July 2014)

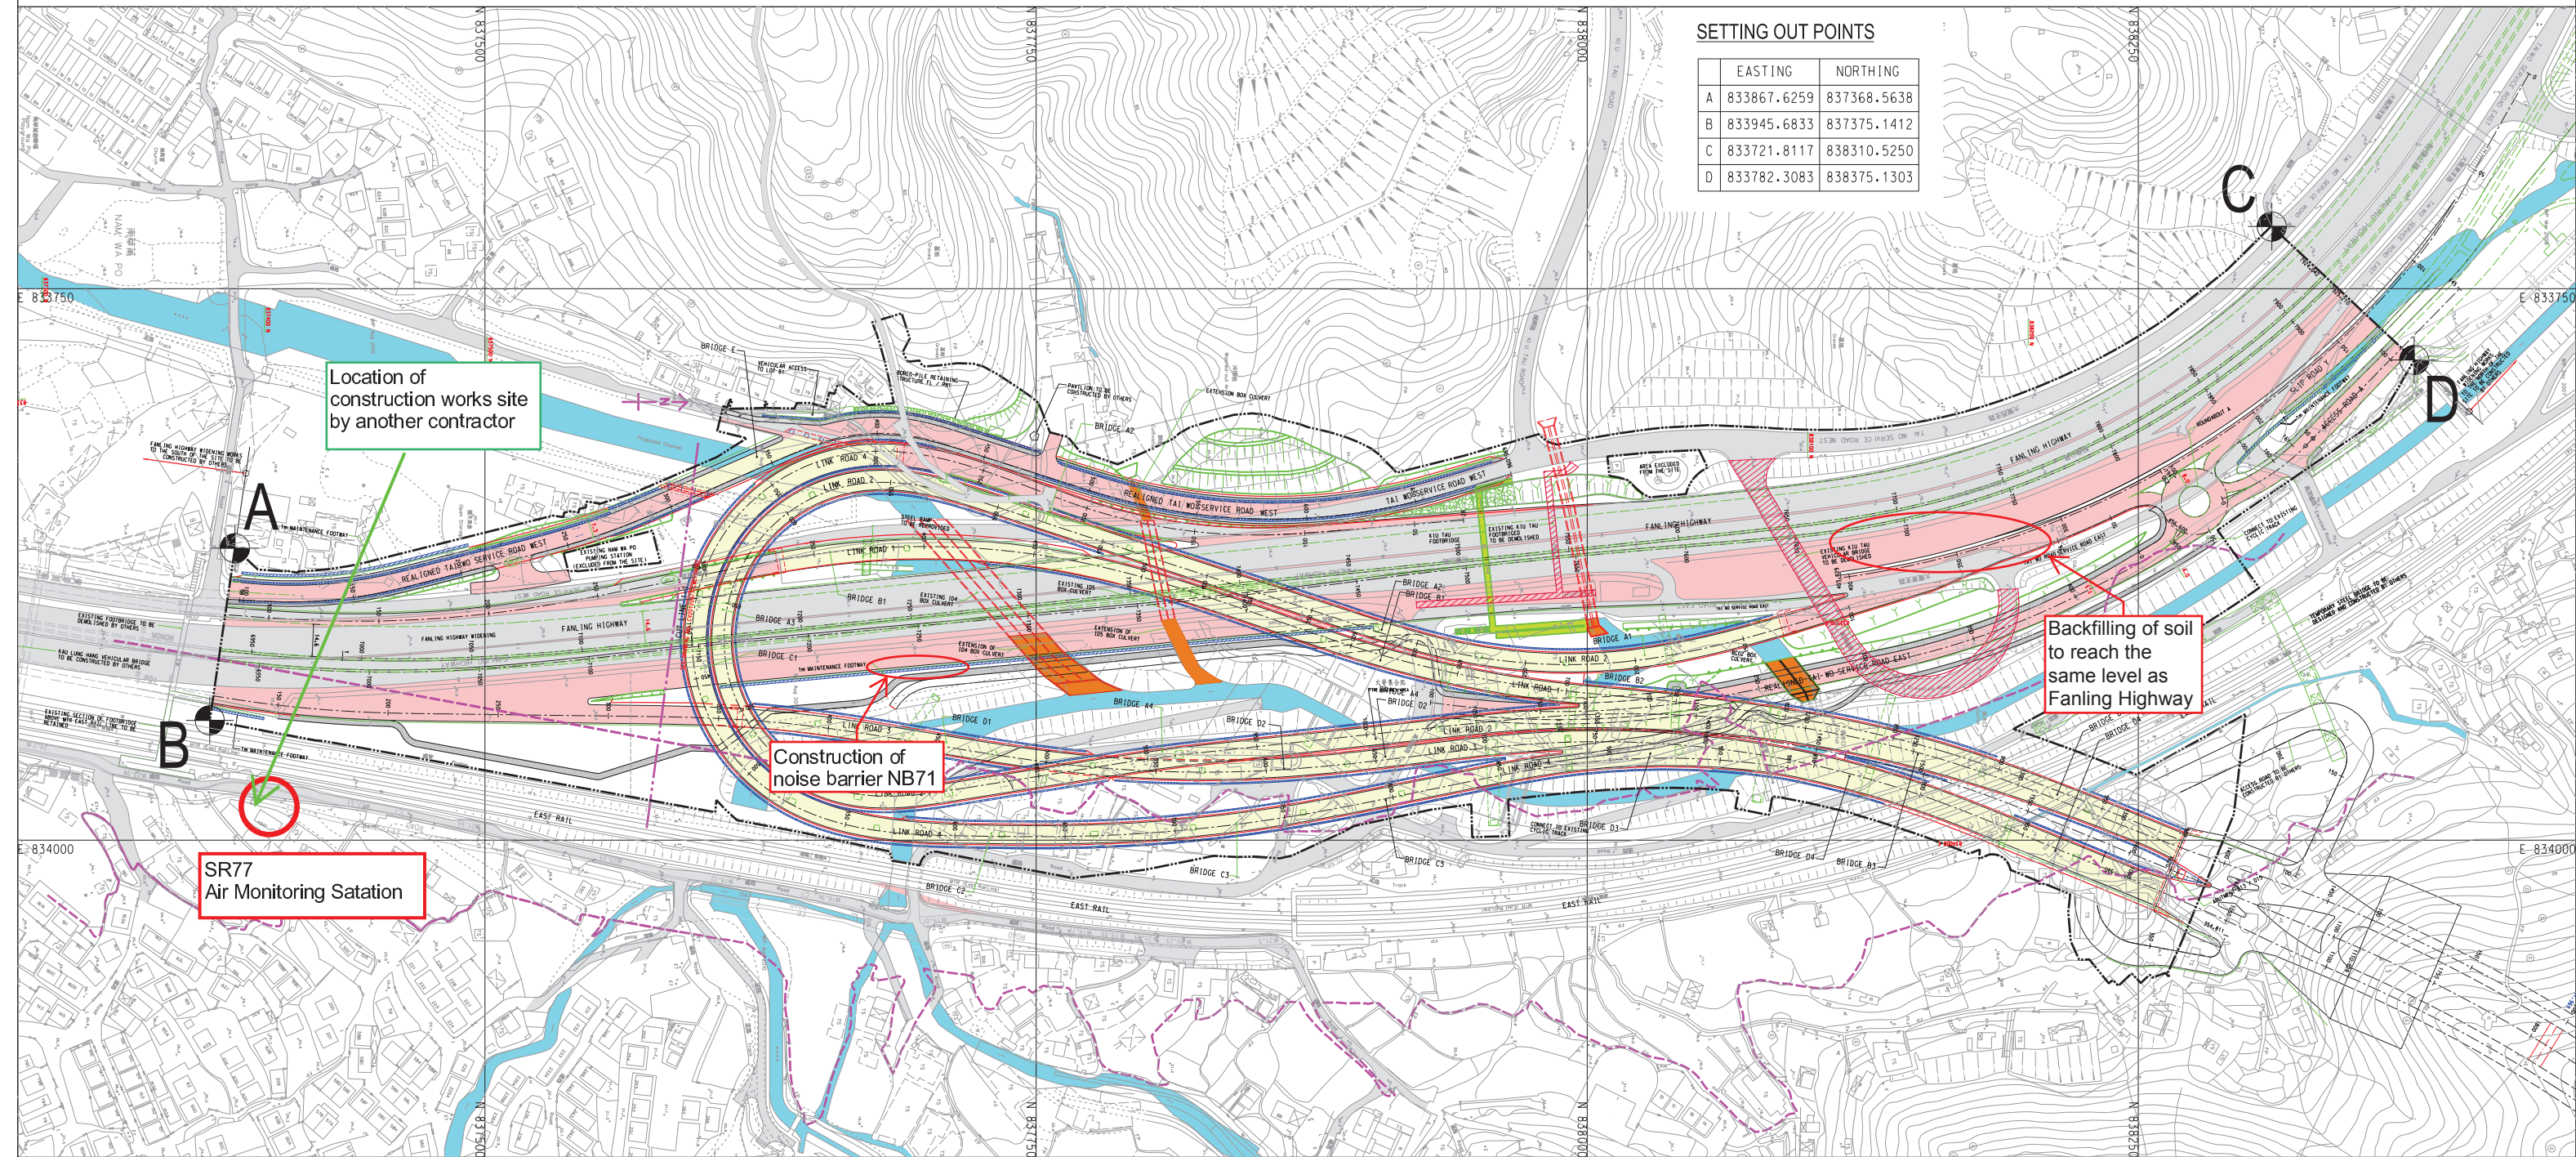
Location of construction works site by another contractor

Backfilling of soil to reach the same level as Fanling Highway

Construction of noise barrier NB71

SR77
 Air Monitoring Satation
