## Investigation Report for Exceedances

Entrusted Portion of Widening of Tolo Highway / Fanling Highway between Island House Interchange and Fanling Stage 2

**Investigation Report of Environmental Quality Exceedance(s)**

Ref. No.: A140902\_24TSP

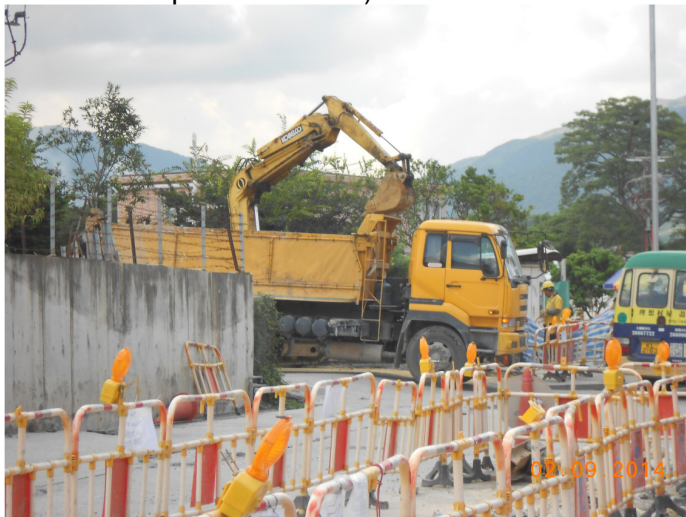
Photo 1: Handling of spoils observed within close proximity of SR77 (Date: 2 September 2014)

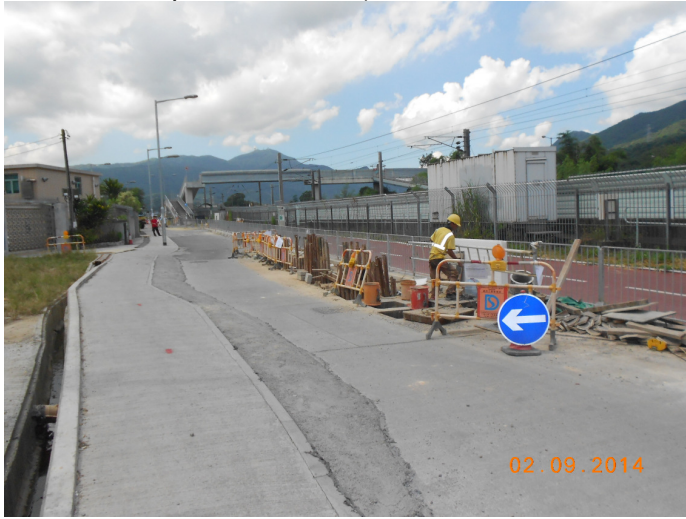
Photo 2: Construction works observed within close proximity of SR77 (Date: 2 September 2014)

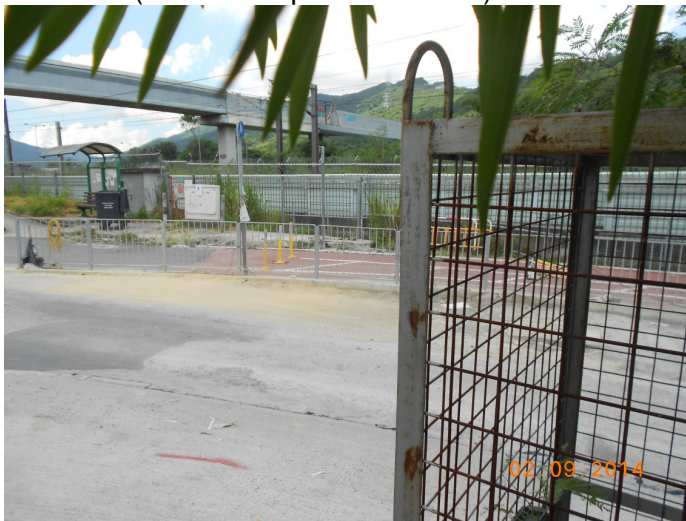
Photo 3: Dusty materials observed unattended within close proximity of SR77 (Date: 2 September 2014)

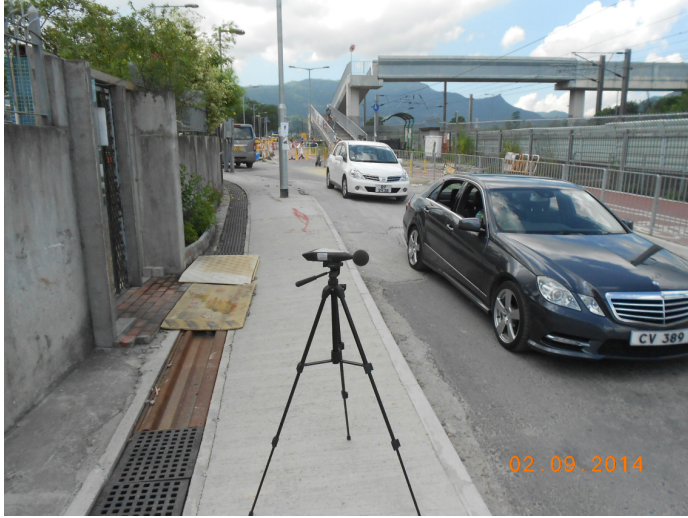
Photo 4: Traffic at road opposite to SR77 (Date: 2 September 2014)

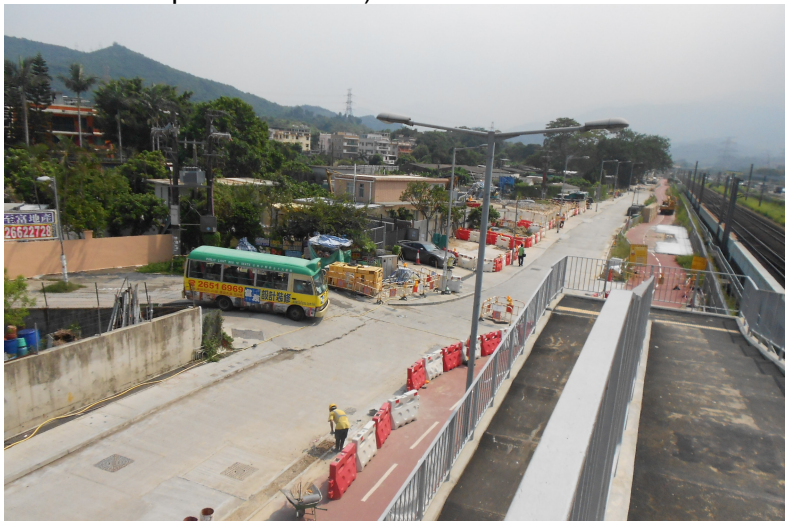
Photo 1: Construction area observed within proximity of SR77 (Date: 19 September 2014)

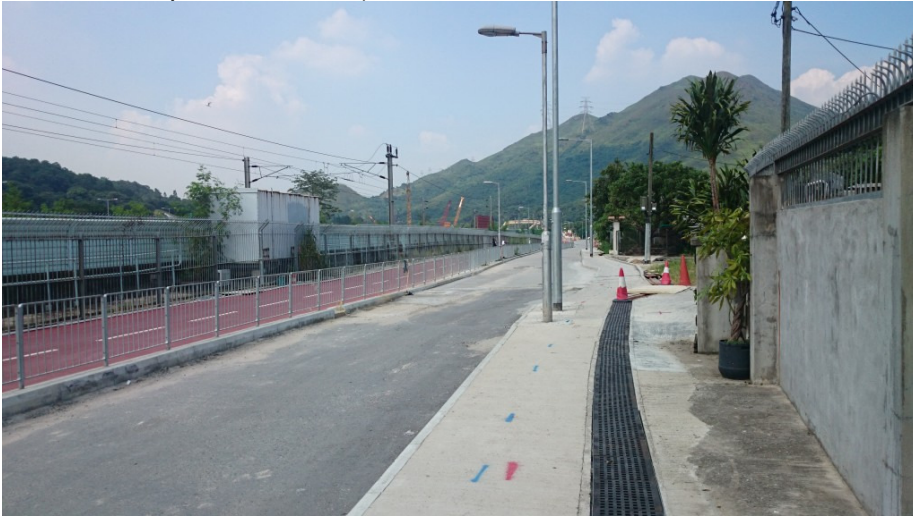
Photo 2: Dusty materials observed near the monitoring station SR77 (Date: 19 September 2014)
