Investigation Report for Exceedances

Entrusted Portion of Widening of Tolo Highway / Fanling Highway between Island House Interchange and Fanling Stage 2

Investigation Report of Environmental Quality Exceedance(s)

Ref. No.: A141017_24TSP

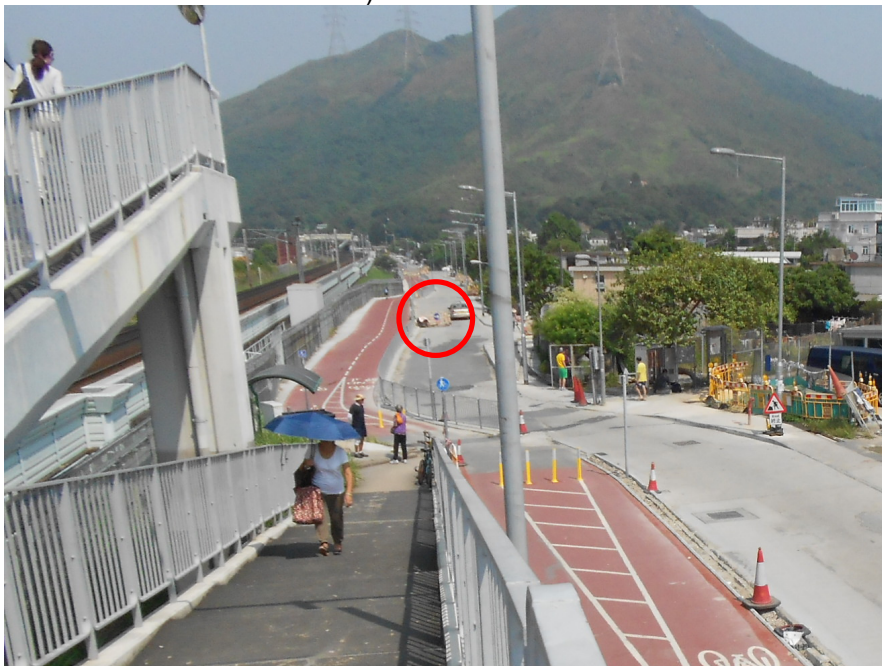
| Possible reason for the exceedance | <p><u>Construction Works of other Contracts</u></p> <p>Multiple construction works being undertaken by other Contractors have been observed within proximity of the High Volume Sampler (HVS) of the air quality monitoring station at SR77 (refer to the attached photos).</p> <p>Identified construction works including an excavation site (refer to the attached Photo 1); construction of a brick wall with a stockpile of sands (refer to the attached Photo 2) and excavation works under another contractor for Highway's Department (refer to attached Photo 3). These construction sites are located within a distance of about 20m from the SR77. Handling of spoils or concreting has also been observed as evidenced by an empty cement bag near the HVS (refer to the attached Photo 4). These operations may generate dust issues and would contribute to a higher TSP Level during sampling.</p> <p>Also, dusty materials may be disturbed by traffics and release fugitive dust during the sunny weather and such emission would contribute to a higher TSP Level (refer to attached Photo 5).</p> <p>Therefore, these construction works are anticipated to cause the elevated TSP levels as have been measured by our HVS.</p> <p><u>Construction Works of Entrusted Portion</u></p> <p>On the other hand, the construction works carried out for the Entrusted Portion during the monitoring period included backfilling works being carried out at northern side of the site and erection of noise barrier NB71, which were at a much farther distance from the air quality monitoring station at SR77 (refer to the attached location plan showing the works activities of the entrusted portion).</p> <p>In addition, proper mitigation measures for these construction works, including the use of water spraying and covering of exposed slopes where applicable, have been implemented and being monitored by an</p> |

Photo 1: Excavation Site observed within proximity of SR77 (Red Circle) (Date: 17 October 2014)

| Action taken / to be taken | As the exceedance was non-project related, no further investigation and specific remedial measure(s) would be recommended for the Entrusted Works. Nevertheless, the following mitigation measures had been implemented on-site for dust suppression: 1. Exposed slopes near the river were covered with impervious sheets; 2. Any open stockpile of construction materials were covered with impervious sheet; and 3. Sufficient watering was applied along the haul road. |

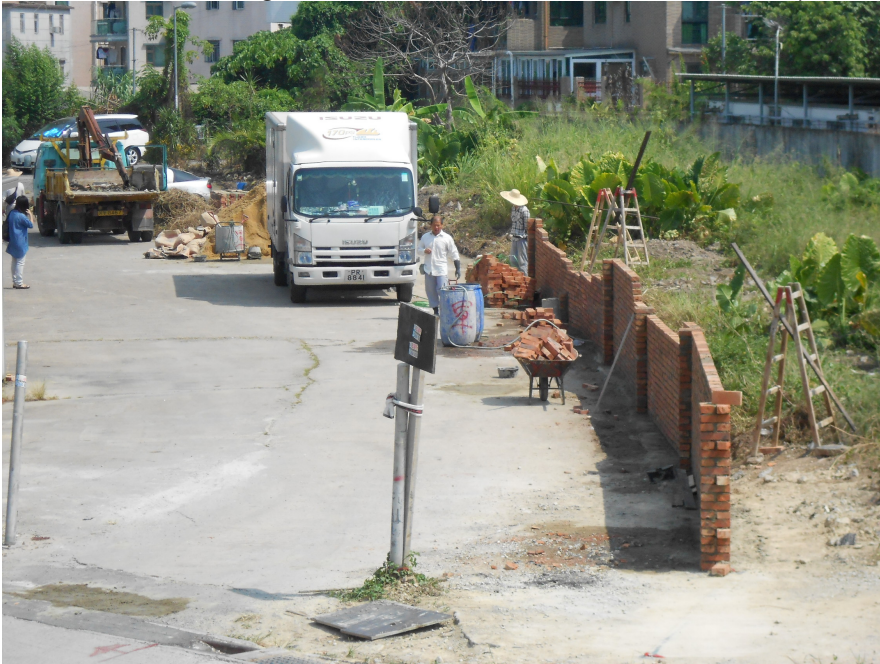
Photo 2: Construction of a brick wall with a stockpile of sands observed near the monitoring station SR77 (Date: 17 October 2014)

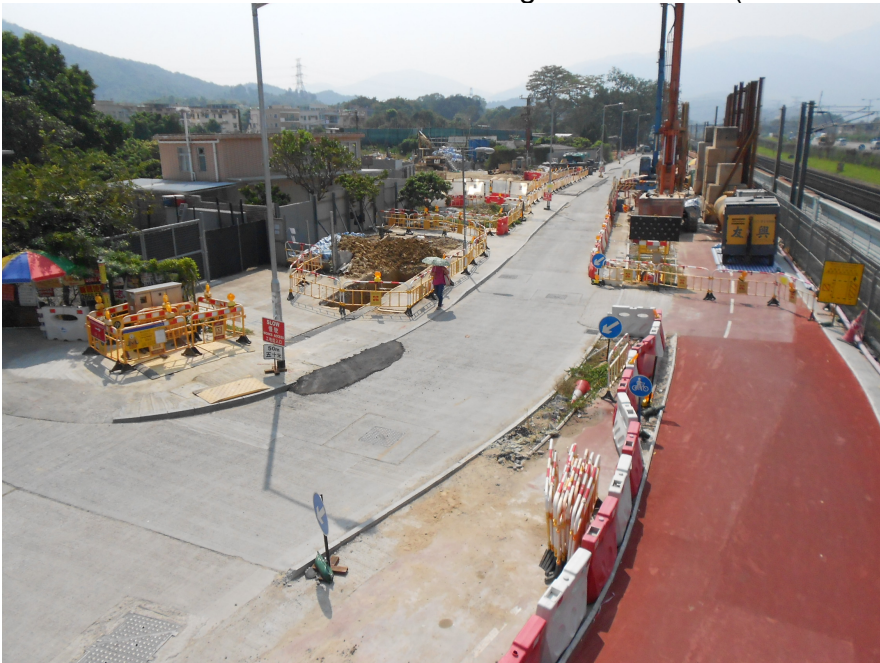
Photo 3: Excavation works under another contractor for Highway's Department observed near the monitoring station SR77 (Date: 17 October 2014)

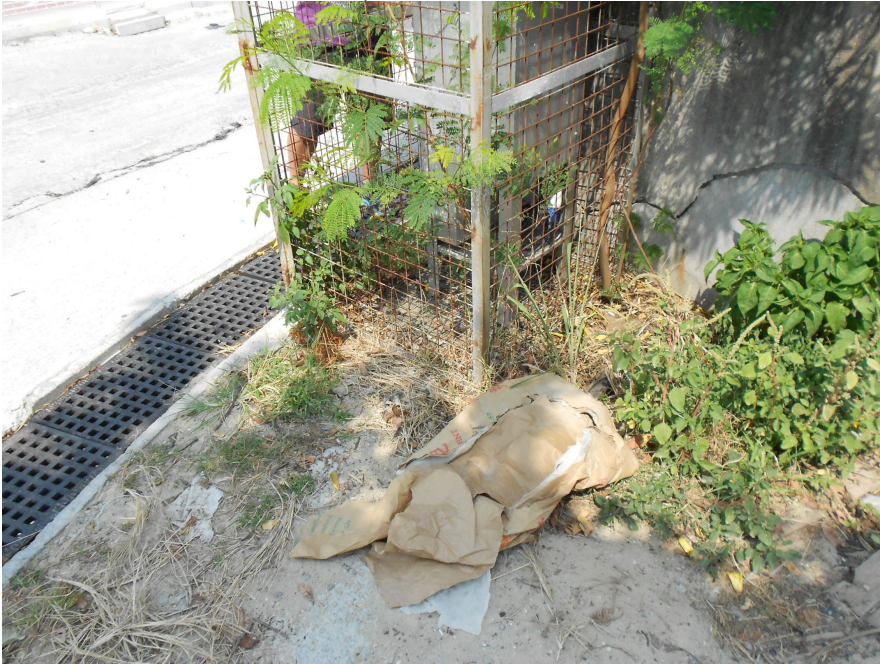
Photo 4: Empty cement bag observed near the monitoring station SR77 (Date: 17 October 2014)

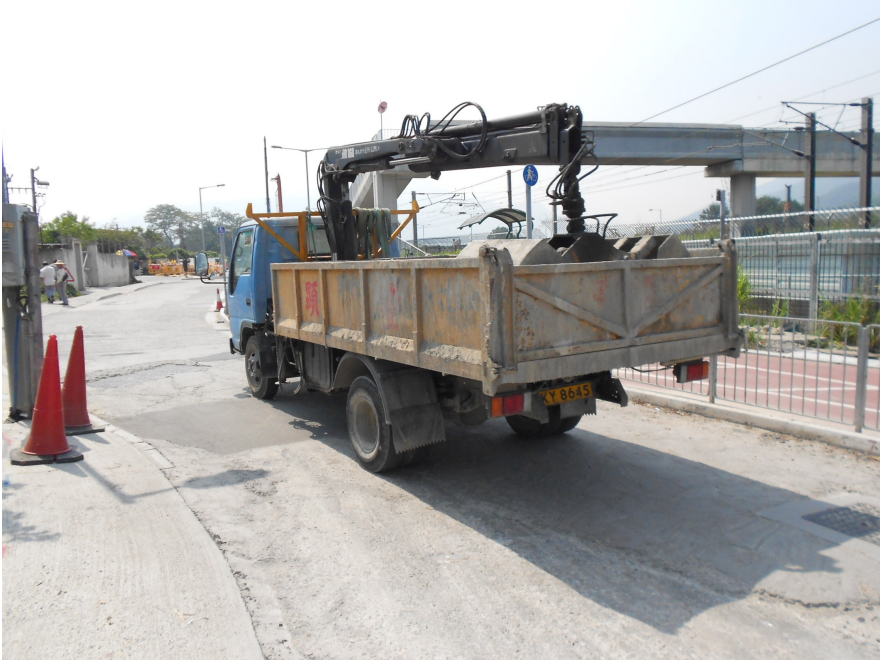
Photo 5: Traffic may disturb dusty material and generate fugitive dust as observed near the monitoring station SR77 (Date: 17 October 2014)

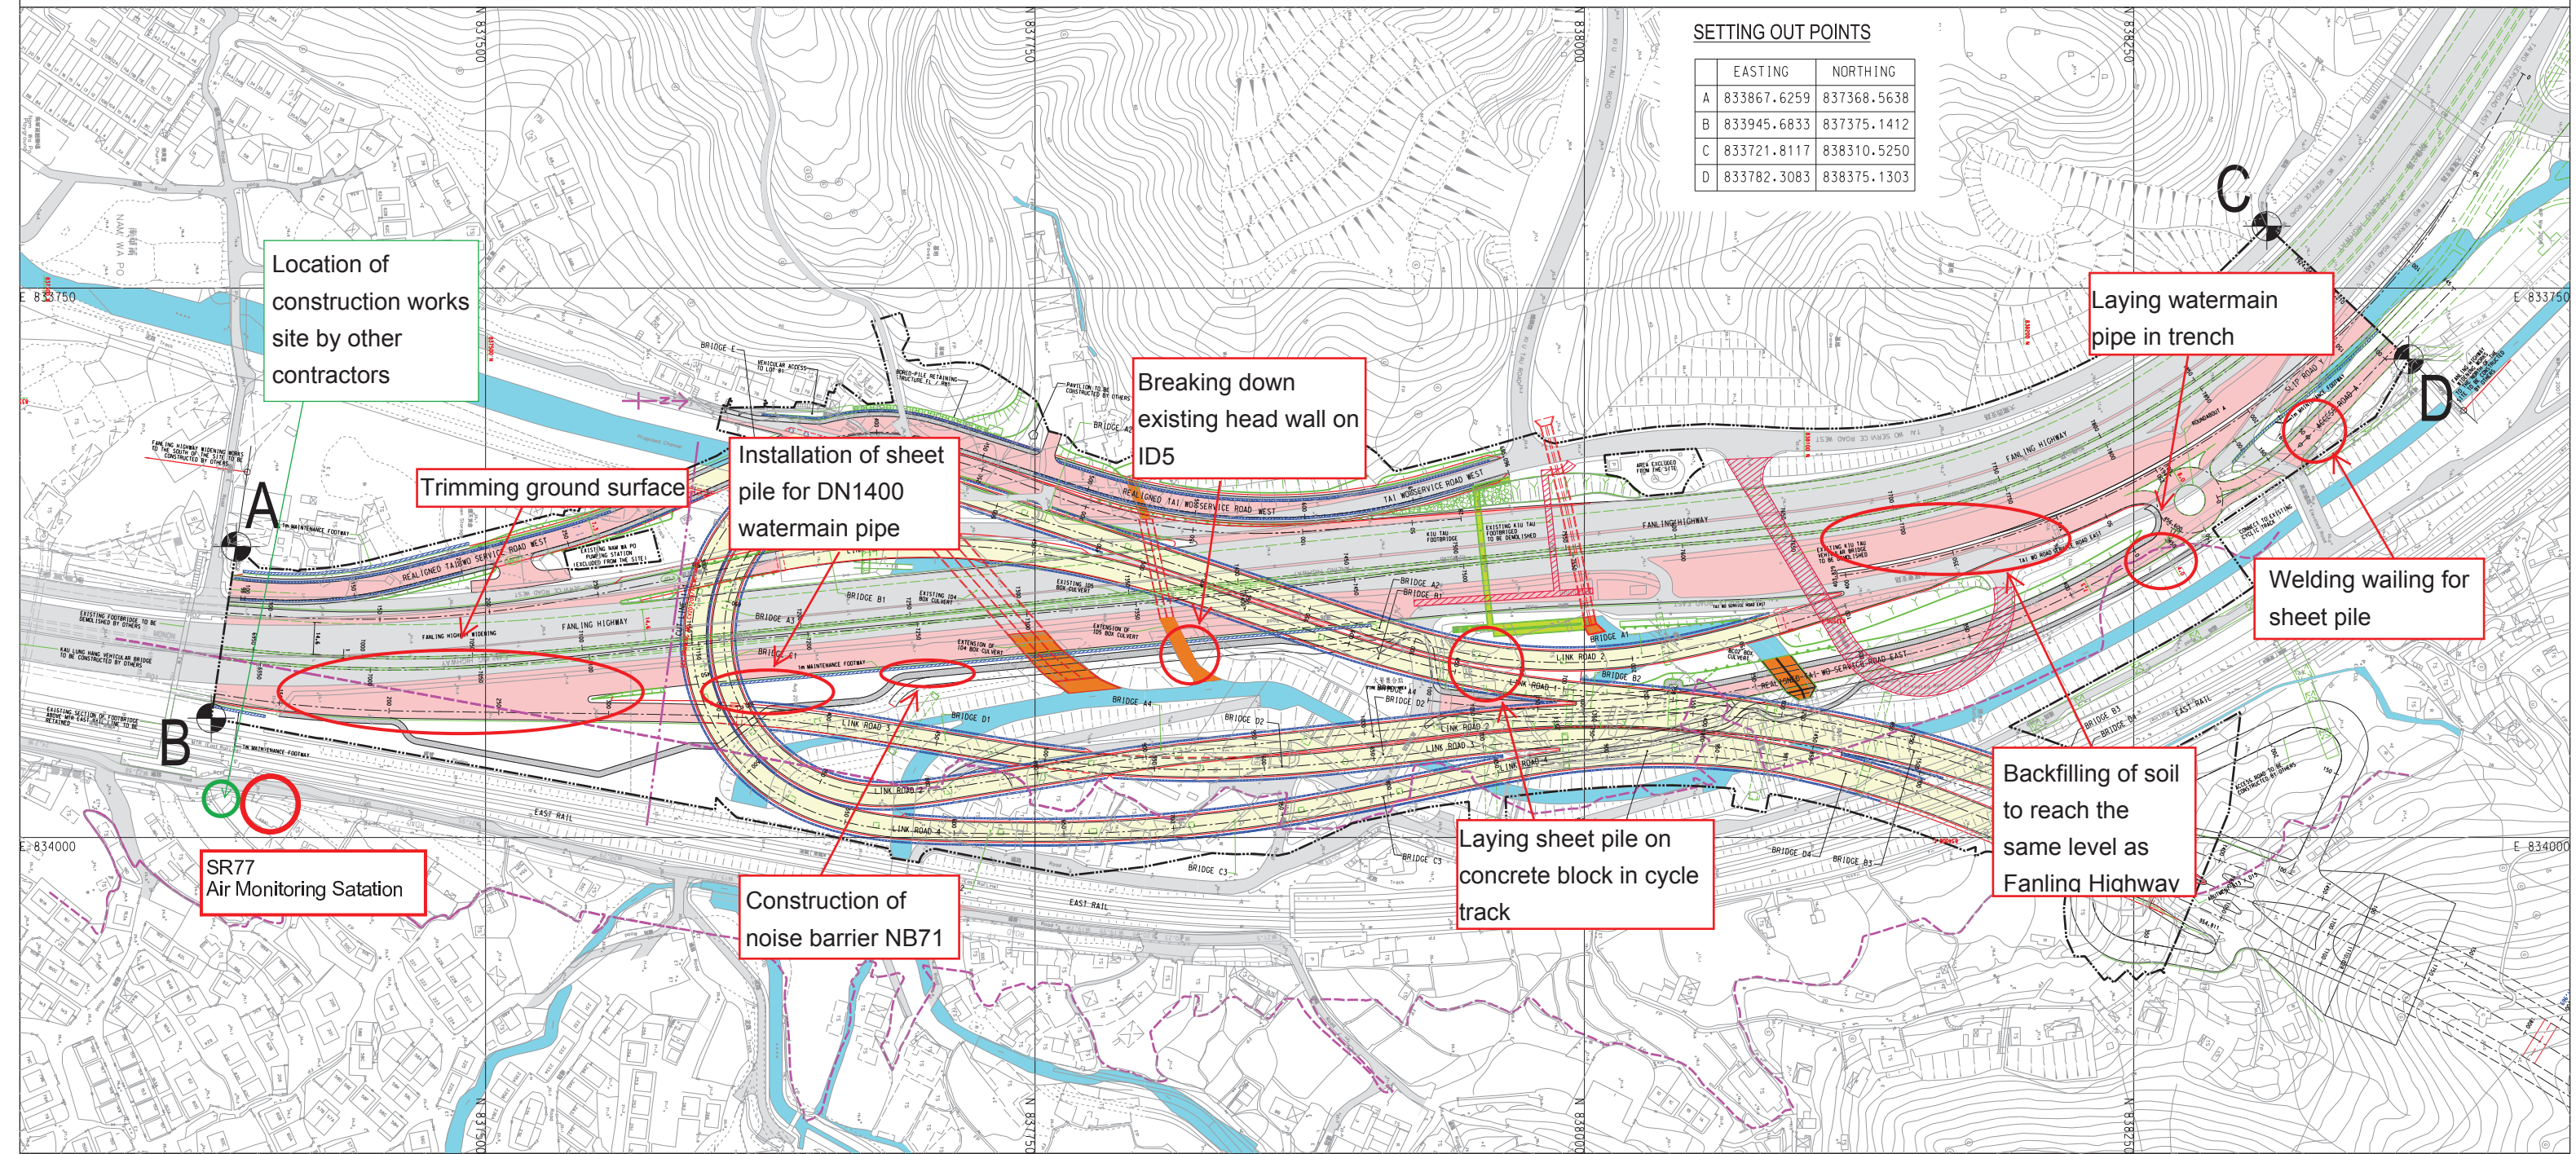
Location of construction works site by other contractors

Trimming ground surface

Installation of sheet pile for DN1400 watermain pipe

Breaking down existing head wall on ID5

Laying watermain pipe in trench

Welding wailing for sheet pile

Construction of noise barrier NB71

Laying sheet pile on concrete block in cycle track

Backfilling of soil to reach the same level as Fanling Highway

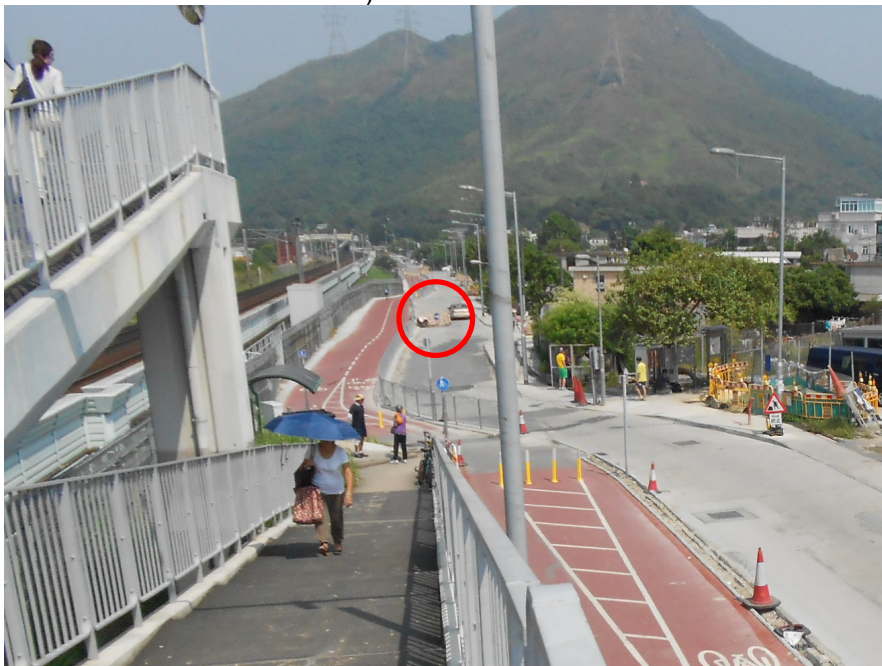
| Possible reason for the exceedance | <p><u>Construction Works of other Contracts</u></p> <p>Multiple construction works being undertaken by other Contractors have been observed within proximity of the High Volume Sampler (HVS) of the air quality monitoring station at SR77 (refer to the attached photos).</p> <p>Identified construction works including an excavation site (refer to the attached Photo 1); construction of a brick wall with a stockpile of sands (refer to the attached Photo 2) and excavation works under another contractor for Highway's Department (refer to attached Photo 3). These construction sites are located within a distance of about 20m from the SR77. Handling of spoils or concreting has also been observed as evidenced by an empty cement bag near the HVS (refer to the attached Photo 4). These operations may generate dust issues and would contribute to a higher TSP Level during sampling.</p> <p>Also, dusty materials may be disturbed by traffics and release fugitive dust during the sunny weather and such emission would contribute to a higher TSP Level (refer to attached Photo 5).</p> <p>Therefore, these construction works are anticipated to cause the elevated TSP levels as have been measured by our HVS.</p> <p><u>Construction Works of Entrusted Portion</u></p> <p>On the other hand, the construction works carried out for the Entrusted Portion during the monitoring period included backfilling works being carried out at northern side of the site and erection of noise barrier NB71, which were at a much farther distance from the air quality monitoring station at SR77 (refer to the attached location plan showing the works activities of the entrusted portion).</p> <p>In addition, proper mitigation measures for these construction works, including the use of water spraying and covering of exposed slopes where applicable, have been implemented and being monitored by an</p> |

Photo 1: Excavation Site observed within proximity of SR77 (Red Circle) (Date: 17 October 2014)

| Action taken / to be taken | <p>As the exceedance was non-project related, no further investigation and specific remedial measure(s) would be recommended for the Entrusted Works. Nevertheless, the following mitigation measures had been implemented on-site for dust suppression:</p> <ol style="list-style-type: none"> 1. Exposed slopes near the river were covered with impervious sheets; 2. Any open stockpile of construction materials were covered with impervious sheet; and 3. Sufficient watering was applied along the haul road. |

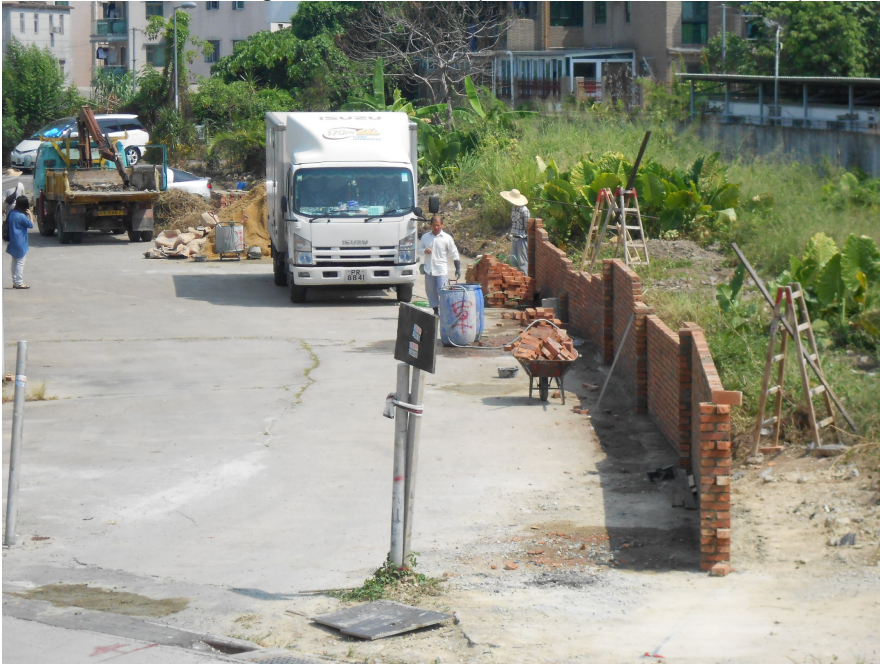
Photo 2: Construction of a brick wall with a stockpile of sands observed near the monitoring station SR77 (Date: 17 October 2014)

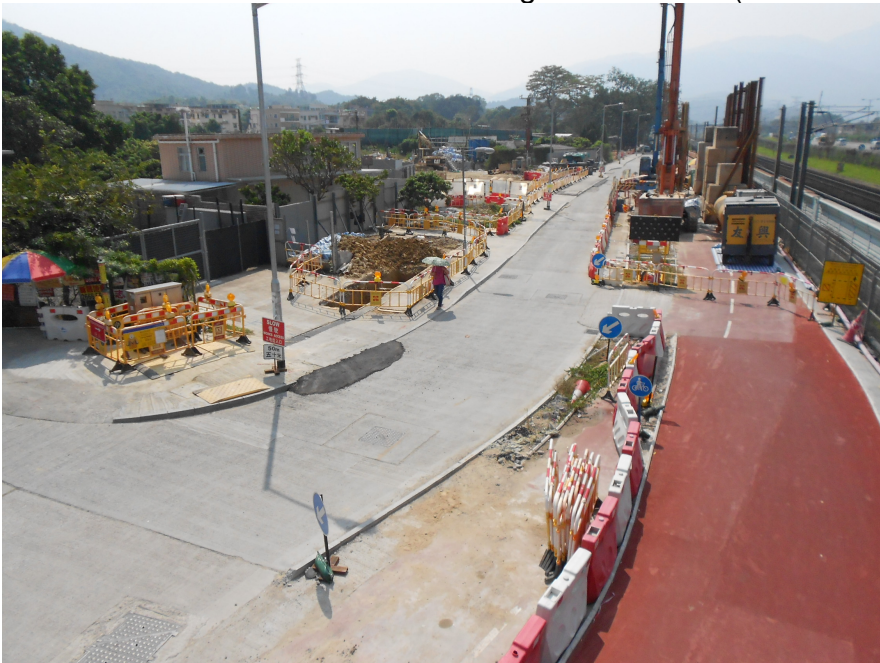
Photo 3: Excavation works under another contractor for Highway's Department observed near the monitoring station SR77 (Date: 17 October 2014)

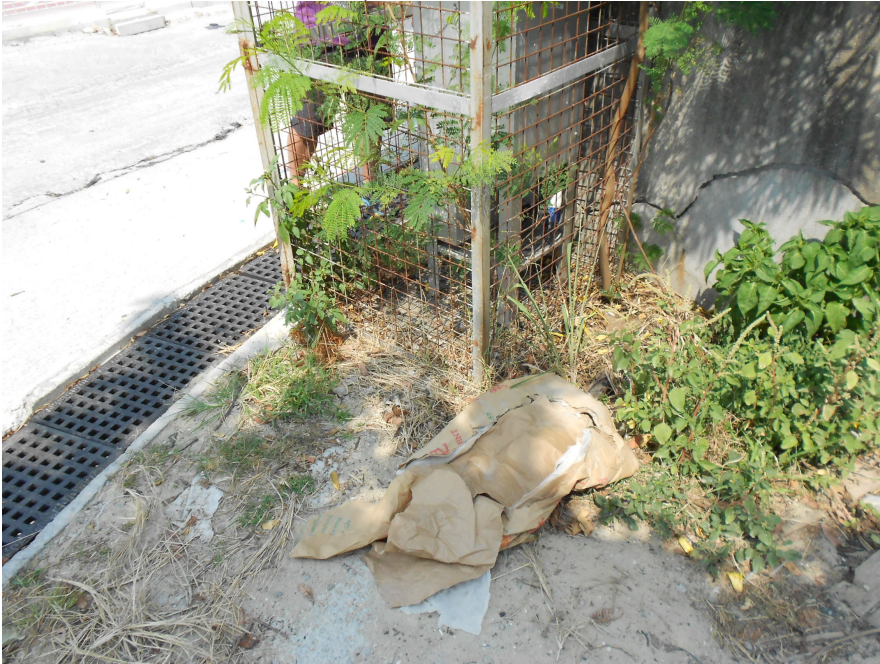
Photo 4: Empty cement bag observed near the monitoring station SR77 (Date: 17 October 2014)

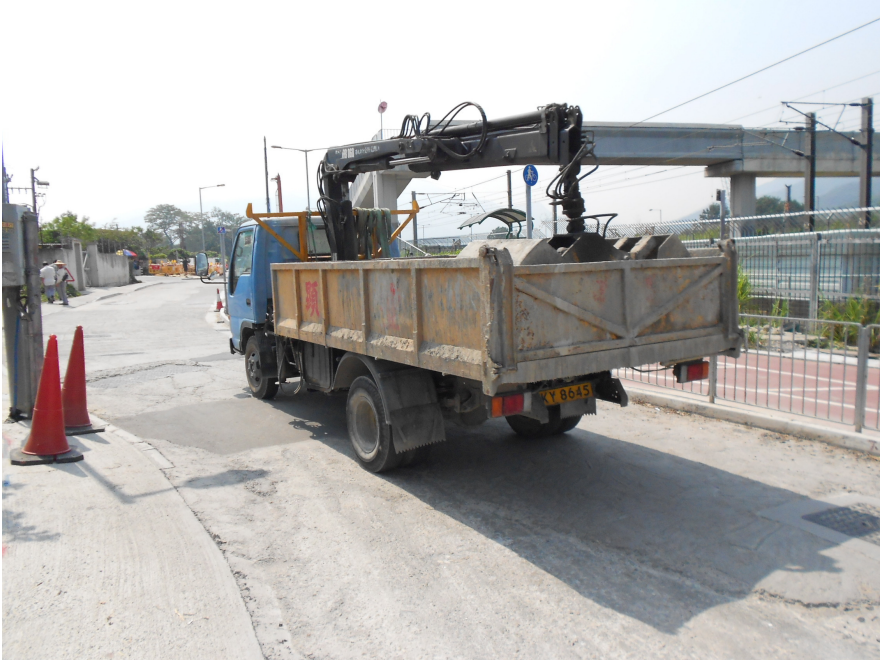
Photo 5: Traffic may disturb dusty material and generate fugitive dust as observed near the monitoring station SR77 (Date: 17 October 2014)
