Appendix M Investigation Report for Exceedance

Entrusted Portion of Widening of Tolo Highway / Fanling Highway between Island House Interchange and Fanling Stage 2

Investigation Report of Environmental Quality Exceedance(s)

Ref. No.: A160723_24TSP

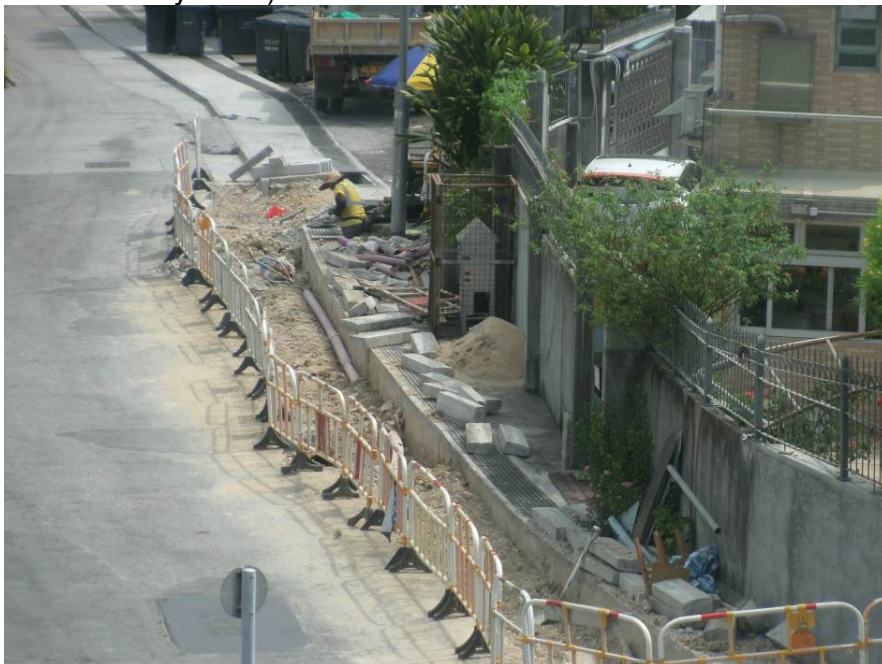
Date	23 July 2016
Time	--
Monitoring Location	SR77
Parameter	24-Hr Total Suspended Particulate
Action / Limit Levels	Action Level: 170.3µg/m ³ Limit Level: 260µg/m ³
Measured Level	172.3µg/m ³ (Action level being exceeded)
Possible reason for the exceedance	<p><u>Construction Works of Entrusted Portion</u></p> <p>The construction works being carried out within the Entrusted Portion during the monitoring period including construction of Pier AC4, which is located approximately 100 meters from the monitoring location at SR77, and the works being carried out at northern side of the site near Tong Hang East, which were at a much farther distance of more than 300 meters from the monitoring location at SR77. These works are far away from the monitoring location and also the formworks are not dusty operations. (refer to the attached location plan showing the works activities of the Entrusted Portion).</p> <p>Hence, the works activities under Entrusted Portion during the monitoring period are not considered to be the major dust sources of the exceedance.</p> <p><u>Disturbance during Monitoring</u></p> <p>Road works being carried out by another Contractor (under Contract No. TP/2010/02 Cycle Tracks From Sheung Shui to Ma On Shan) were observed within close proximity of the monitoring works. Excavation has been conducted during the monitoring period and exposed earth and stockpiles were found within close proximity of the monitoring station. (See Photo 1 and Photo 2)</p> <p>Such dusty materials may contribute to the dust sources being recorded by the high volume sampler.</p> <p><u>Conclusion</u></p> <p>Hence, it is considered that the exceedance was unlikely due to the construction works of the Entrusted Portion.</p>

Photo 1: Road Works observed near the Air Quality Monitoring Station (Date: 23 July 2016)

Action taken / to be taken	As the exceedance was non-project related, no further investigation and specific remedial measure(s) would be recommended for the Entrusted Works. Nevertheless, the following mitigation measures had been implemented on-site for dust suppression: <ol style="list-style-type: none">1. Any open stockpile of construction materials were covered with impervious sheet; and2. Sufficient watering was applied along the haul road.
Remarks	-

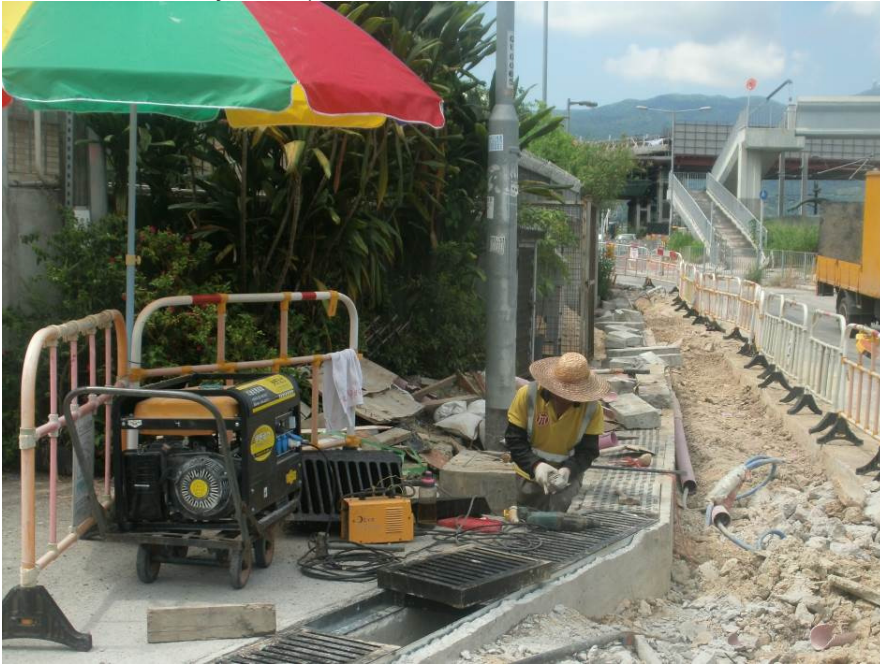
Photo 2: Excavated area and exposed earth near the monitoring location (Date: 23 July 2016)
