# Appendix M Investigation Report for Exceedances

Entrusted Portion of Widening of Tolo Highway / Fanling Highway between Island House Interchange and Fanling Stage 2

**Investigation Report of Environmental Quality Exceedance(s)**

Ref. No.: W170322\_DO

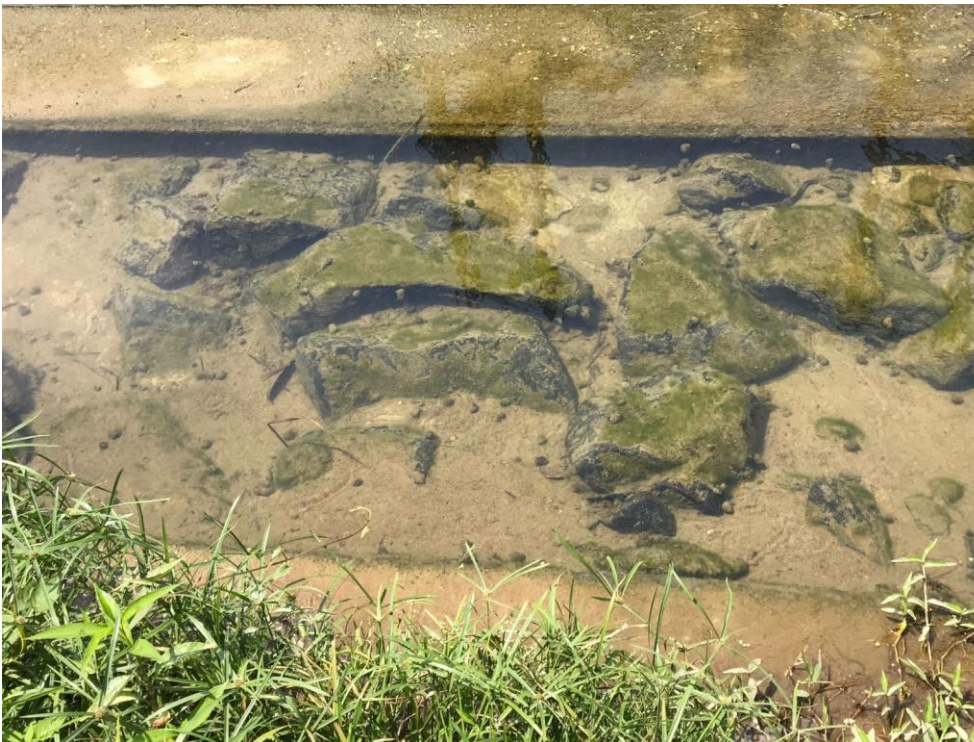
(At I5)

<b>Date</b>	22 March 2017
<b>Time</b>	12:22 PM
<b>Monitoring Location</b>	I5 - downstream of Ma Wat River at Yuen Leng
<b>Parameter</b>	Dissolved Oxygen
<b>Action / Limit Levels</b>	Action Level: 6.7 mg/L Limit Level: 4 mg/L or 40% saturation at 15 degree Celsius
<b>Measured Level</b>	6.4mg/L (Action level being exceeded)
<b>Possible reason for the exceedance</b>	The exceedance has been investigated and was considered not related to the project works as DO levels were low among all monitoring stations, including the control stations. No abnormal condition was observed during the monitoring. As such, the natural variation of water quality has been considered attributed to the low DO level.
<b>Action taken / to be taken</b>	As the non-compliance was non-project related, no further investigation and remedial measure(s) would be required.
<b>Remarks</b>	-

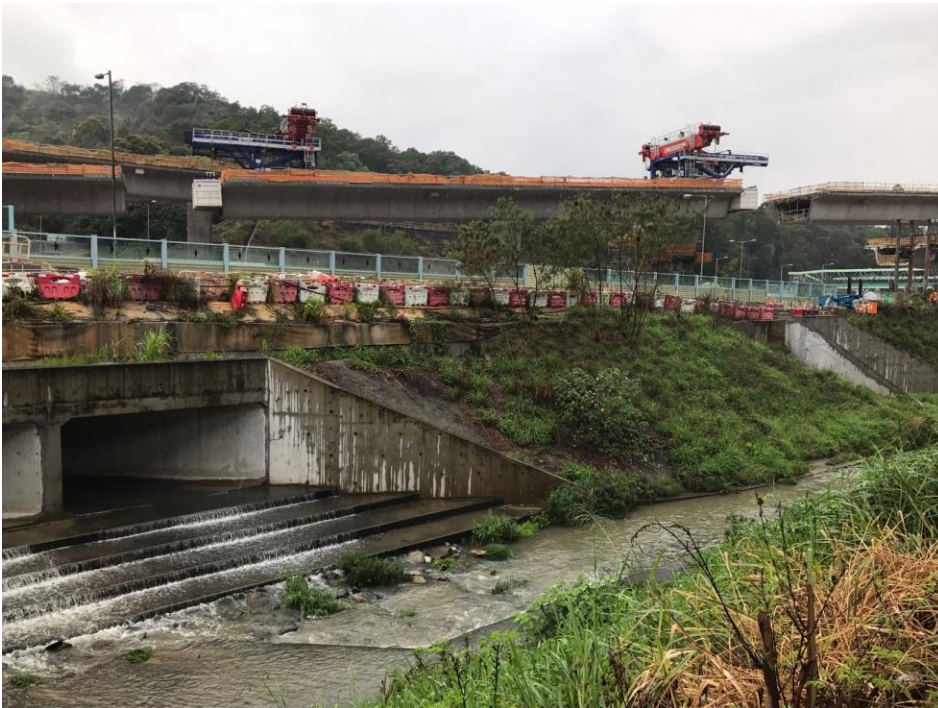
(At I5)

<b>Date</b>	29 March 2017
<b>Time</b>	11:34 AM
<b>Monitoring Location</b>	I5 - downstream of Ma Wat River at Yuen Leng
<b>Parameter</b>	Dissolved Oxygen
<b>Action / Limit Levels</b>	Action Level: 6.7 mg/L Limit Level: 4 mg/L or 40% saturation at 15 degree Celsius
<b>Measured Level</b>	6.3mg/L (Action level being exceeded)
<b>Possible reason for the exceedance</b>	The exceedance has been investigated and was considered not related to the project works as DO levels were low among all monitoring stations, including the control stations. No abnormal condition was observed during the monitoring. As such, the natural variation of water quality has been considered attributed to the low DO level.
<b>Action taken / to be taken</b>	As the non-compliance was non-project related, no further investigation and remedial measure(s) would be required.
<b>Remarks</b>	-

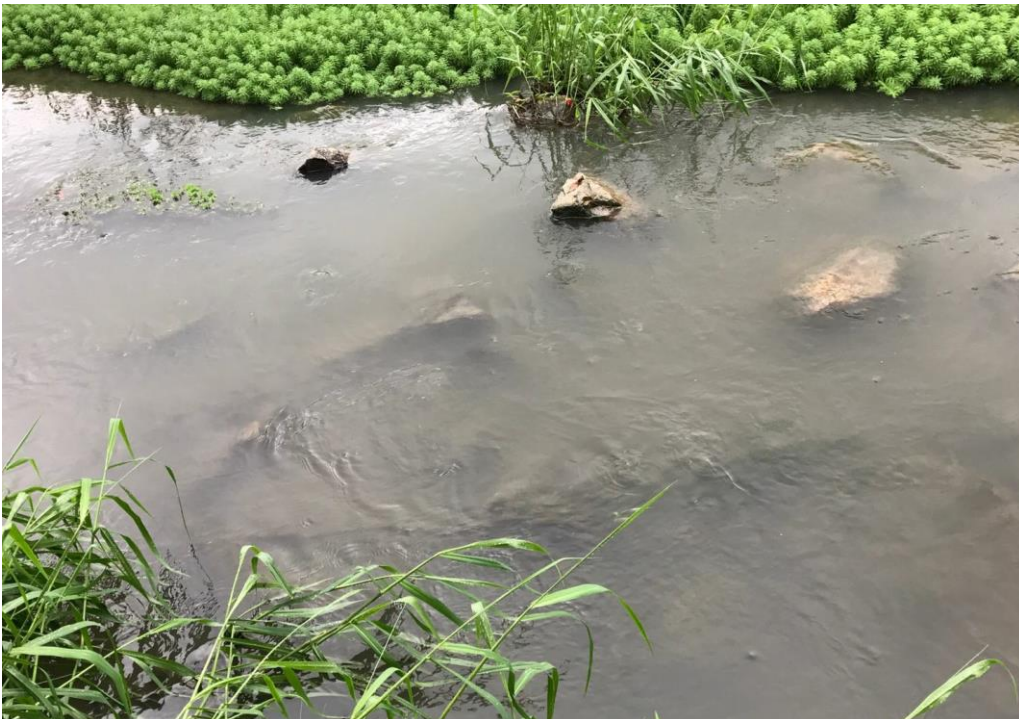
(At I5)

<b>Date</b>	31 March 2017
<b>Time</b>	12:42 PM
<b>Monitoring Location</b>	I5 - downstream of Ma Wat River at Yuen Leng
<b>Parameter</b>	Suspended Solid
<b>Action / Limit Levels</b>	Action Level: 42.6 mg/L or 120% of upstream control station's SS of the same day (i.e. 36mg/L) Limit Level: 46.8 mg/L or 130% of upstream control station's SS of the same day (i.e. 39mg/L)
<b>Measured Level</b>	40.5mg/L (Limit level being exceeded)
<b>Possible reason for the exceedance</b>	<p>There was rain and the river was muddy due to vigorous water flow. The disturbed riverbed caused an elevation of suspended solids level. Control station C3a also showed elevated suspended solids level due to the adverse weather condition.</p> <p>During the water sampling, the box culvert works had been completed and post monitoring had begun. There was no works being carried out.</p> <p>It is therefore considered that elevation of suspended solids level would be due to natural fluctuation.</p>

<b>Action taken / to be taken</b>	As the non-compliance was non-project related, no further investigation and remedial measure(s) would be required.
<b>Remarks</b>	-
