Appendix M Investigation Report for Exceedances

Entrusted Portion of Widening of Tolo Highway / Fanling Highway between Island House Interchange and Fanling Stage 2

Investigation Report of Environmental Quality Exceedance(s) Ref. No.: A171208_24TSP

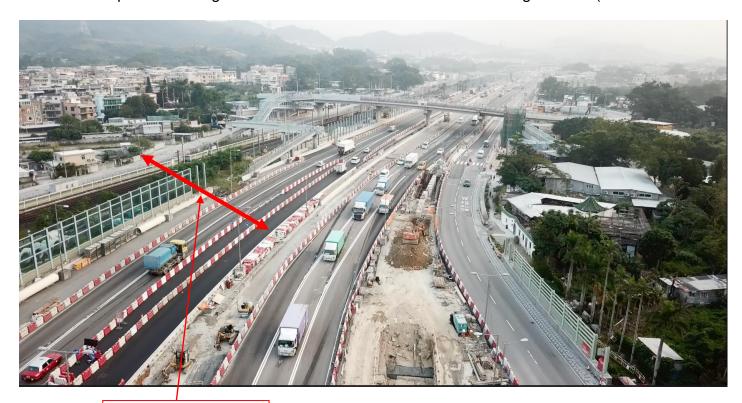
Photo 1: Site photo showing the construction works area and monitoring location (Date: 8 December 2017)

Distance: Approximately 70m

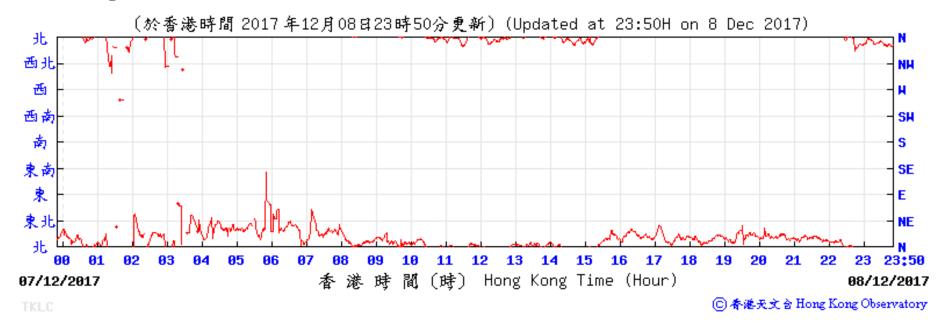
Photo 2: Wind Direction at Ta Kwu Ling Ta Kwu Ling:
