Entrusted Portion of Widening of Tolo Highway / Fanling Highway between Island House Interchange and Fanling Stage 2

**Investigation Report of Environmental Quality Exceedance(s)**

Ref. No.: W170420\_DO

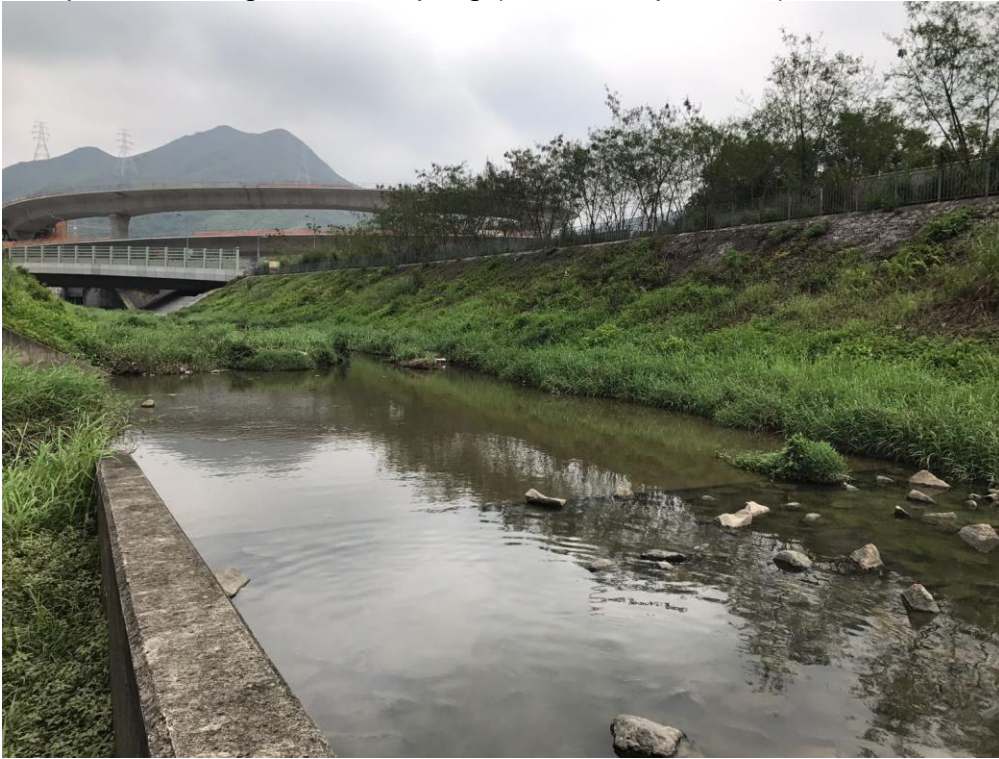
(At C3a)

<b>Date</b>	20 April 2017
<b>Time</b>	11:07 AM
<b>Monitoring Location</b>	I5 - downstream of Ma Wat River at Yuen Leng
<b>Parameter</b>	Dissolved Oxygen
<b>Action / Limit Levels</b>	Action Level: 6.7 mg/L Limit Level: 4 mg/L or 40% saturation at 15 degree Celsius
<b>Measured Level</b>	5.9mg/L (Action level being exceeded)
<b>Possible reason for the exceedance</b>	The exceedance has been investigated and was considered not related to the project works as DO levels were low among all monitoring stations, including the control stations. The construction works at box culvert has been completed in March 2017. No abnormal condition was observed during the monitoring. As such, the natural variation of water quality has been considered attributed to the low DO level.
<b>Action taken / to be taken</b>	As the non-compliance was non-project related, no further investigation and remedial measure(s) would be required.

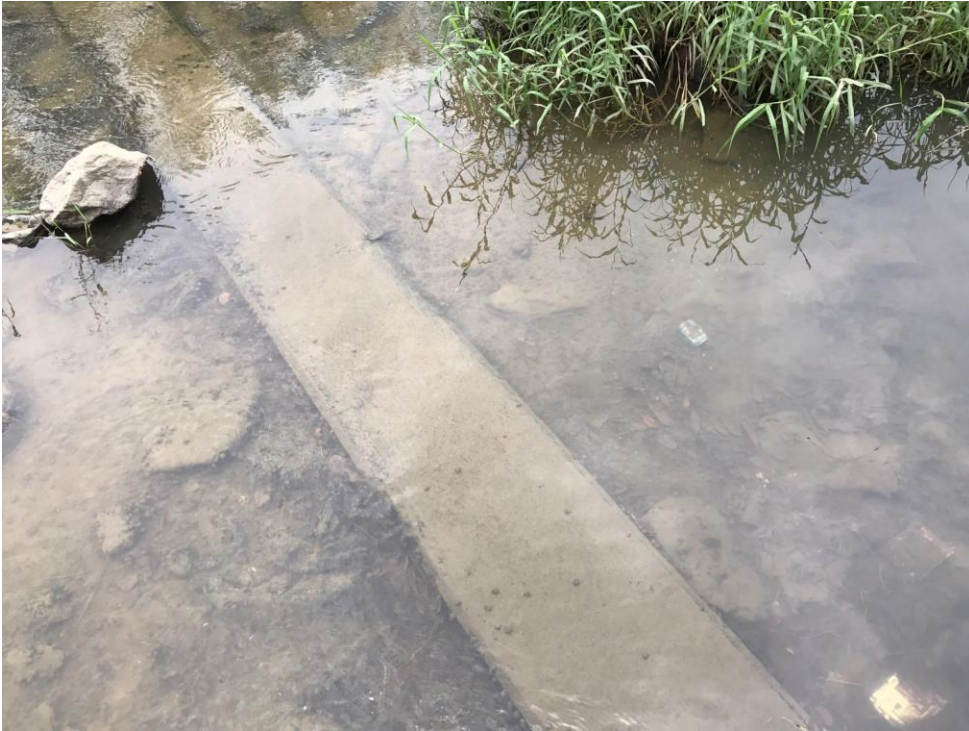
(At C3a)

<b>Date</b>	24 April 2017
<b>Time</b>	11:31 AM
<b>Monitoring Location</b>	I5 - downstream of Ma Wat River at Yuen Leng
<b>Parameter</b>	Dissolved Oxygen
<b>Action / Limit Levels</b>	Action Level: 6.7 mg/L Limit Level: 4 mg/L or 40% saturation at 15 degree Celsius
<b>Measured Level</b>	6.0mg/L (Action level being exceeded)
<b>Possible reason for the exceedance</b>	The exceedance has been investigated and was considered not related to the project works as DO levels were low among all monitoring stations, including the control stations. The construction works at box culvert has been completed in March 2017. No abnormal condition was observed during the monitoring. As such, the natural variation of water quality has been considered attributed to the low DO level.
<b>Action taken / to be taken</b>	As the non-compliance was non-project related, no further investigation and remedial measure(s) would be required.
