# **Entrusted Portion of Widening of Tolo Highway / Fanling Highway between Island House Interchange and Fanling Stage 2**

Monthly EM&A Report

December 2014

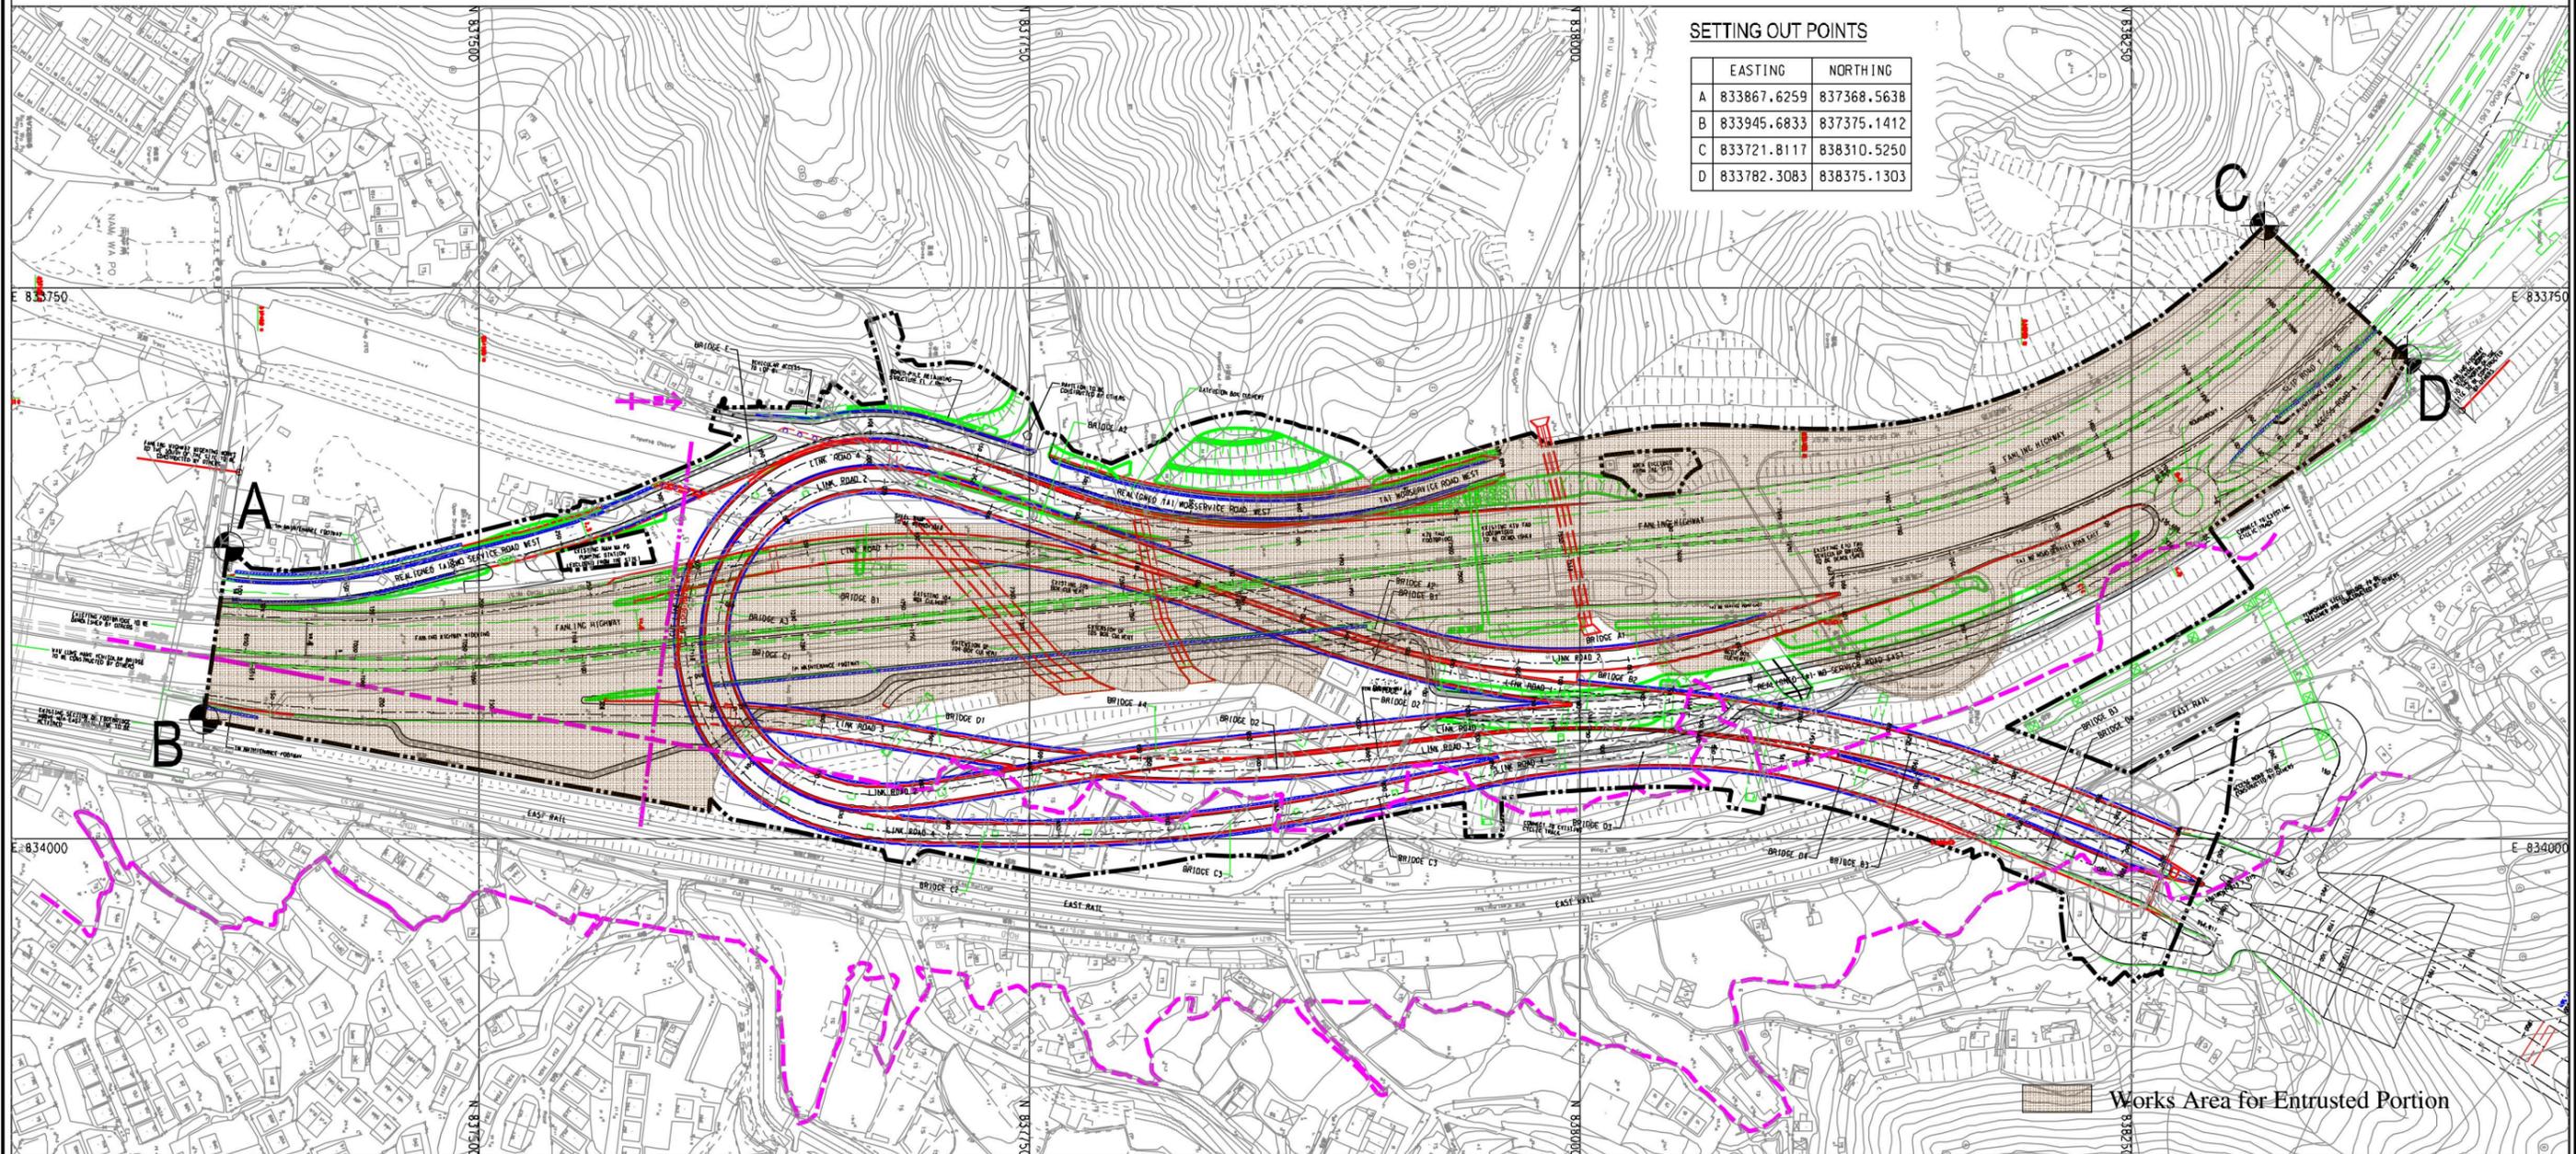
2.2.2 **Figure 1** shows the works areas for the Entrusted Portion of Widening of Tolo Highway / Fanling Highway between Island House Interchange and Fanling Stage 2.

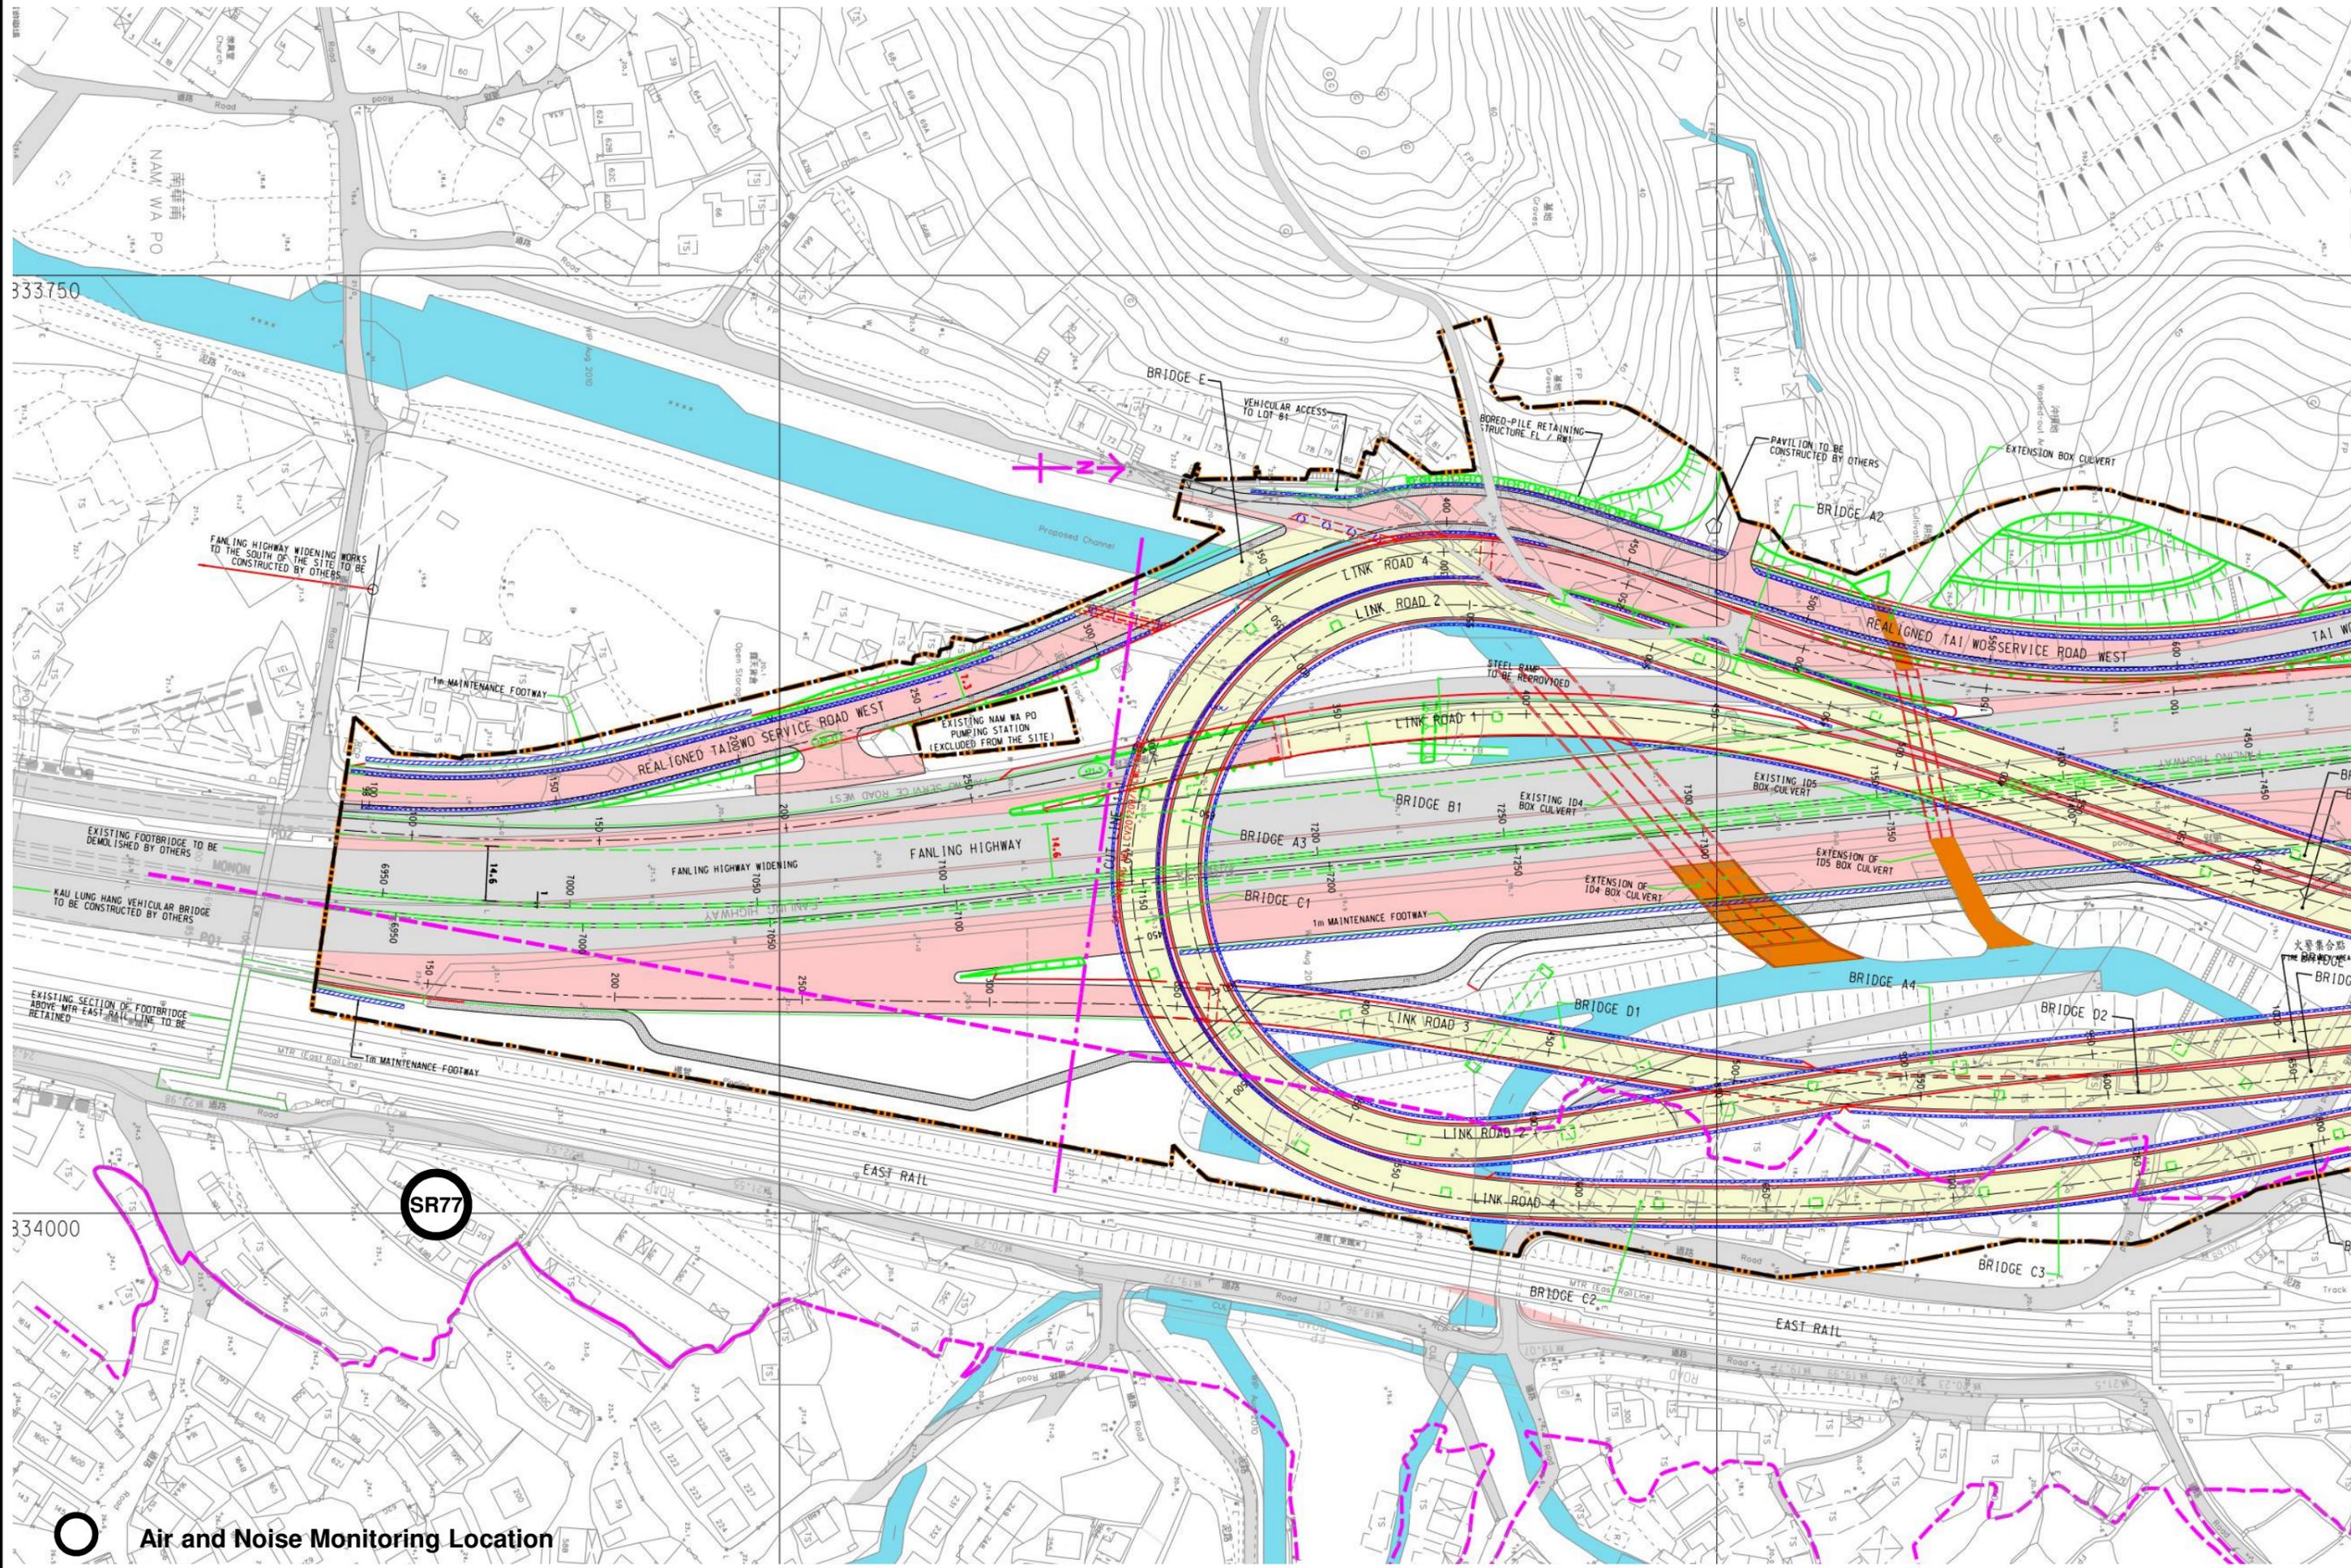
4.3.1 Air quality monitoring was conducted at the location specified in the Updated EM&A Manual. **Table 4.2** describes the details of the air quality monitoring station with its location as shown in **Figure 2**.

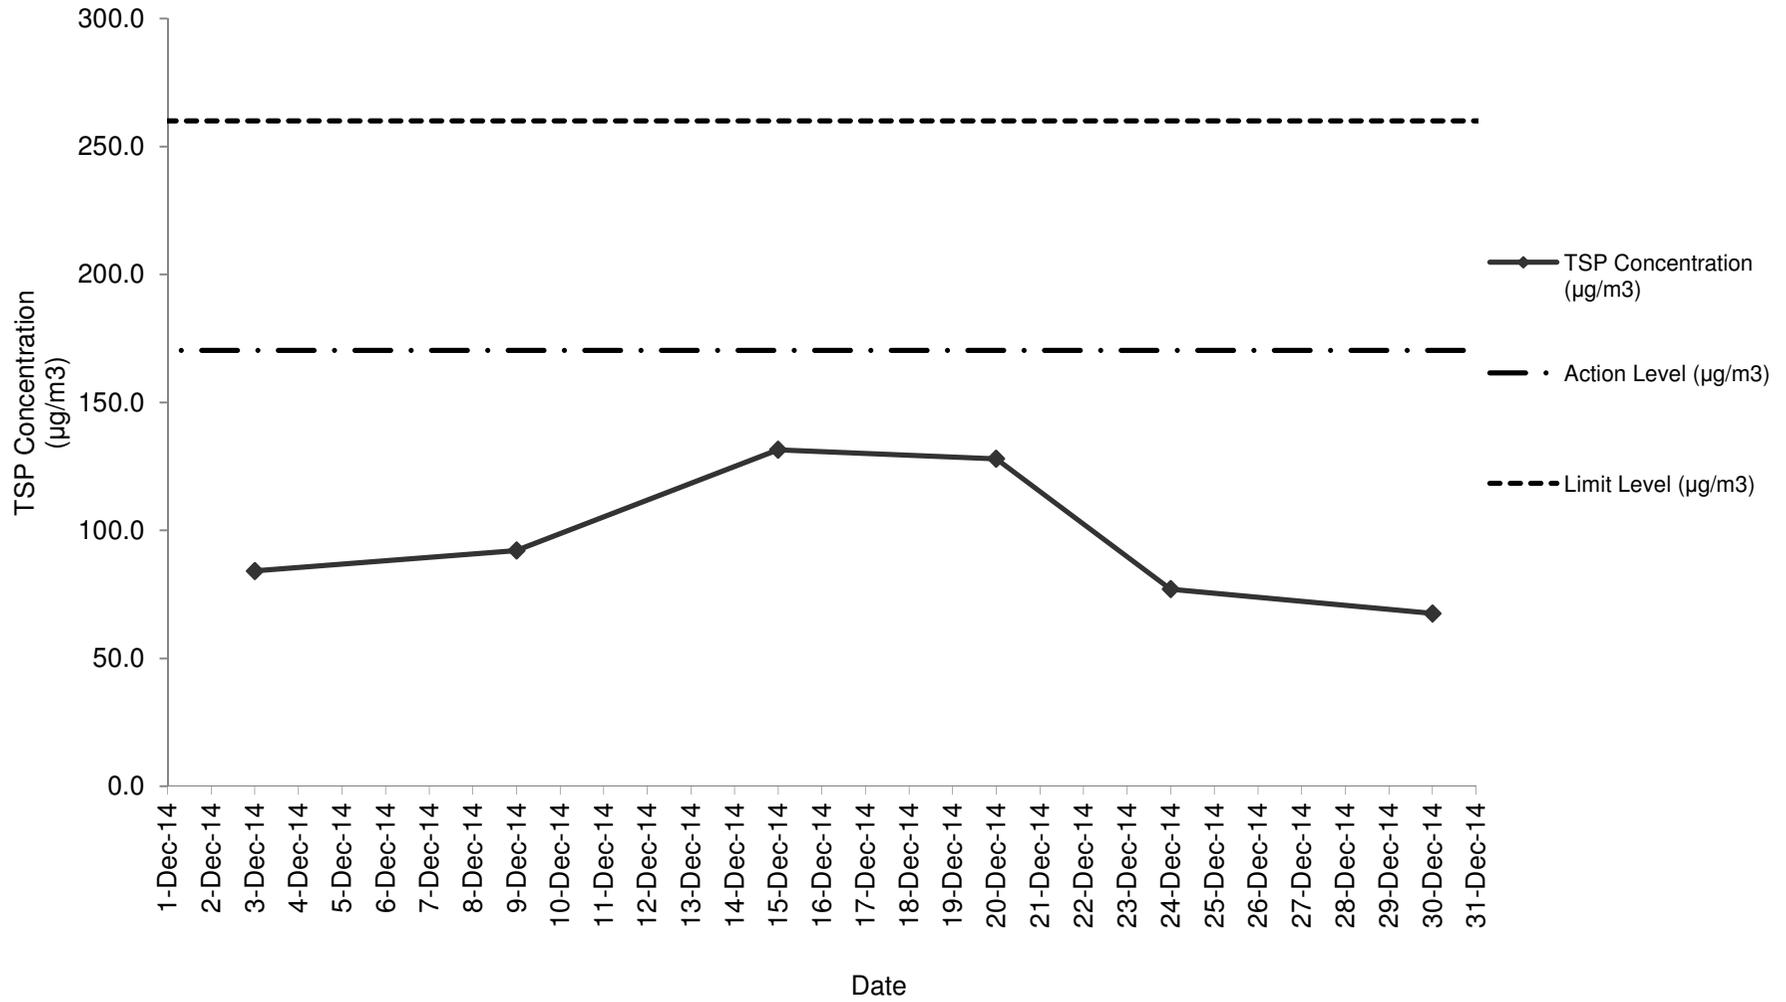
### 24-Hour TSP Monitoring Result at Station: SR77

No exceedance of Action and Limit Level was recorded for 24-hour TSP monitoring at the monitoring location AM1(SR77) in the reporting month.

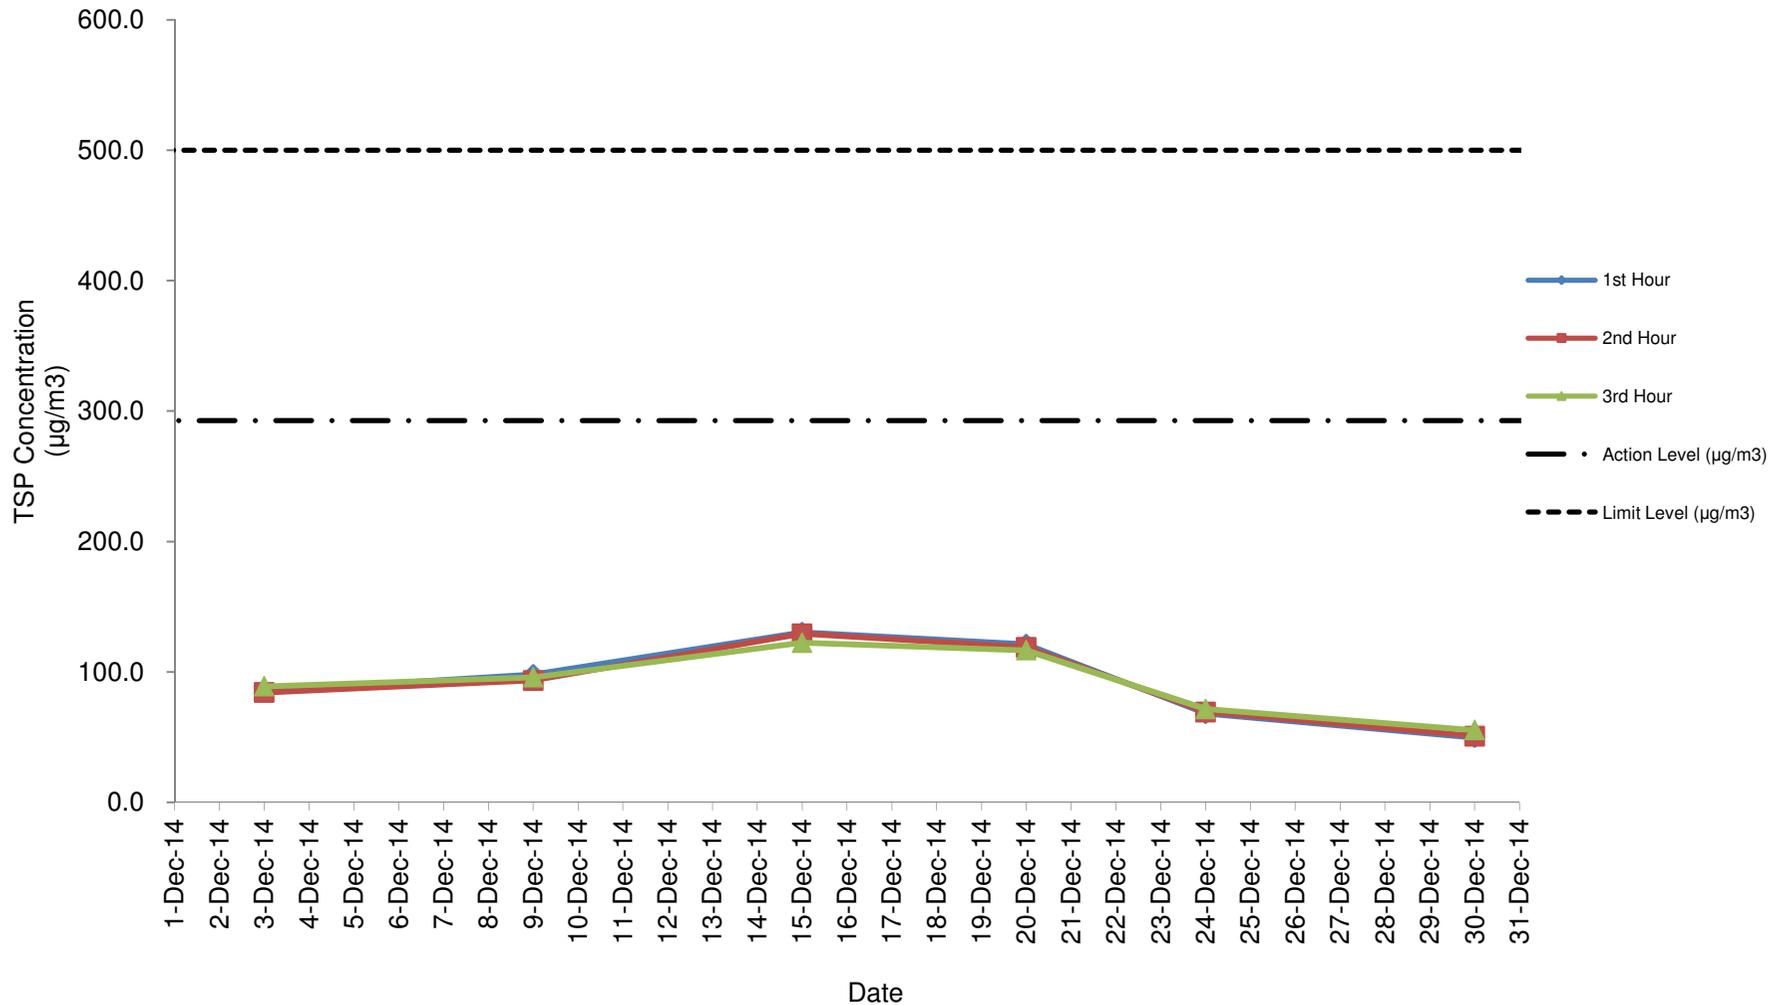
### 1-Hour TSP Monitoring Result at station: SR77

No exceedance of Action and Limit Level was recorded for 1-hour TSP monitoring at the monitoring location AM1(SR77) in the reporting month.

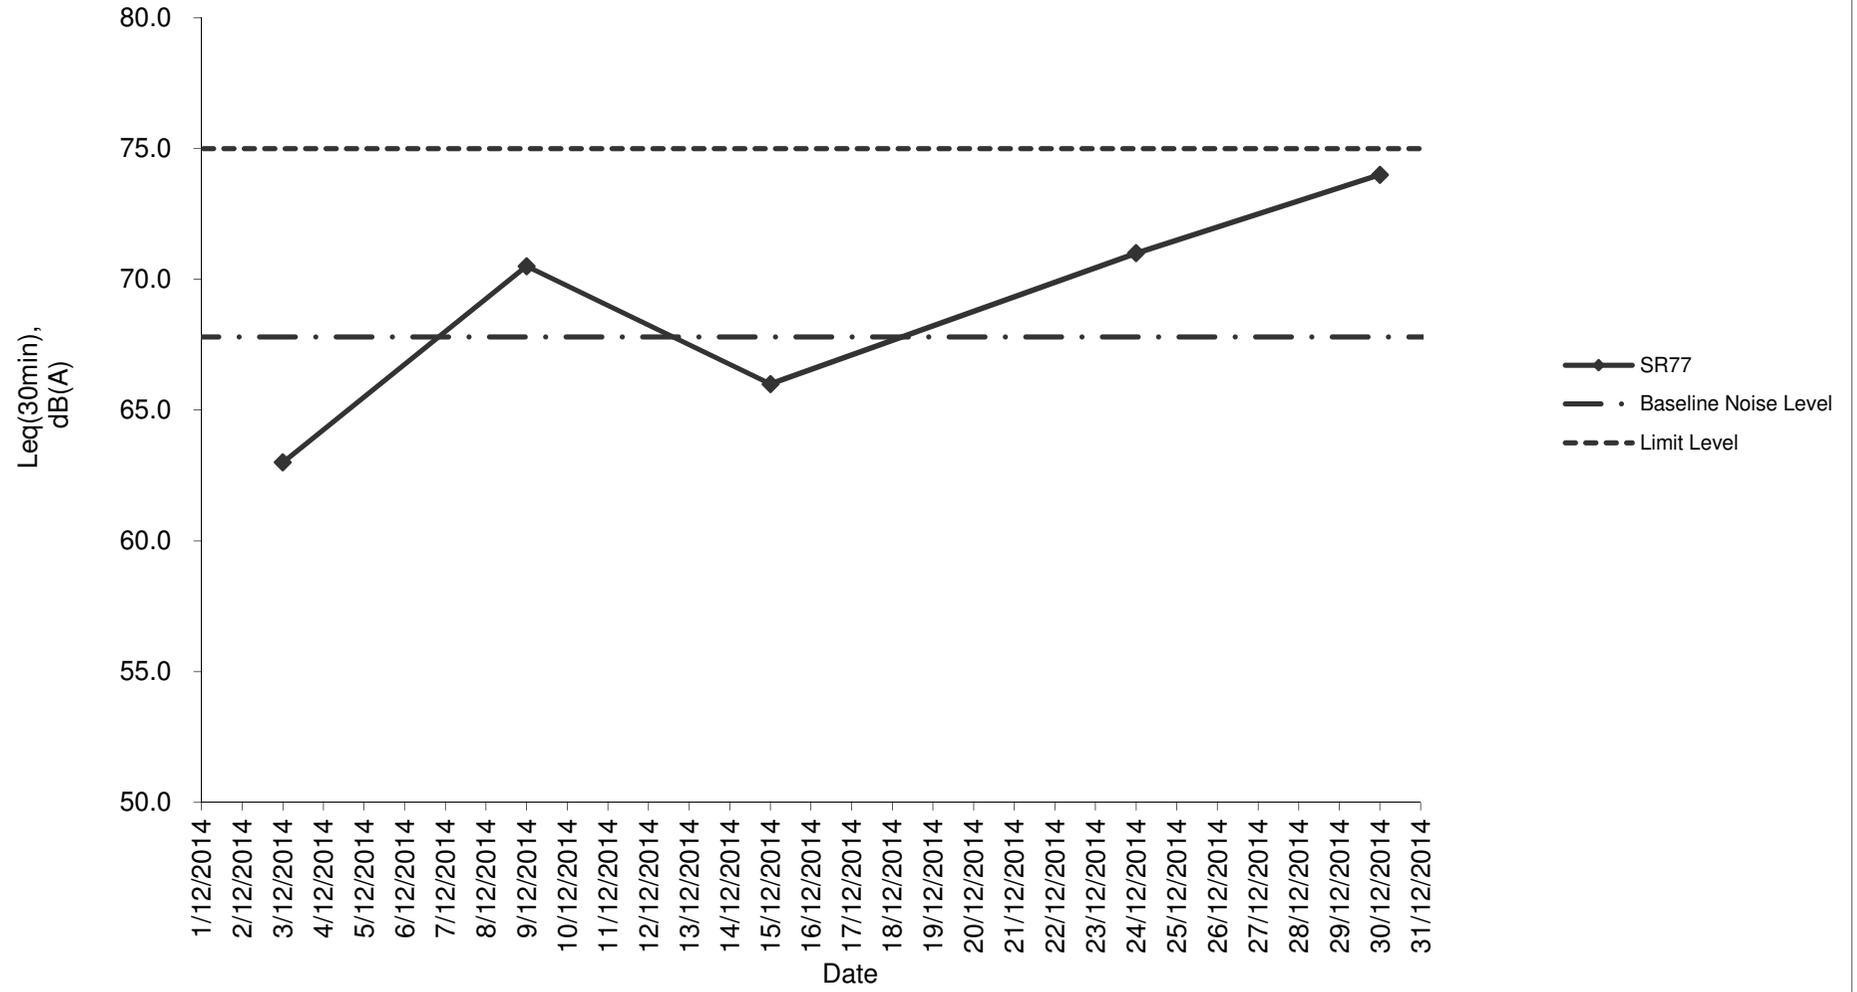
### Noise monitoring result: SR77

No noise complaint was received in the reporting month, so no Action Level exceedance was recorded. Also, no Limit Level exceedance of noise monitoring was recorded in the reporting month.
