# Entrusted Portion of Widening of Tolo Highway / Fanling Highway between Island House Interchange and Fanling Stage 2

Monthly EM&A Report

March 2017

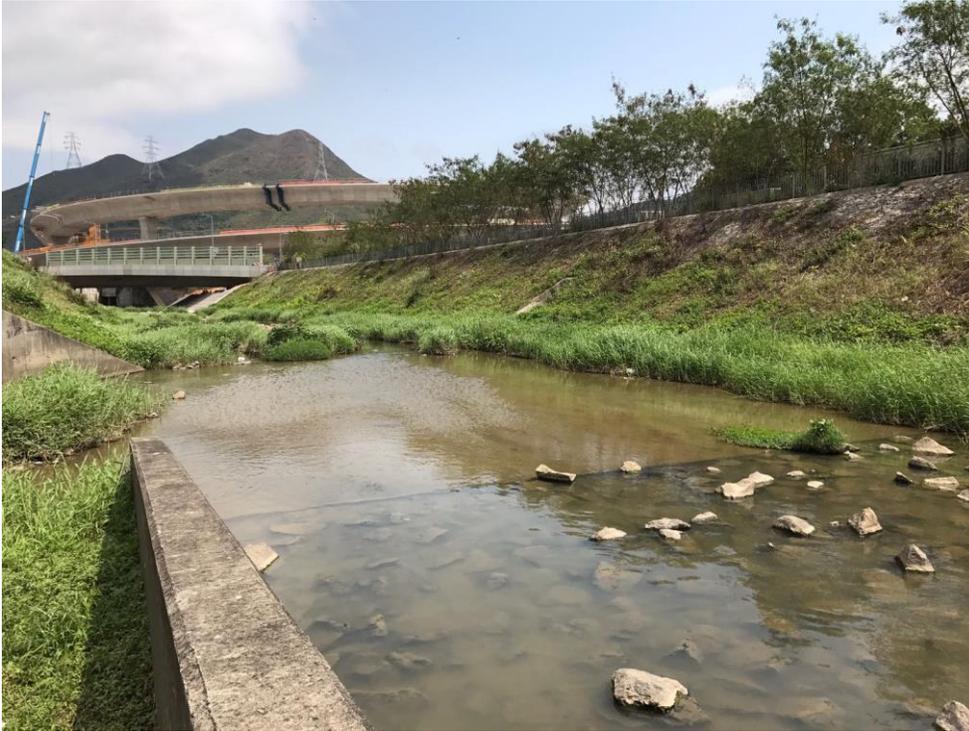
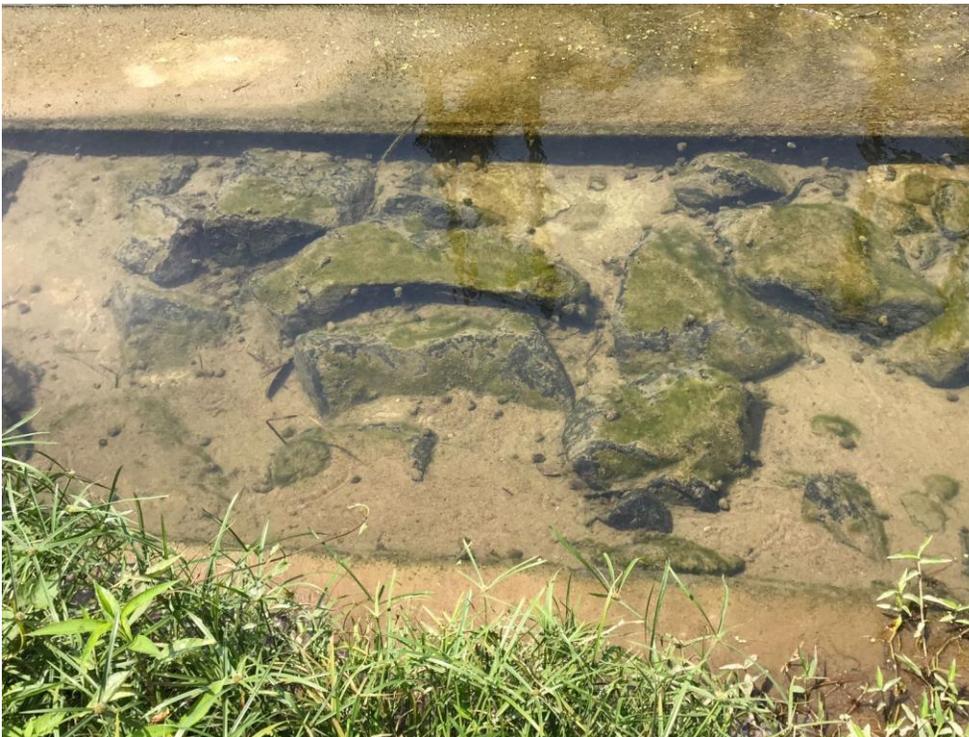
Site photos during water sampling (Date: 22 March 2017)

<b>Date</b>	22 March 2017
<b>Time</b>	12:22 PM
<b>Monitoring Location</b>	I5 - downstream of Ma Wat River at Yuen Leng
<b>Parameter</b>	Dissolved Oxygen
<b>Action / Limit Levels</b>	Action Level: 6.7 mg/L Limit Level: 4 mg/L or 40% saturation at 15 degree Celsius
<b>Measured Level</b>	6.4mg/L (Action level being exceeded)
<b>Possible reason for the exceedance</b>	The exceedance has been investigated and was considered not related to the project works as DO levels were low among all monitoring stations, including the control stations. No abnormal condition was observed during the monitoring. As such, the natural variation of water quality has been considered attributed to the low DO level.
<b>Action taken / to be taken</b>	As the non-compliance was non-project related, no further investigation and remedial measure(s) would be required.
<b>Remarks</b>	-

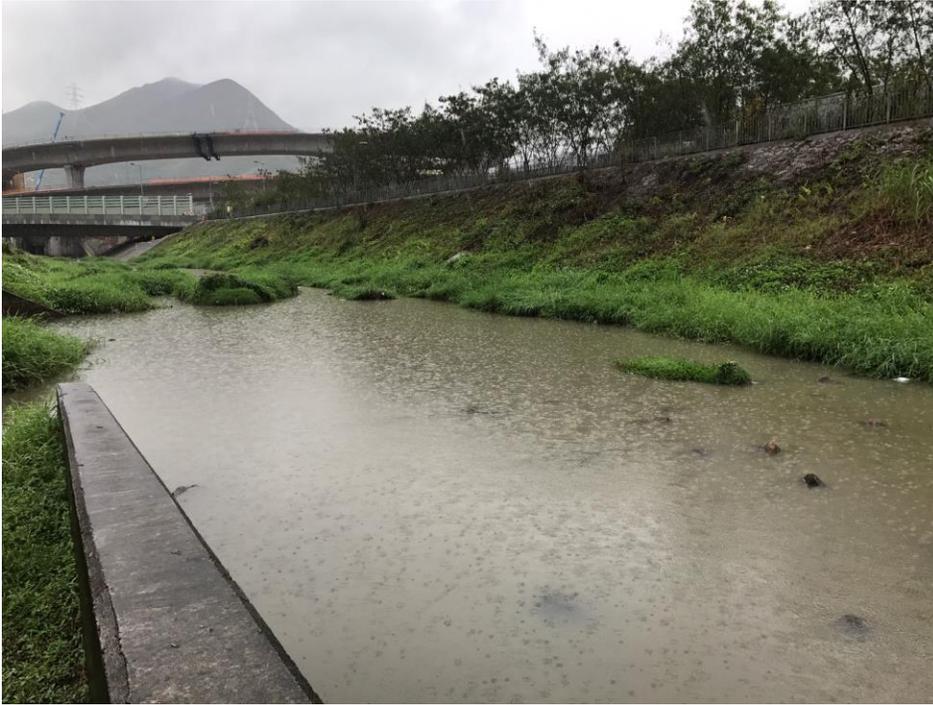
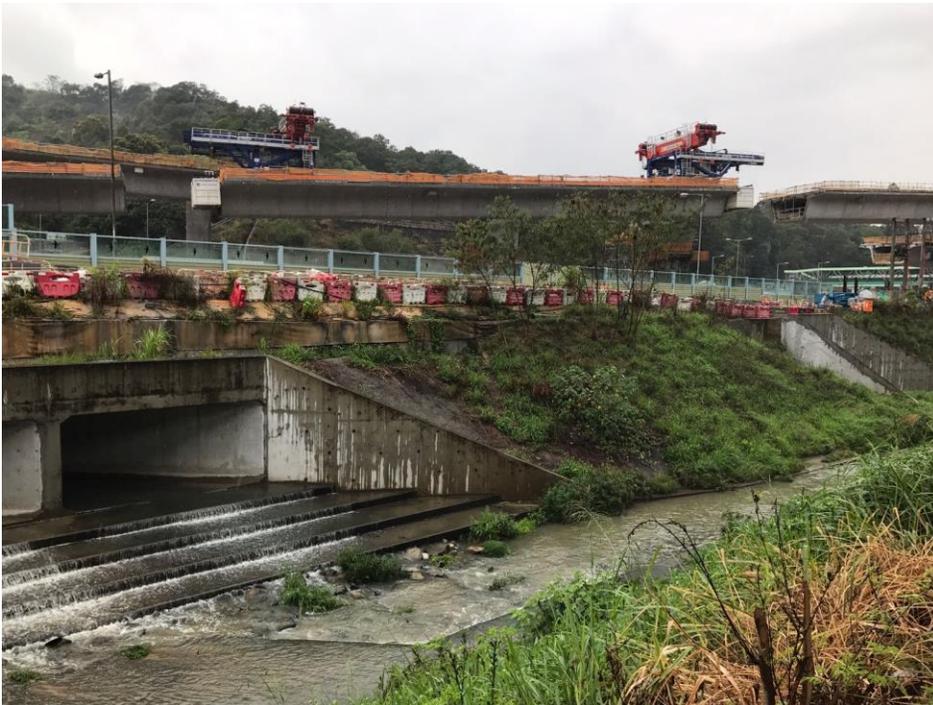
Site photos during water sampling (Date: 29 March 2017)

<b>Date</b>	29 March 2017
<b>Time</b>	11:34 AM
<b>Monitoring Location</b>	I5 - downstream of Ma Wat River at Yuen Leng
<b>Parameter</b>	Dissolved Oxygen
<b>Action / Limit Levels</b>	Action Level: 6.7 mg/L Limit Level: 4 mg/L or 40% saturation at 15 degree Celsius
<b>Measured Level</b>	6.3mg/L (Action level being exceeded)
<b>Possible reason for the exceedance</b>	The exceedance has been investigated and was considered not related to the project works as DO levels were low among all monitoring stations, including the control stations. No abnormal condition was observed during the monitoring. As such, the natural variation of water quality has been considered attributed to the low DO level.
<b>Action taken / to be taken</b>	As the non-compliance was non-project related, no further investigation and remedial measure(s) would be required.
<b>Remarks</b>	-

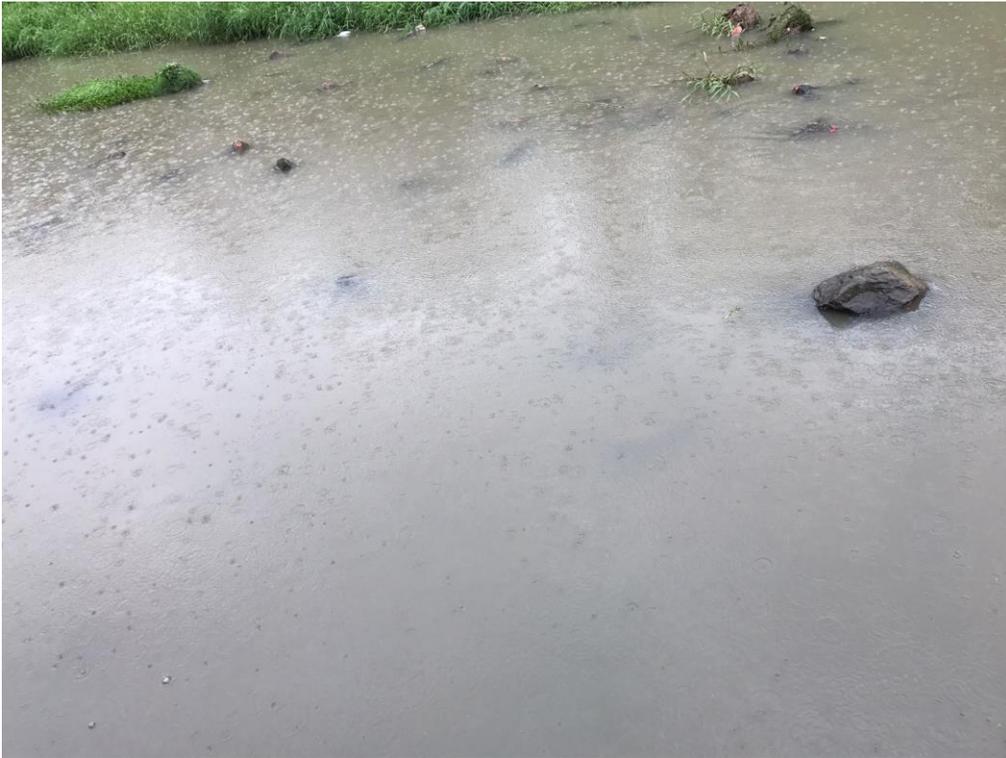
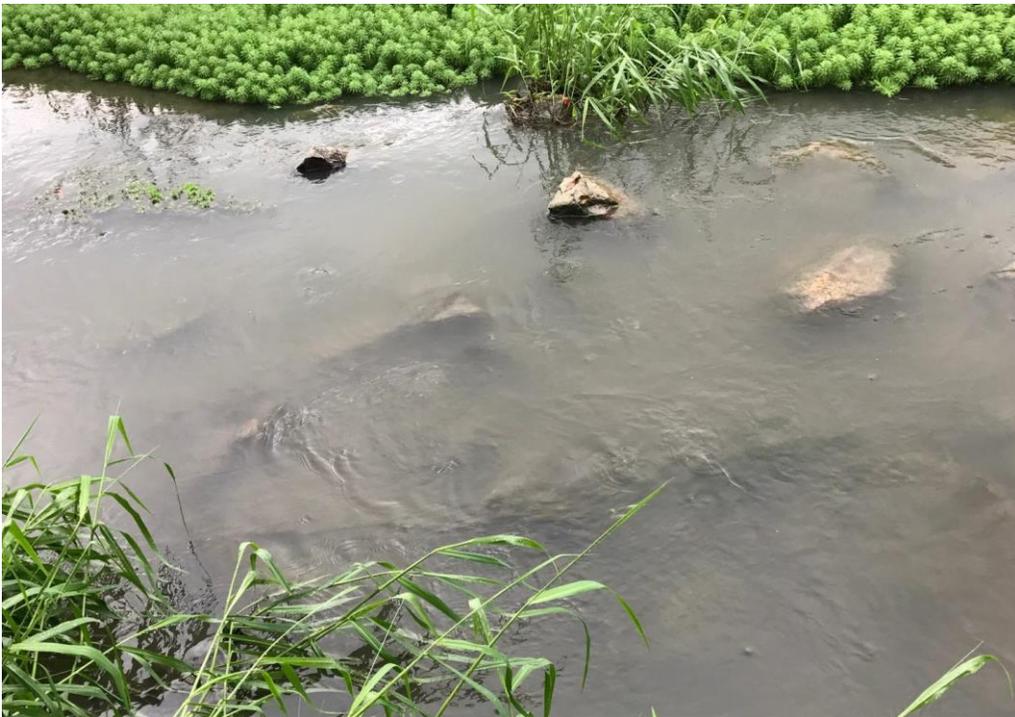
Site photos during water sampling (Date: 31 March 2017)

<b>Date</b>	31 March 2017
<b>Time</b>	12:42 PM
<b>Monitoring Location</b>	I5 - downstream of Ma Wat River at Yuen Leng
<b>Parameter</b>	Suspended Solid
<b>Action / Limit Levels</b>	Action Level: 42.6 mg/L or 120% of upstream control station's SS of the same day (i.e. 36mg/L) Limit Level: 46.8 mg/L or 130% of upstream control station's SS of the same day (i.e. 39mg/L)
<b>Measured Level</b>	40.5mg/L (Limit level being exceeded)
<b>Possible reason for the exceedance</b>	<p>There was rain and the river was muddy due to vigorous water flow. The disturbed riverbed caused an elevation of suspended solids level. Control station C3a also showed elevated suspended solids level due to the adverse weather condition.</p> <p>During the water sampling, the box culvert works had been completed and post monitoring had begun. There was no works being carried out.</p> <p>It is therefore considered that elevation of suspended solids level would be due to natural fluctuation.</p>

<b>Action taken / to be taken</b>	As the non-compliance was non-project related, no further investigation and remedial measure(s) would be required.
<b>Remarks</b>	-
