Entrusted Portion of Widening of Tolo Highway / Fanling Highway between Island House Interchange and Fanling Stage 2

Monthly EM&A Report

July 2017

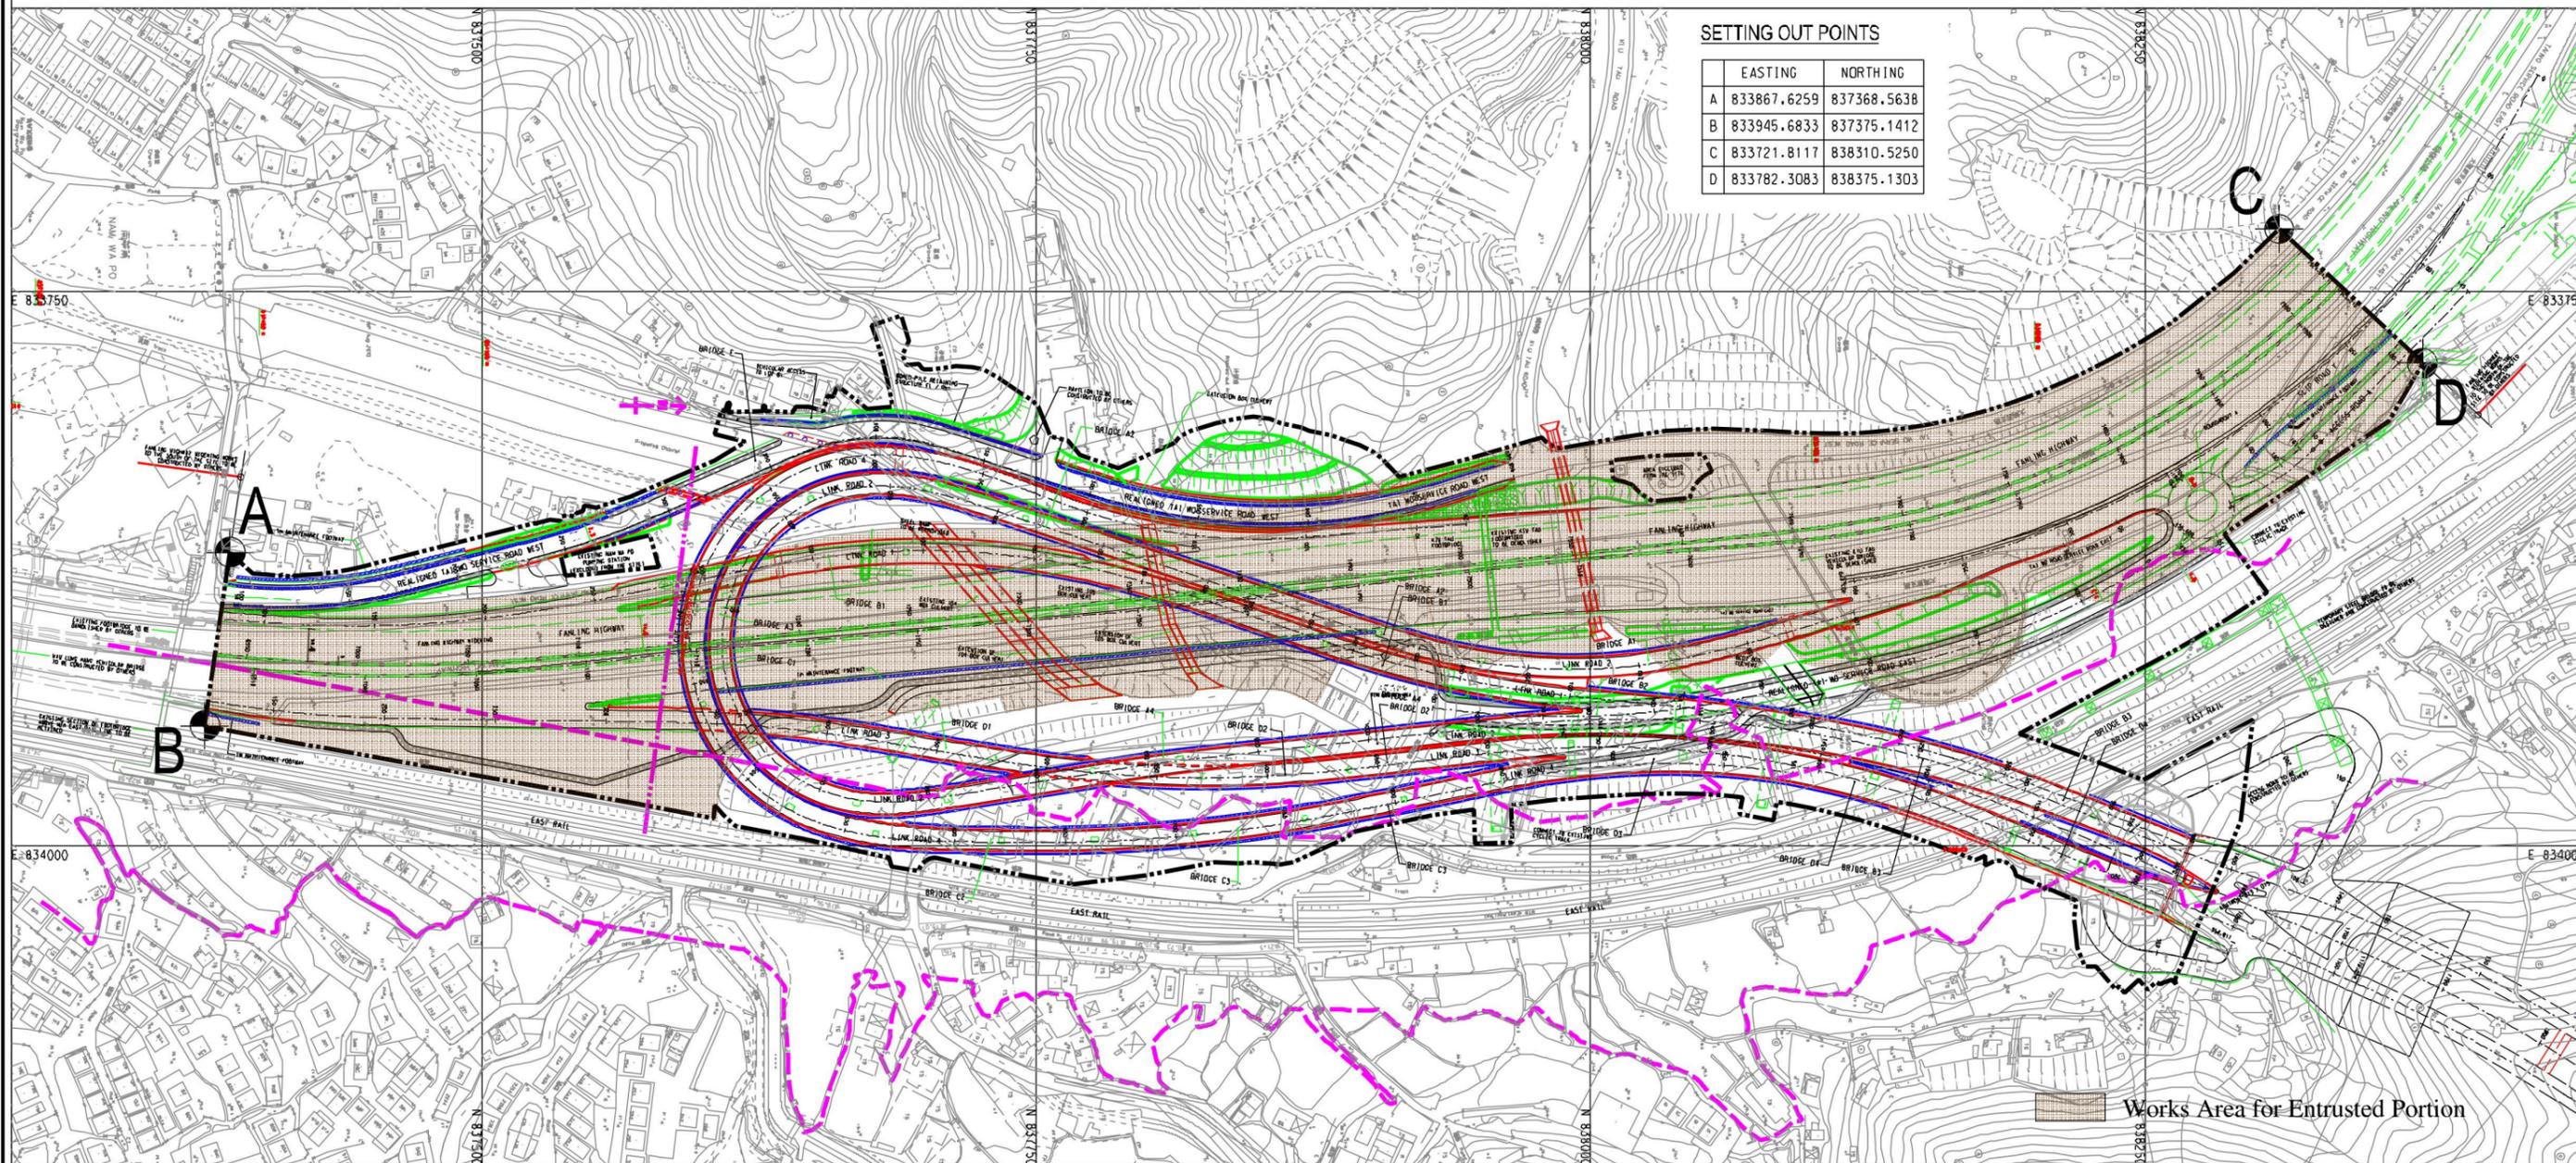
2.2.2 **Figure 1** shows the works areas for the Entrusted Portion of Widening of Tolo Highway / Fanling Highway between Island House Interchange and Fanling Stage 2.
