Contract No. HY/2012/06

**Widening of Fanling Highway  
– Tai Hang to Wo Hop Shek  
Interchange****Monthly EM&A Report  
for February 2014**

[03/2014]

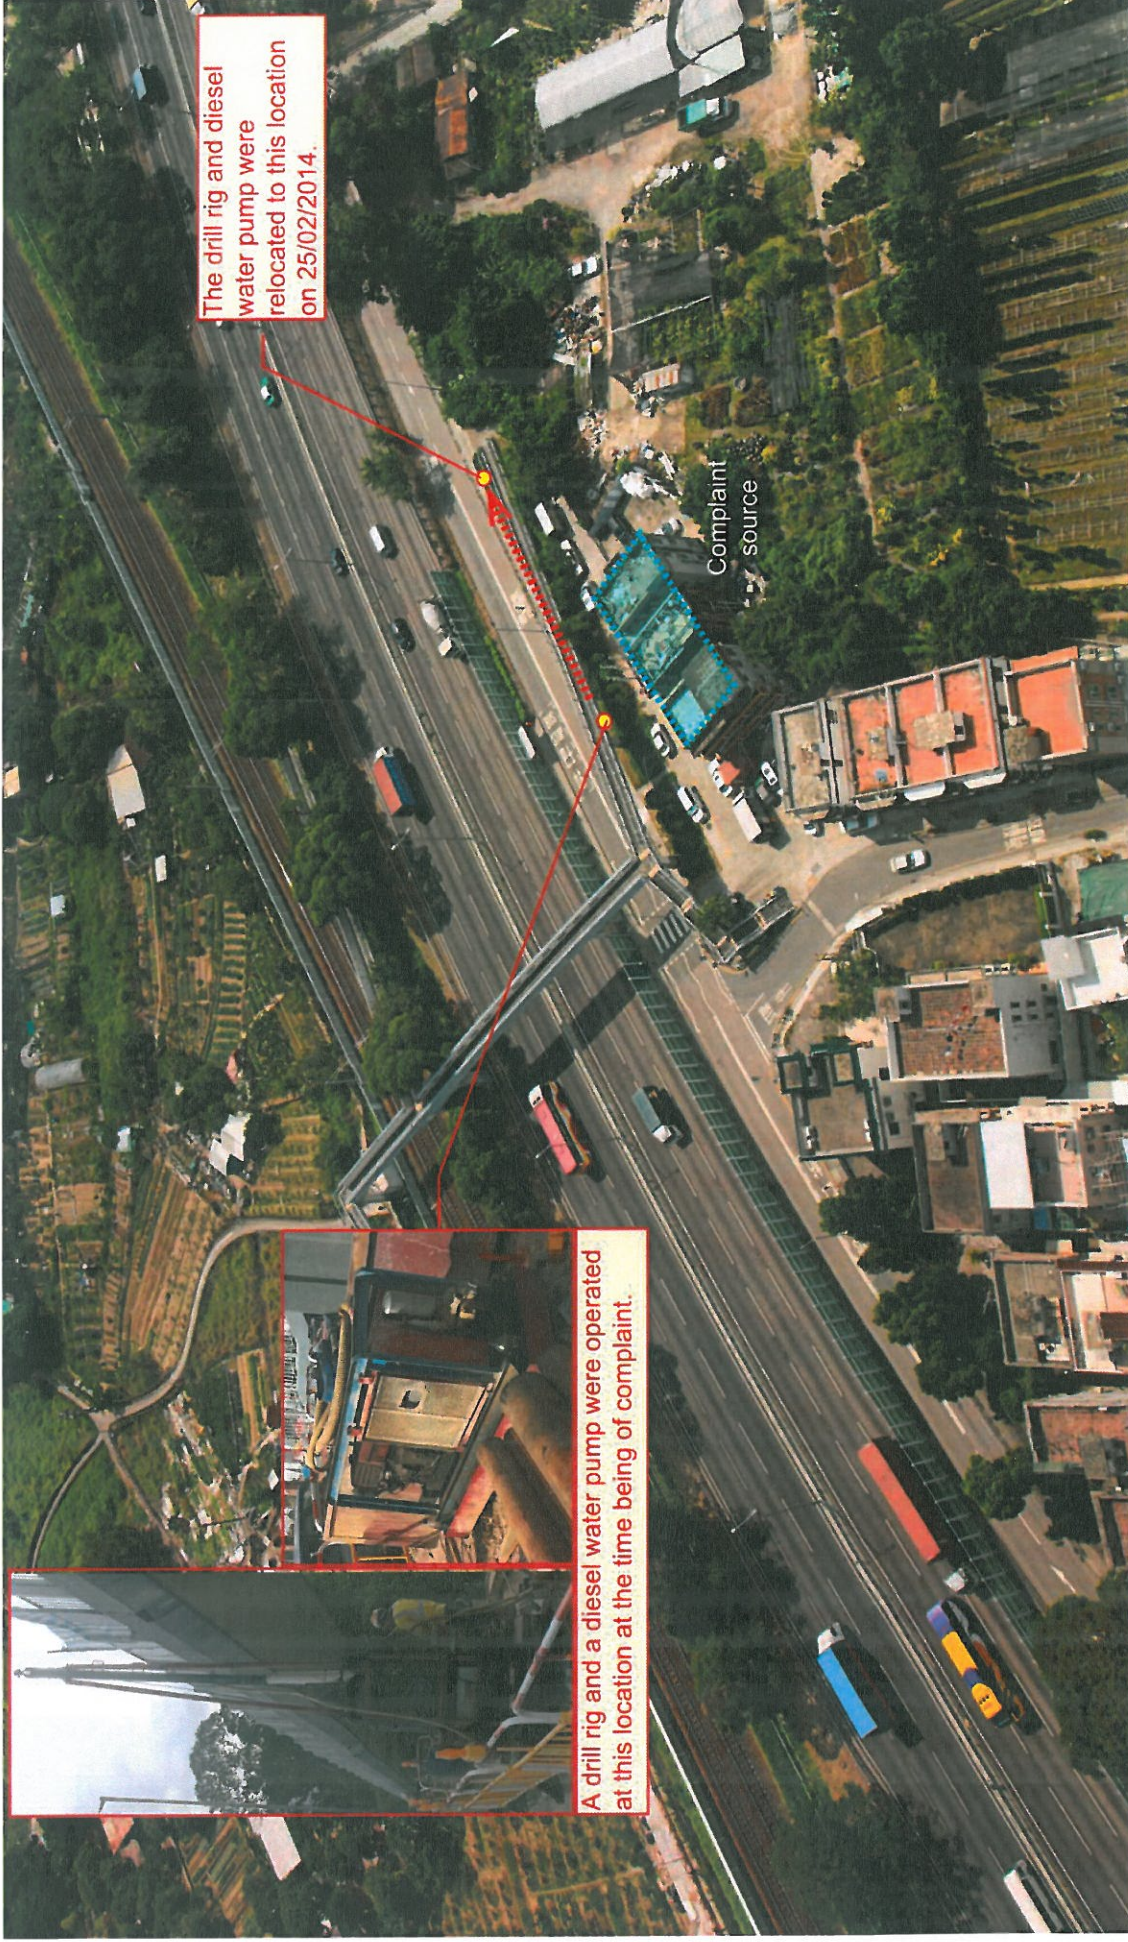
Figure 1A – The concerned drill rig and diesel water pump

<p>Recommended Mitigation Measures:</p> <ol style="list-style-type: none"> <li>1) Extend the exhaust duct of drill rig to a higher position to achieve better gas dispersion to reduce the impact to the residents;</li> <li>2) Reschedule works to minimize disturbance to the residents;</li> <li>3) Inspect the machines regularly to ensure that they are operating efficiently and that exhaust emissions are not causing nuisance;</li> <li>4) Inform residents nearby in advance of any similar works;</li> <li>5) Confirm the implementation of dust mitigation measures during all construction and dusty activities to minimize fugitive dust generation;</li> <li>6) Maintain the frequency of environmental supervision (by the Contractor) to regularly review the adequacy and effectiveness of dust suppression measures to suit the construction progress;</li> <li>7) Inform the complainant before dusty activities are carried out; and</li> <li>8) Foster better public relations with the sensitive receivers and complainants nearby.</li> </ol>

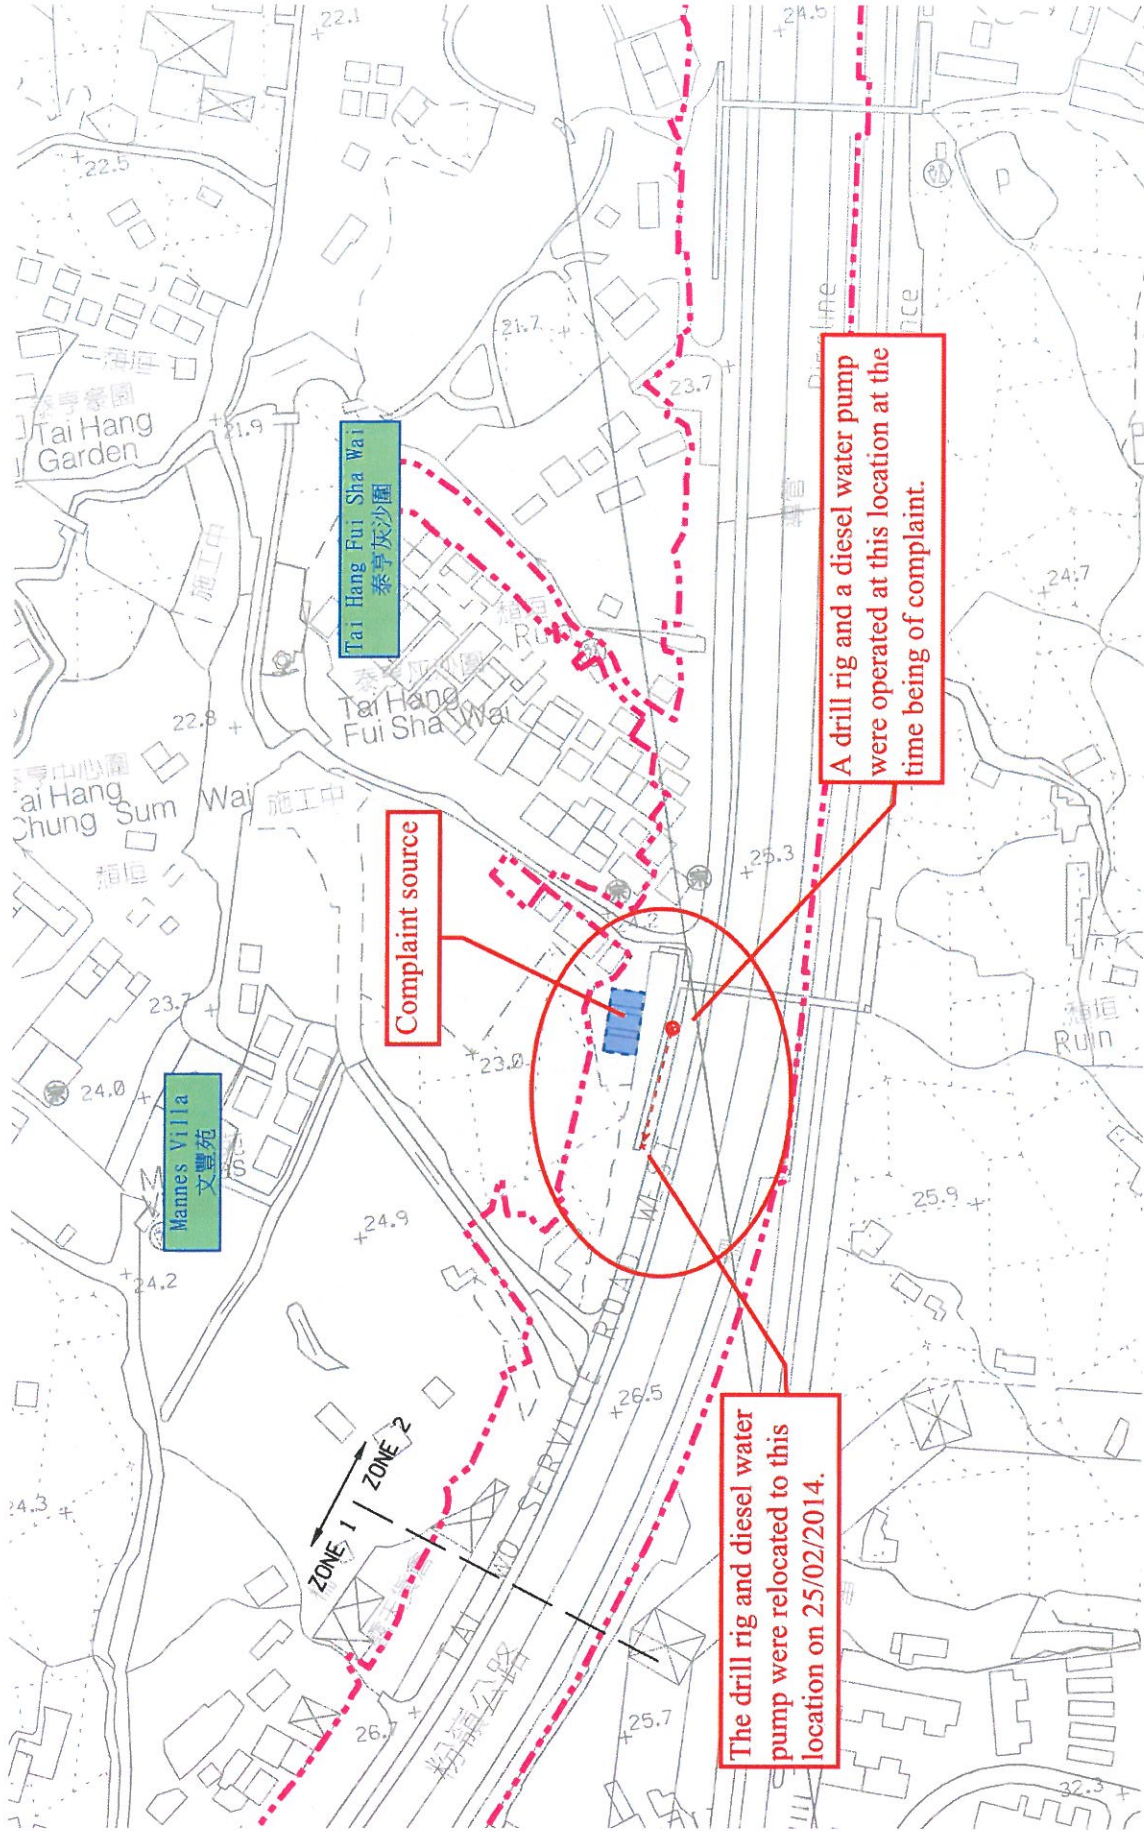
Figure 1B – The concerned drill rig and diesel water pump

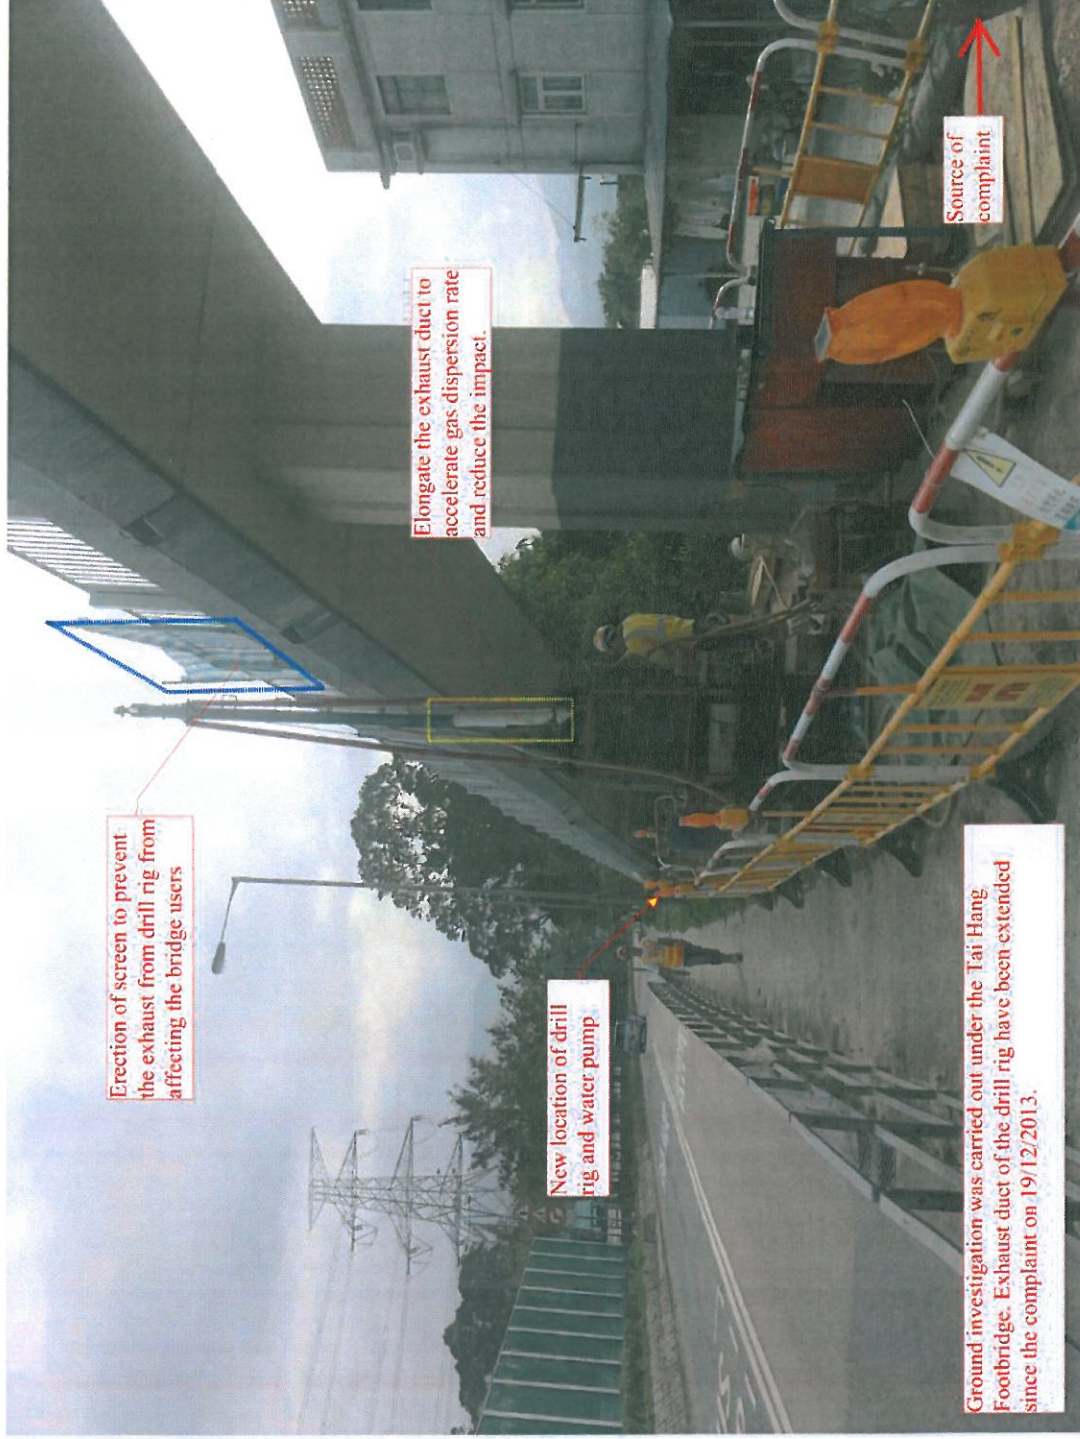
of the exhaust duct is facing the bridge, it cannot be extended too high; otherwise, the bridge users will be affected by the exhaust. In order to further reduce the impacts, a screen was erected to prevent the exhaust of the drill rig from affecting the bridge users. Both the drill rig and diesel water pump were relocated about 30 meters away from the original position on 25 February 2014. Furthermore, the Contractor was reminded to shorten the operation time of the drill rig to minimize the impacts caused to the public.

During the construction works, the Contractor has sprayed water in case there was any fugitive dust emission. Thus, it is believed that the ground investigation works did not involve dusty processes. As seen from Figures 2 and 4, no dust emission was observed.

Figure 2 – Extension of the exhaust duct of drill rig

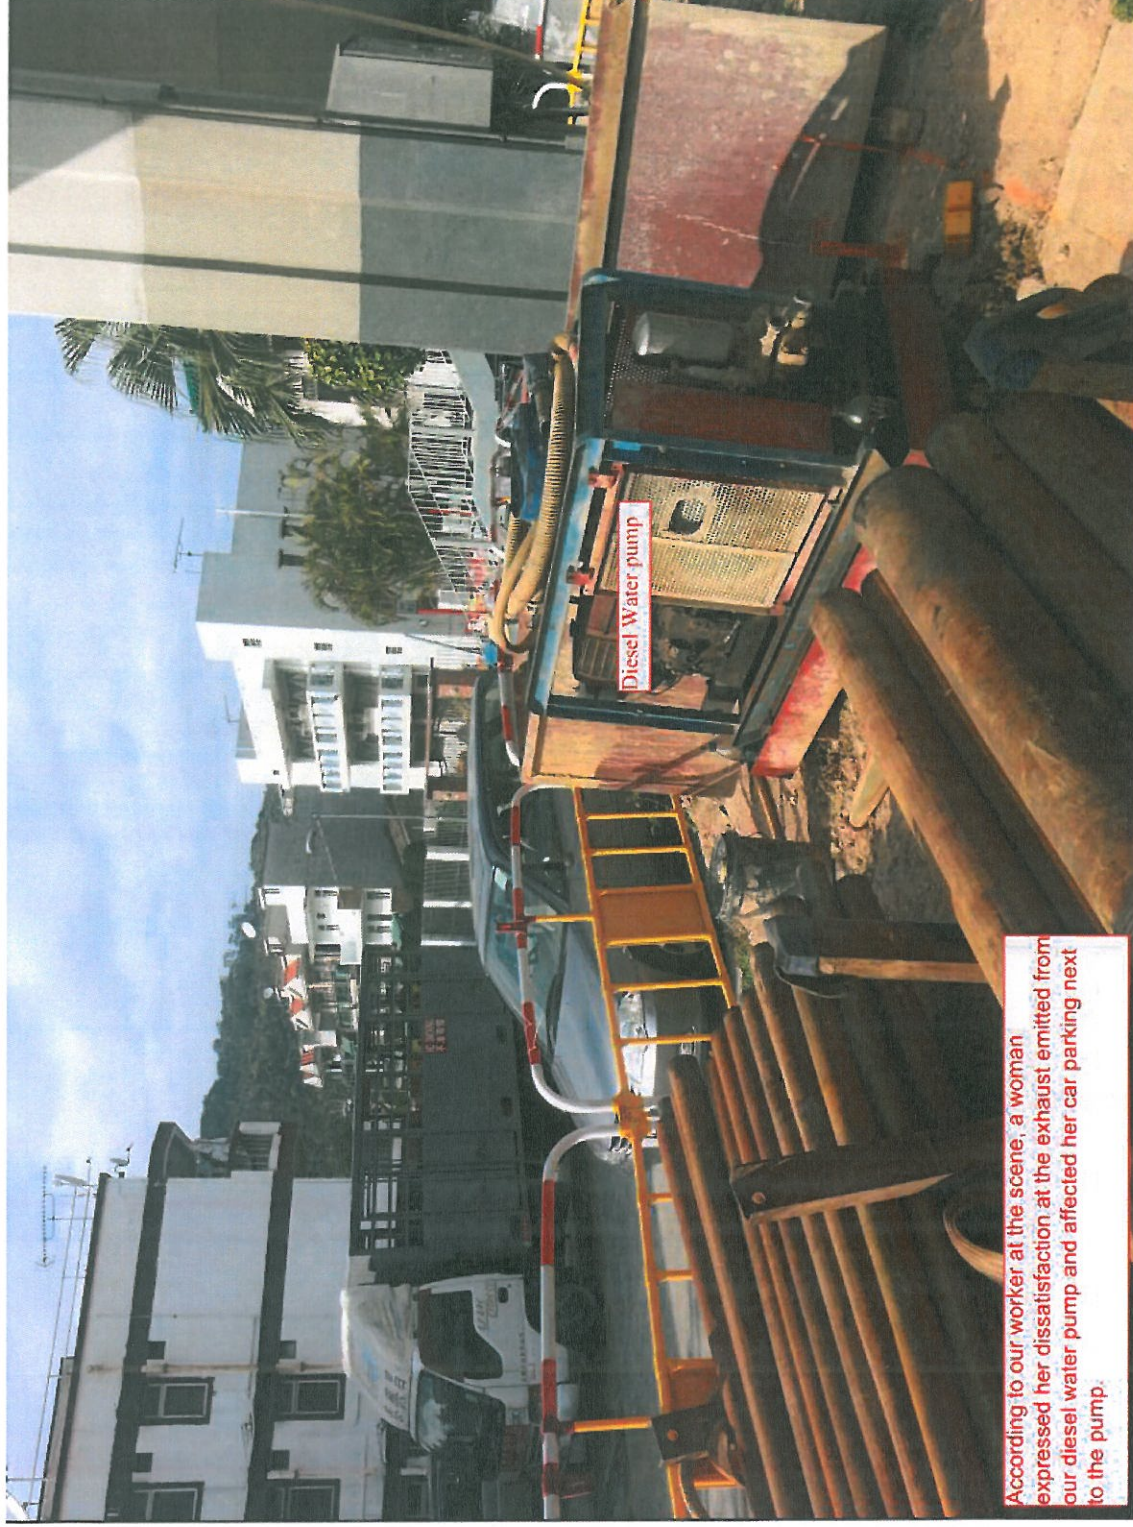
Figure 4 – No observed dust emission from the diesel water pump
