Contract No. HY/2012/06

**Widening of Fanling Highway
- Tai Hang to Wo Hop Shek
Interchange****Monthly EM&A Report
For September 2018**

Environmental Monitoring and Audit (EM&A) for Widening of Tolo Highway/Fanling Highway between Island House Interchange and Fanling Stage 2 (between Tai Hang to Wo Hop Shek Interchange)
Environmental Permit No. EP-324/2008/E Condition 3.3 – Submission of Monthly EM&A Report – September 2018 for the portion of Stage 2 works under Contract No. HY/2012/06

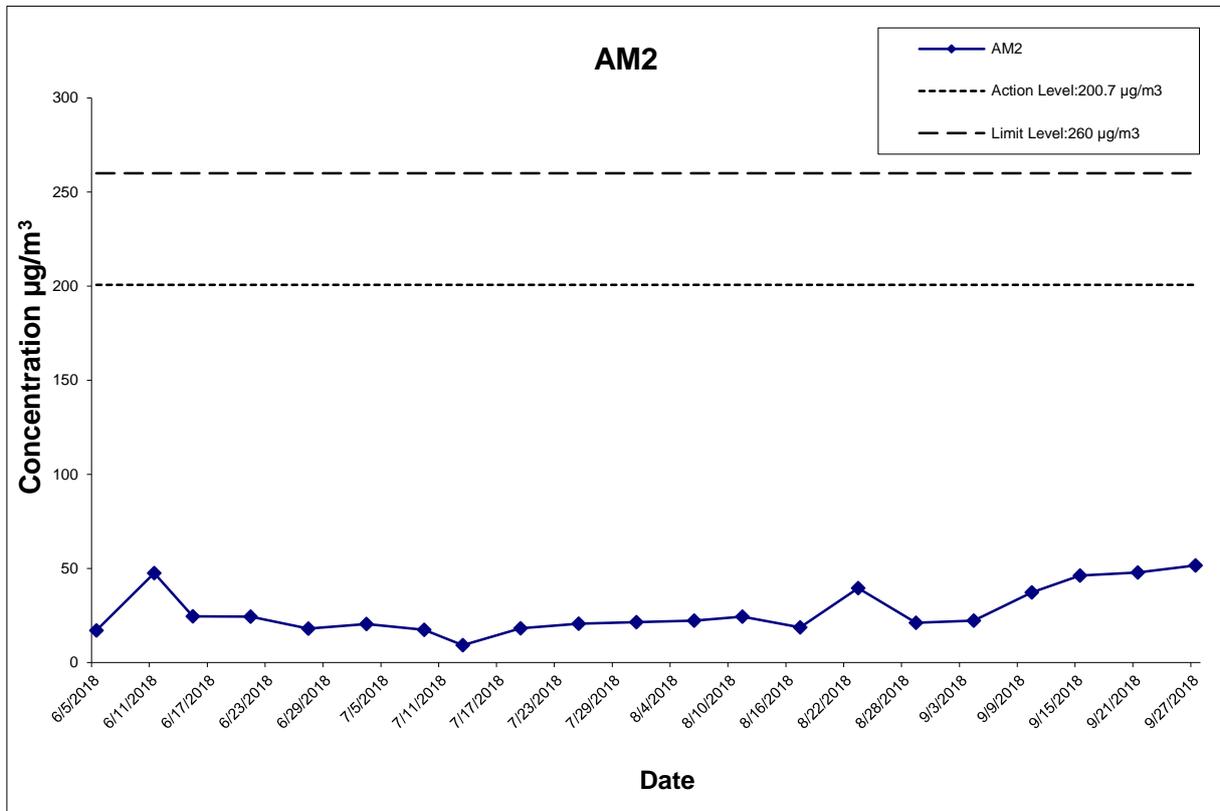
1-hour TSP Monitoring Results at Station AM2
(Fanling Government Secondary School)

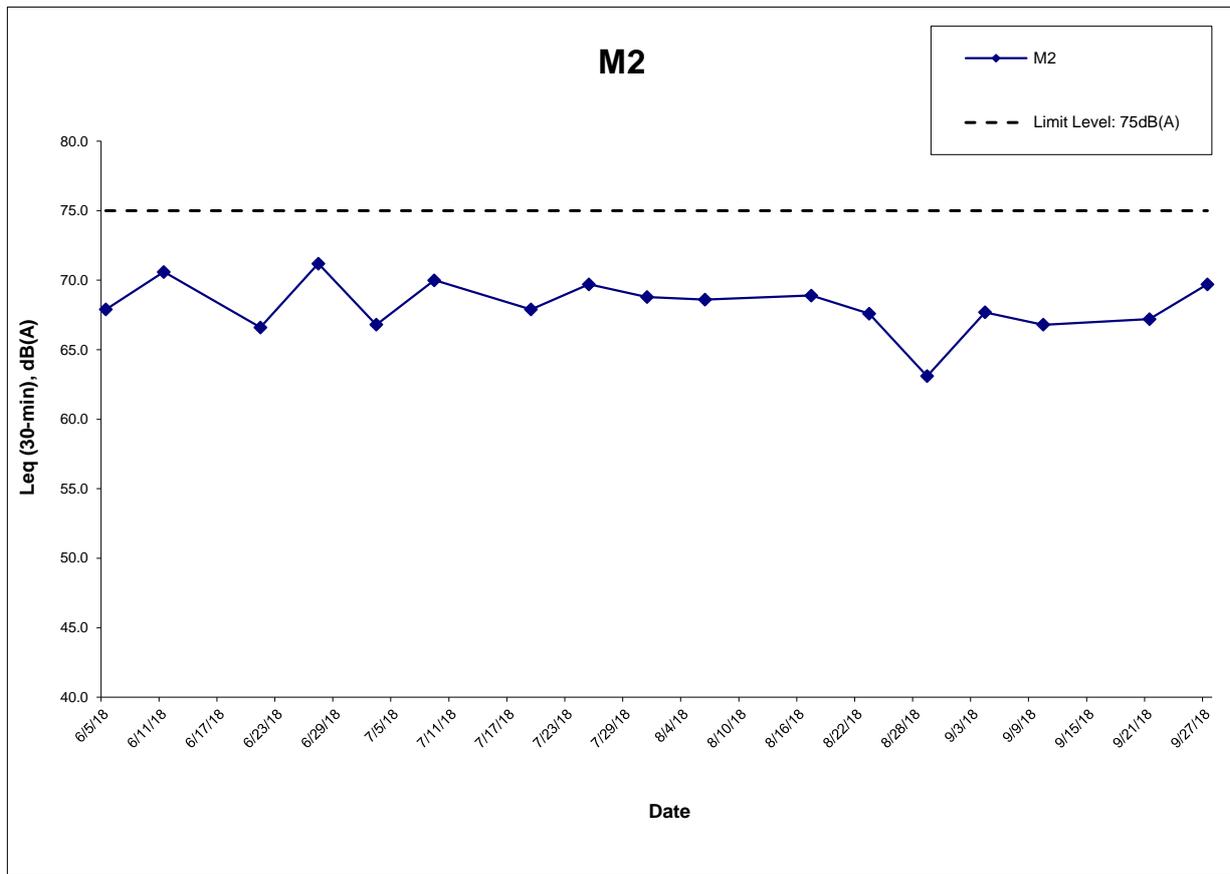
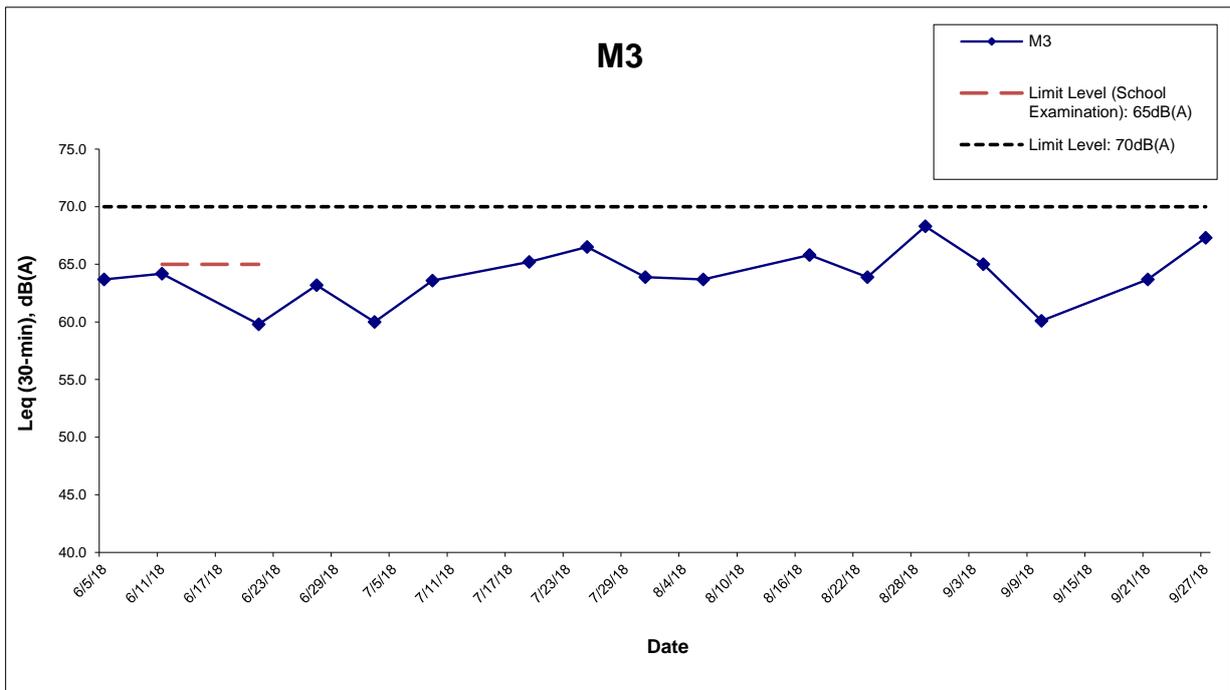
* +3dB(A) Façade effect correction included

^ Limit Level of 70dB(A) applies to education institutes while 65dB(A) applies during school examination period.

^ Limit Level of 70dB(A) applies to education institutes while 65dB(A) applies during school examination period. Examination period of Fanling Government Secondary School (M3) in this reporting period is 8 - 26 June 2018.
